# City of Carpinteria

## Environmental Review & Monitoring

### Status Report

### 2012

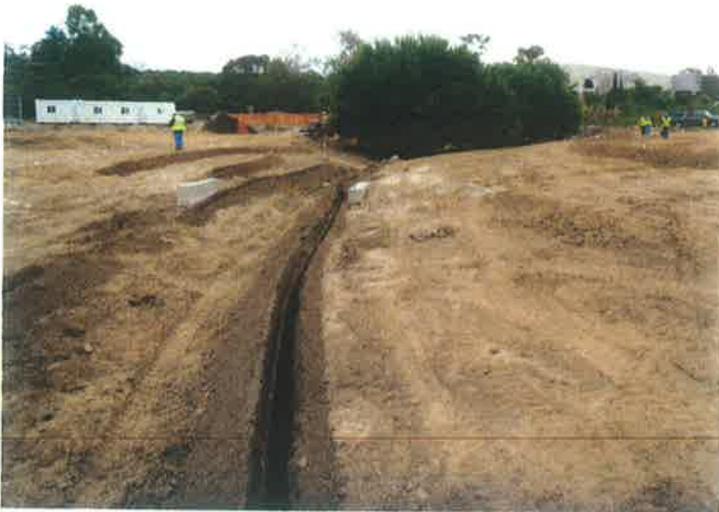
***Preparation of the stream channel –  
installation of the irrigation system.***

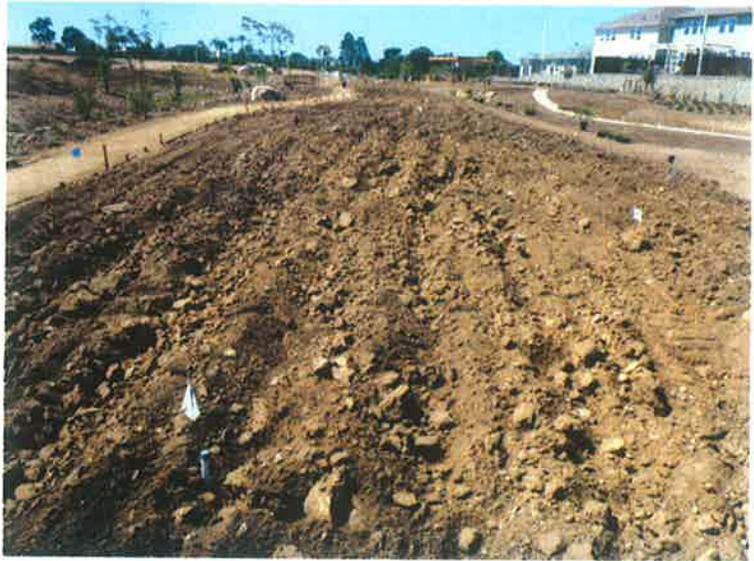
***Decompaction of the restoration area  
prior to planting.***

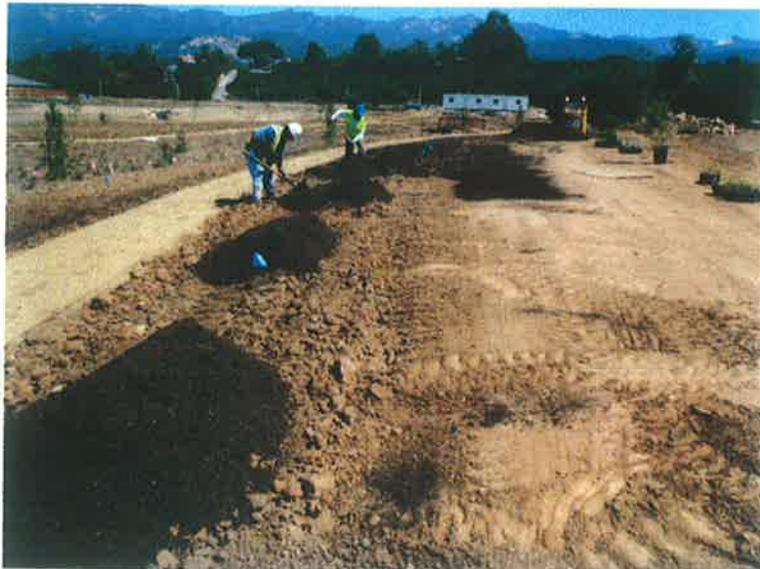
***Adding soil amendments prior to  
planting the native trees and shrubs.***

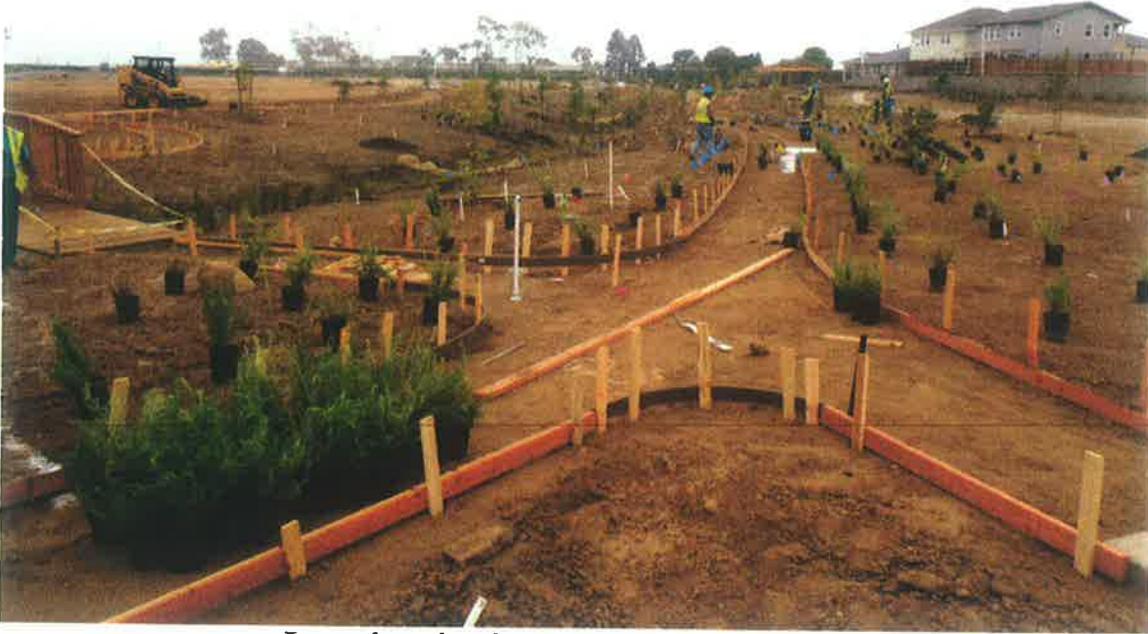
***Lagunitas riparian restoration work.***

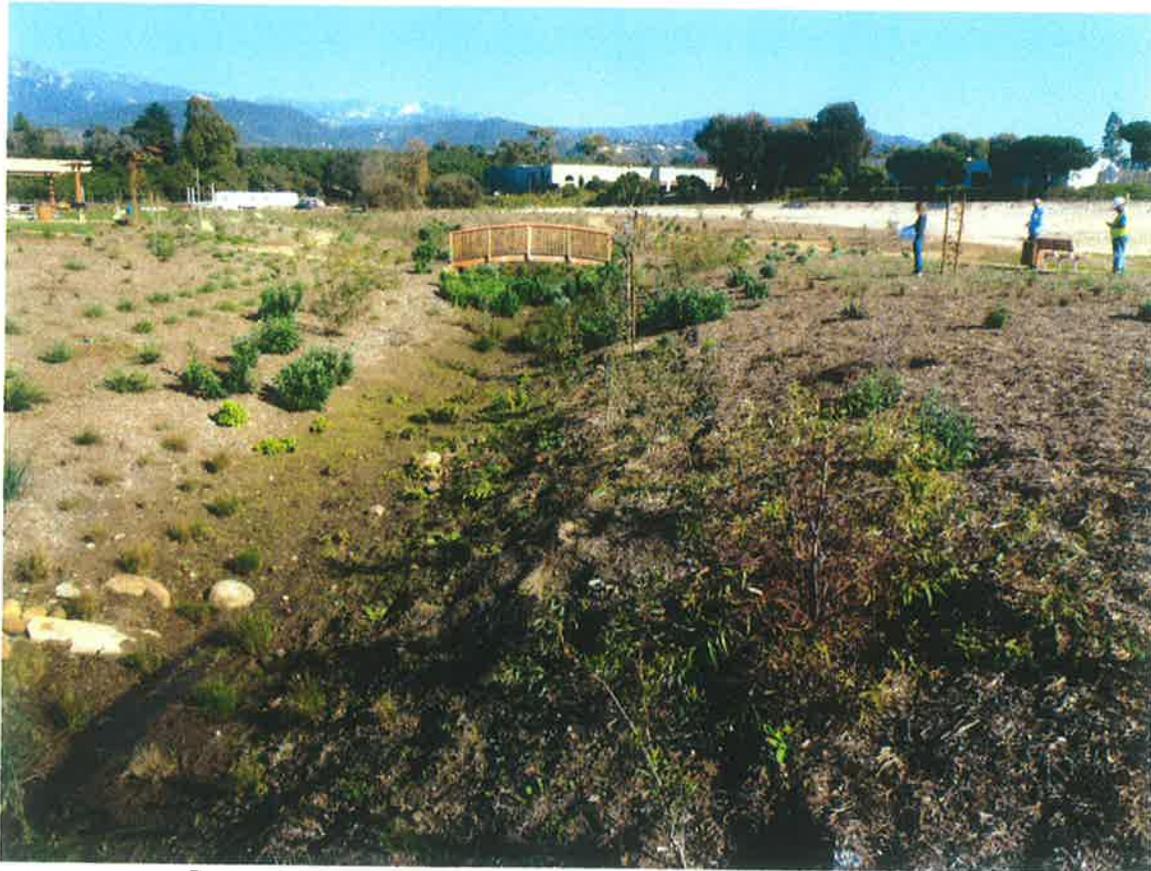
By early October the creek restoration had been completed and it looked good. Oversight will continue, checking on the health of the plantings and watching for any weed invasion; this will continue until the established performance criteria is attained. Outstanding issues include the eventual removal of the bougainvillea along the entrance road – to be replaced by native vegetation.

***Lagunitas Creek restoration nearing completion.***

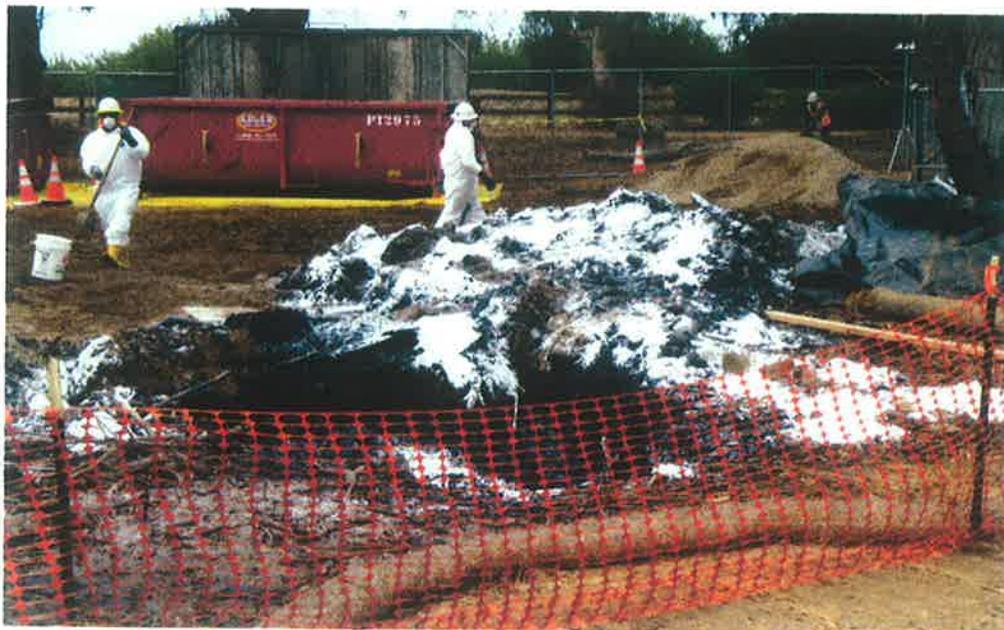
***Excavation of the old Kittie Bailard oil well.***

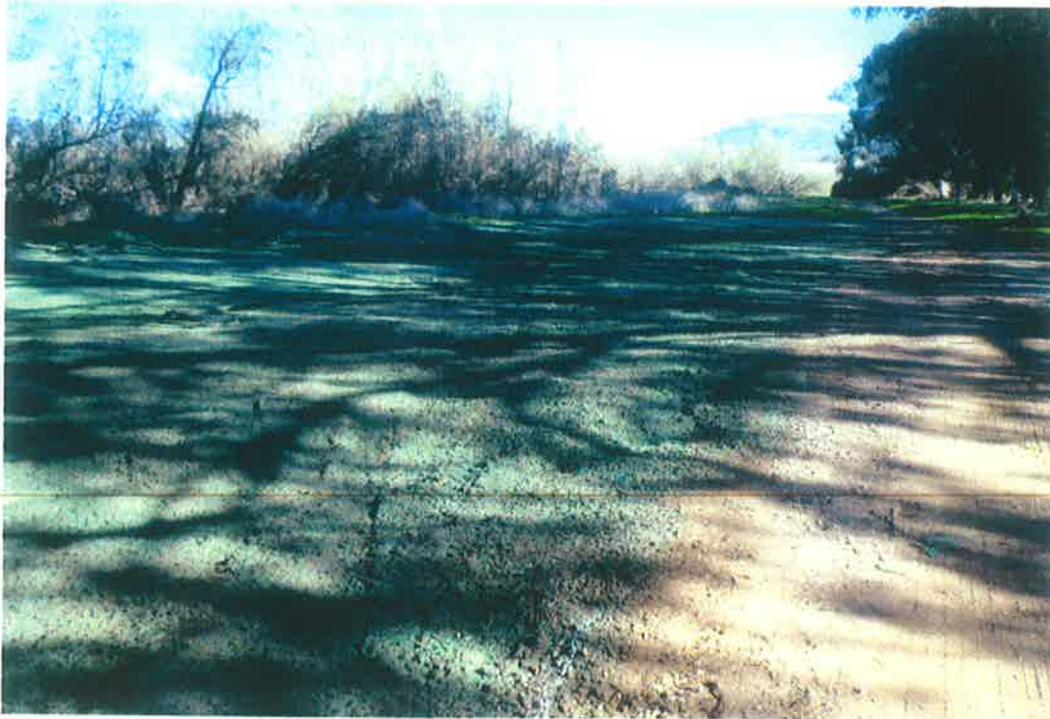
***Final Hydroseeding of the Kittie Bailard site.***

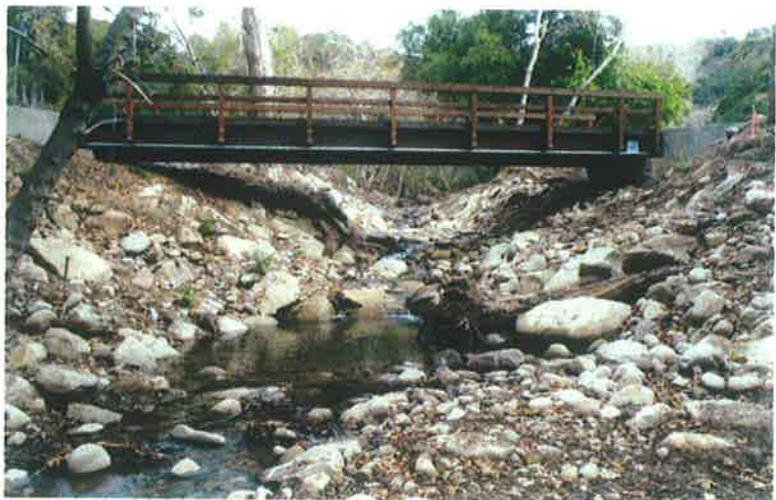
***New Widdoes bridge over the restored stream channel.***

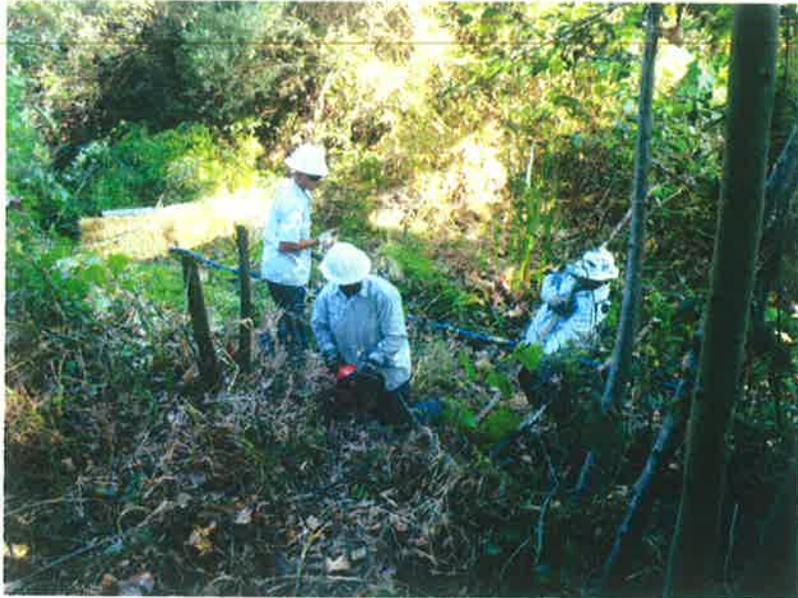
***Flood Control hand crews removing vegetation.***

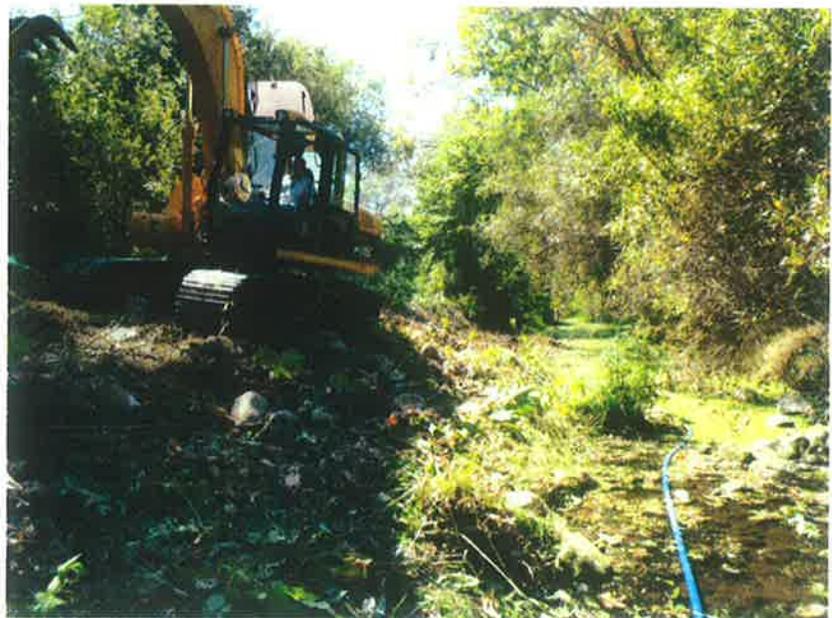
***Excavator brought in to remove the gravel berm within Carpinteria Creek.***

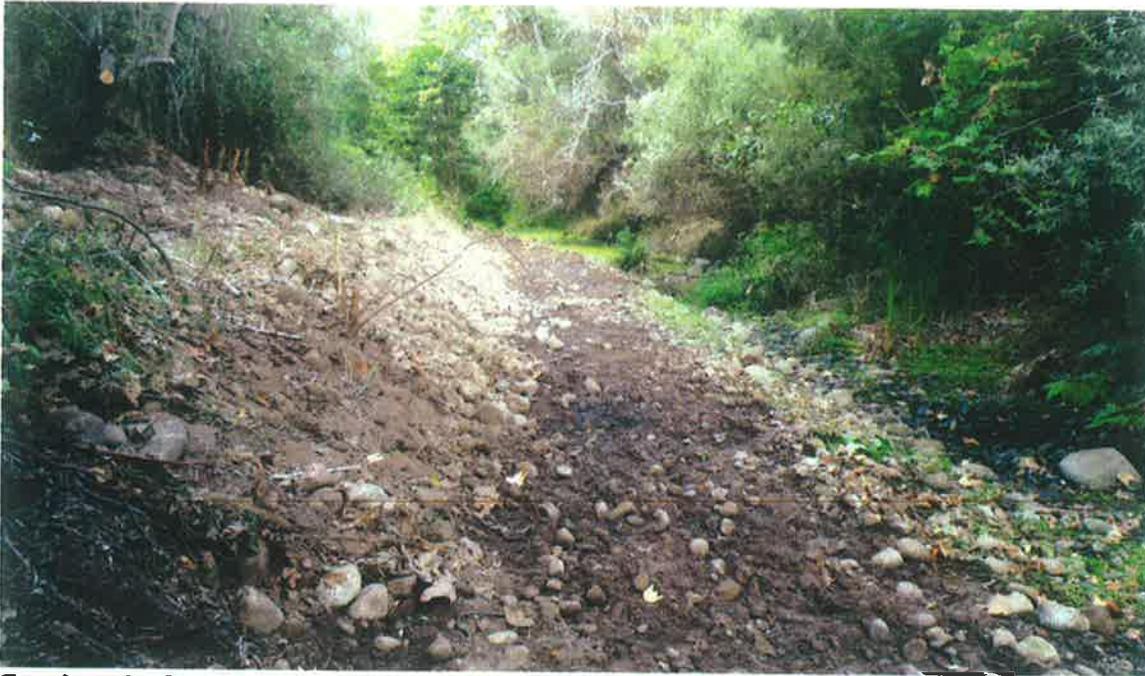
***Carpinteria Creek after the gravel berm was removed by Flood Control crews.***

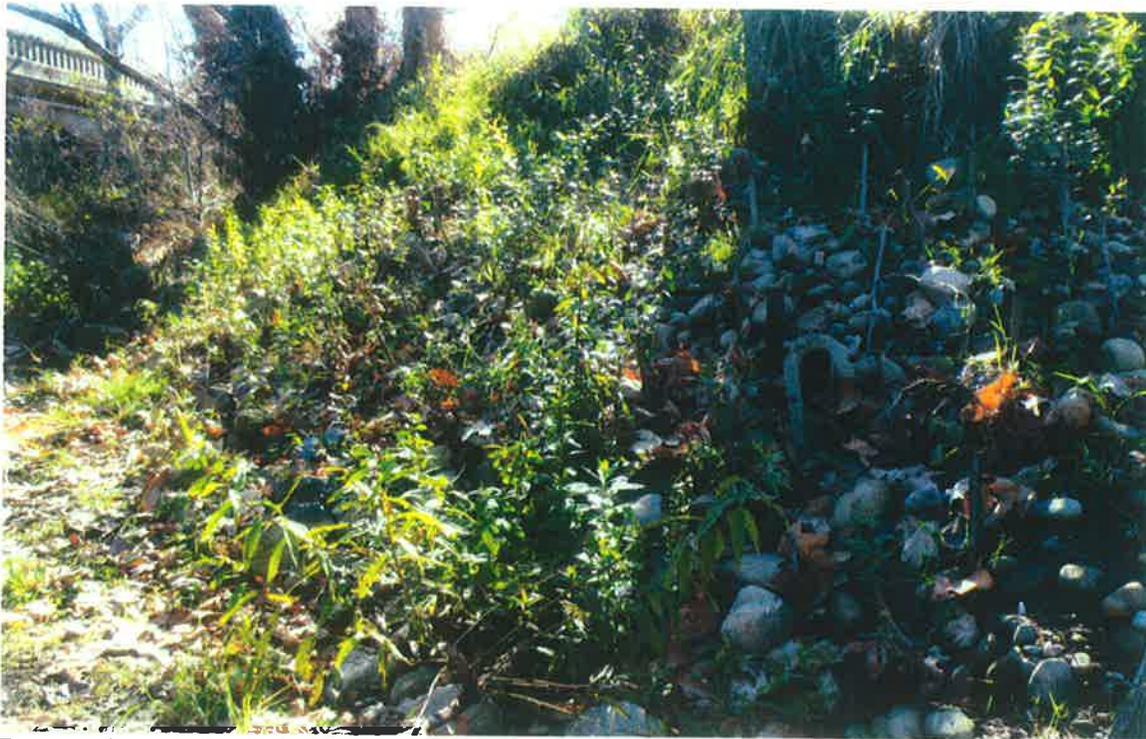
***Restored creek bank following the Flood Control work – note willows resprouting.***

One interesting revegetation note is that the willow root balls removed and replanted by the excavator did not take – fortunately the willow cuttings did really well. The site will need to be monitored since the low rainfall over the 2012/13 winter may not have allowed the willow cutting to establish good, deep root systems.

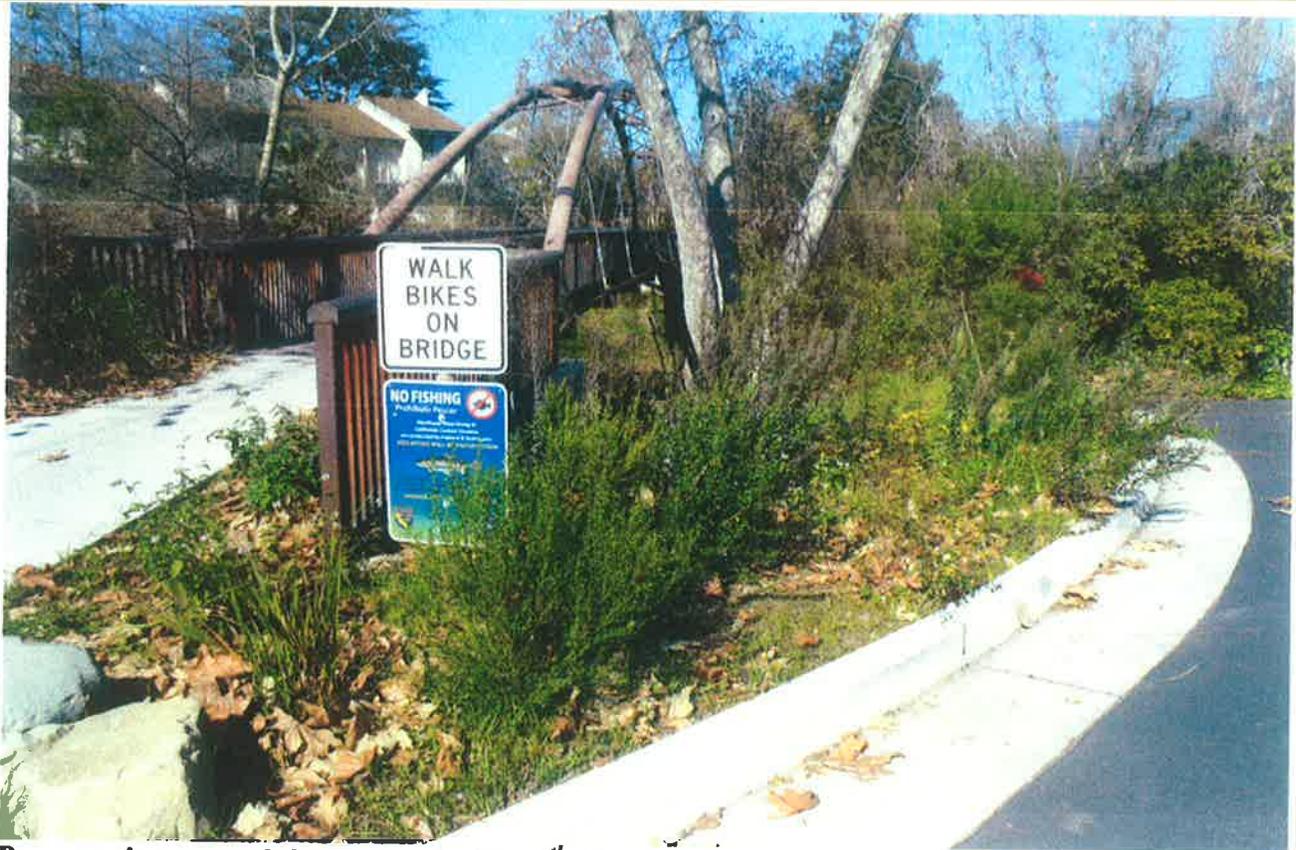
**4.1 8<sup>th</sup> Street Bridge Replacement Project:** Weeding and some additional plantings were undertaken in 2012. The restoration effort looks good with most of the weeds being removed from the impacted area and with a nice variety of well-established native plants. The willows and sycamores are getting tall and the native understory looks healthy with even a small patch of native orchids growing under the west side of the bridge.

**Revegetation around the East end of the 8<sup>th</sup> Street Bridge**

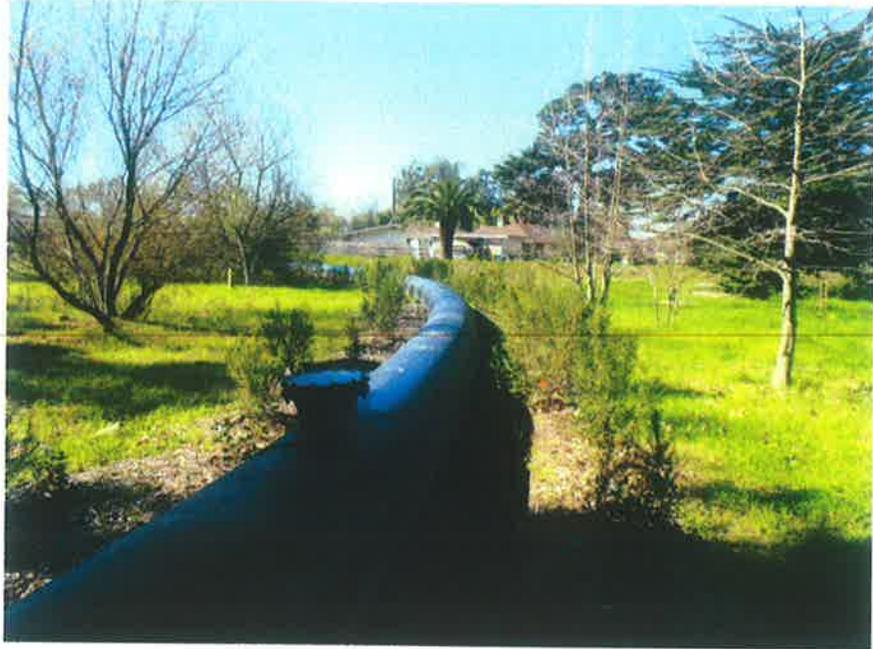
***Restoration within the Chevron/Venoco Soil Remediation Project.***

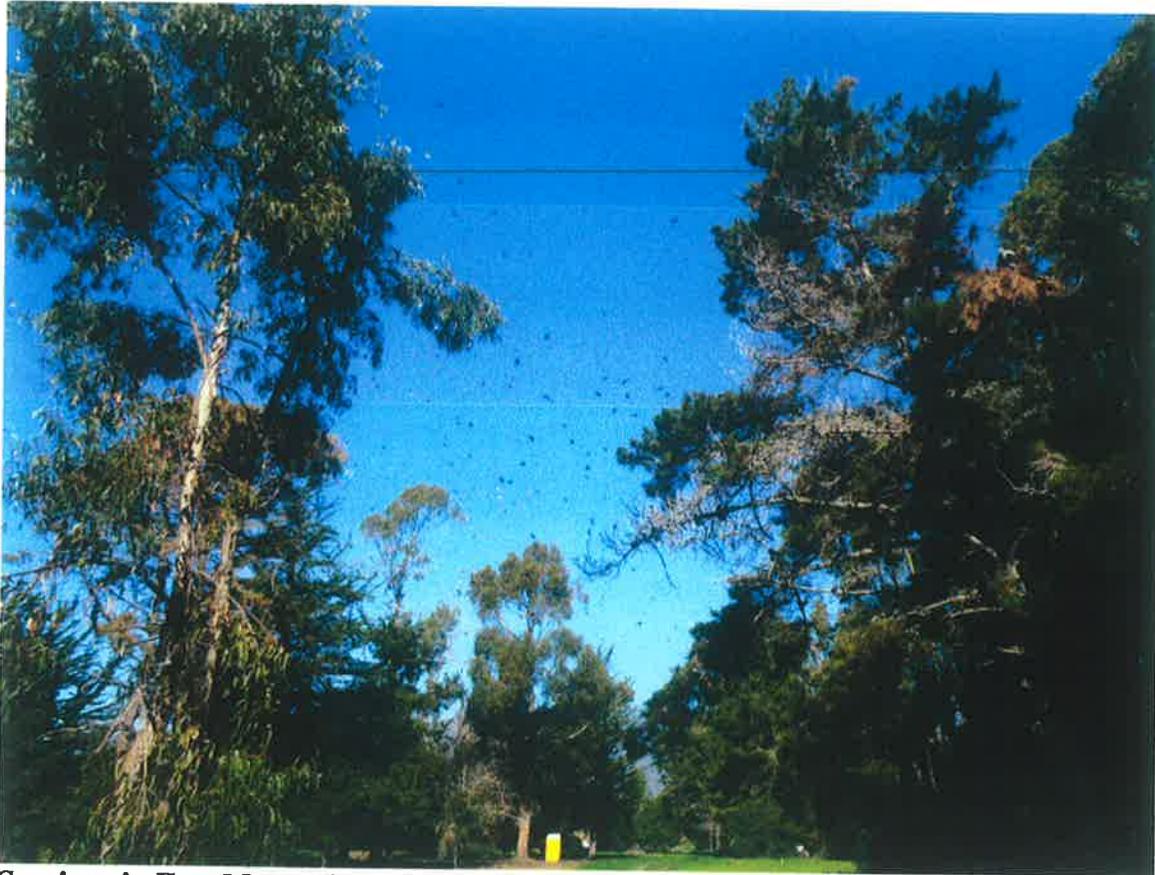
*Carpinteria East Monarch Roost site (Site 100) within the Venoco Buffer parcel.*

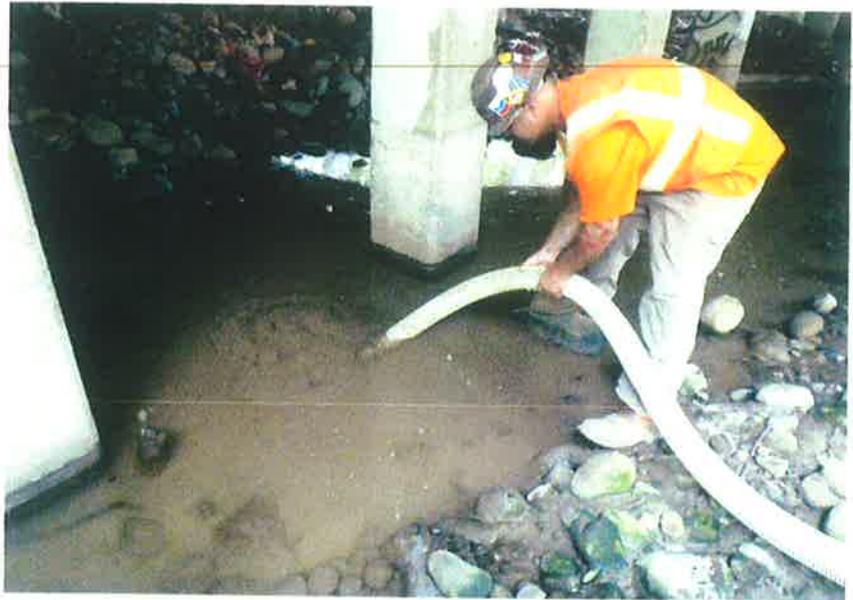
*Crew sucking drilling mud out of Carpinteria Creek.*

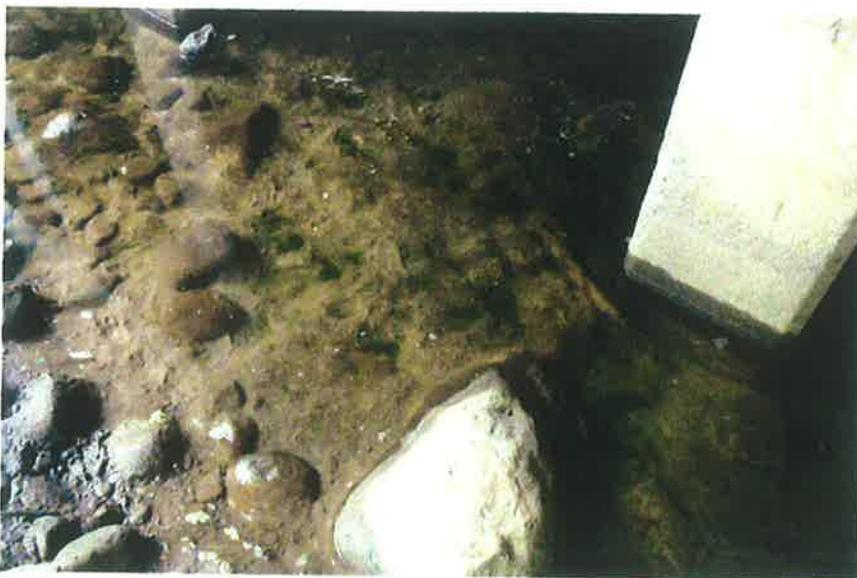
*Drilling muds remaining in the creek several weeks after the Frack-out – note the raccoon tracks and the moss already growing on the mud.*

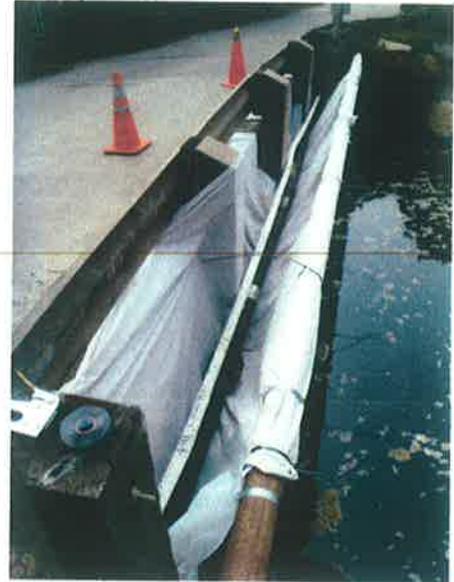
May 2012 met with a painting crew along Padaro Lane where they are repainting pipes that cross the creek corridors. The crews needed to clean and grind the piping prior to repainting so they have hung heavy plastic under the pipe to capture the rusty metal and splattered paint. They set up an excellent catchment system – see the attached photo.
