**CITY OF CARPINTERIA
TREE ADVISORY BOARD
Thursday, February 18, 2016**

1. Stone Pine Assessment & Management Plan Discussion
2. Heath Ranch Park Tree Matters

MEETING MINUTES OF THE TREE ADVISORY BOARD
THURSDAY, NOVEMBER 5, 2015

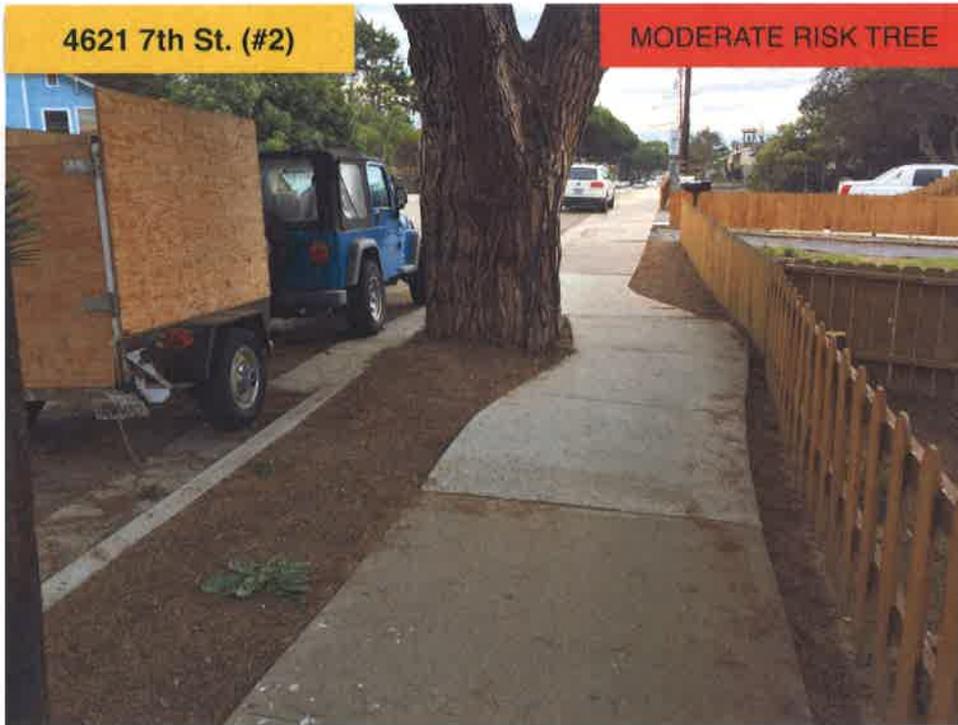
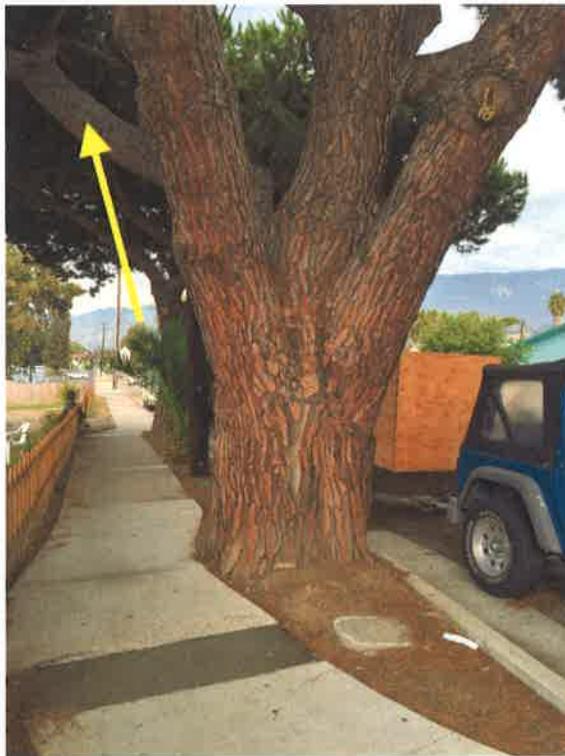
Leader to west, toward residence (yellow arrow), and 12" limb over road, could be removed and others lifted to reduce weight. Consider bulb out as option for curb and more space for roots. Note damage and repairs to sidewalk.

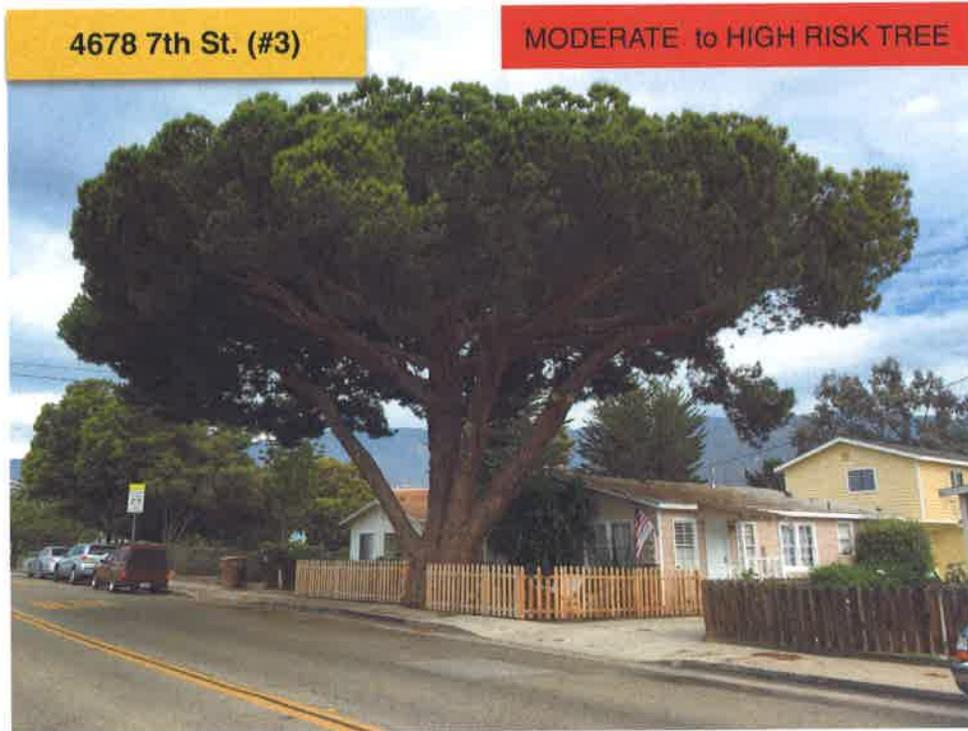
Partially on residential property. Very dense and heavy crown. Prune to reduce the number of leaders & lift horizontal limbs. (more photos on next page)

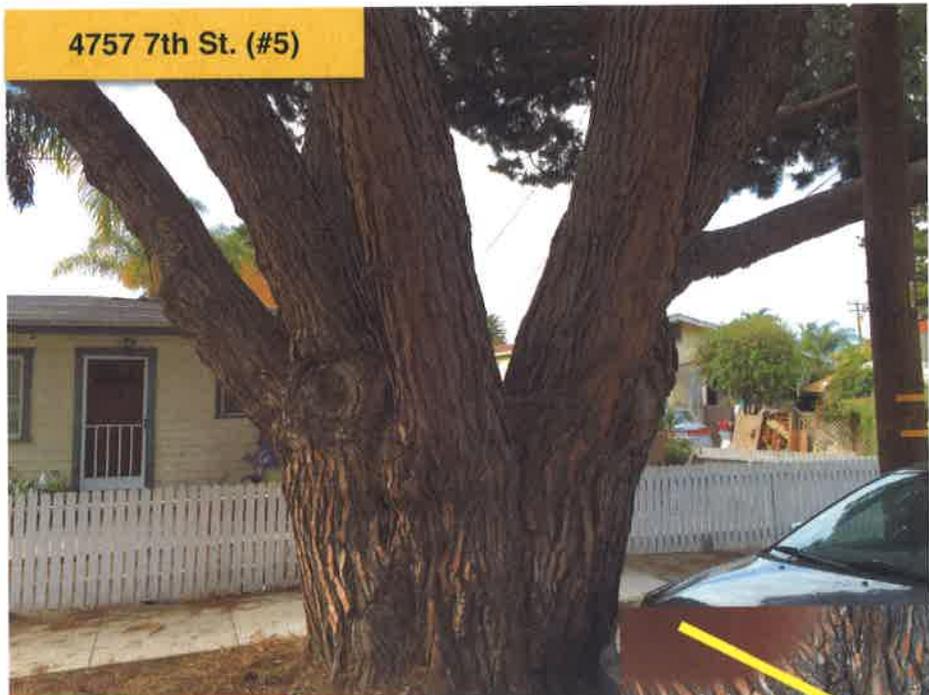
HIGH RISK TREE

Note damage to curb and gutter. Consider bulb out.

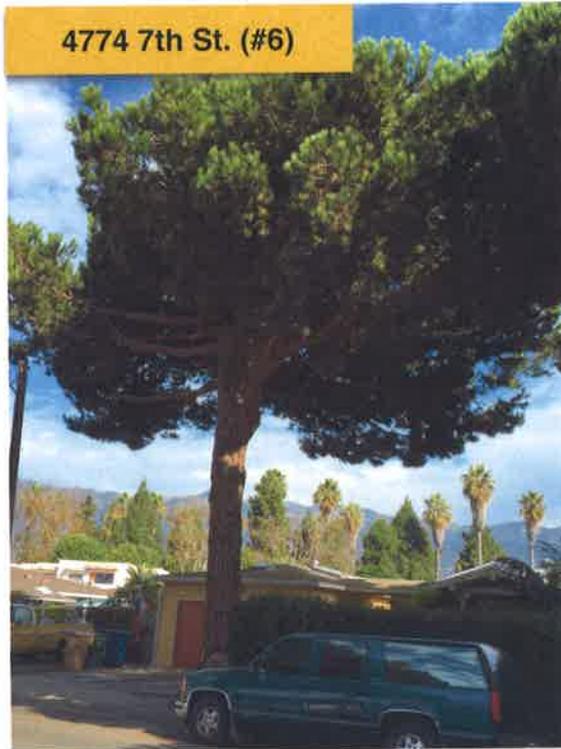
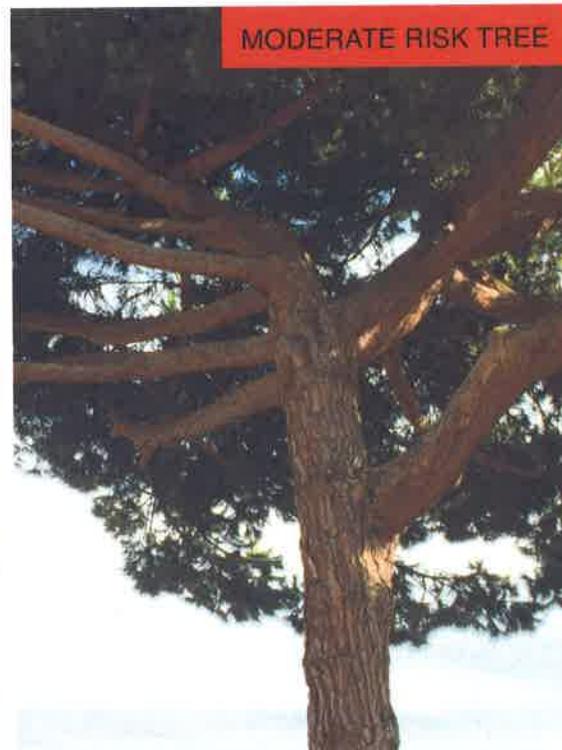
Partially on residence's property or east edge of sidewalk. Crown thin to reduce end weight. A second trunk had been removed. Bulb out is option. Note damage to sidewalk.

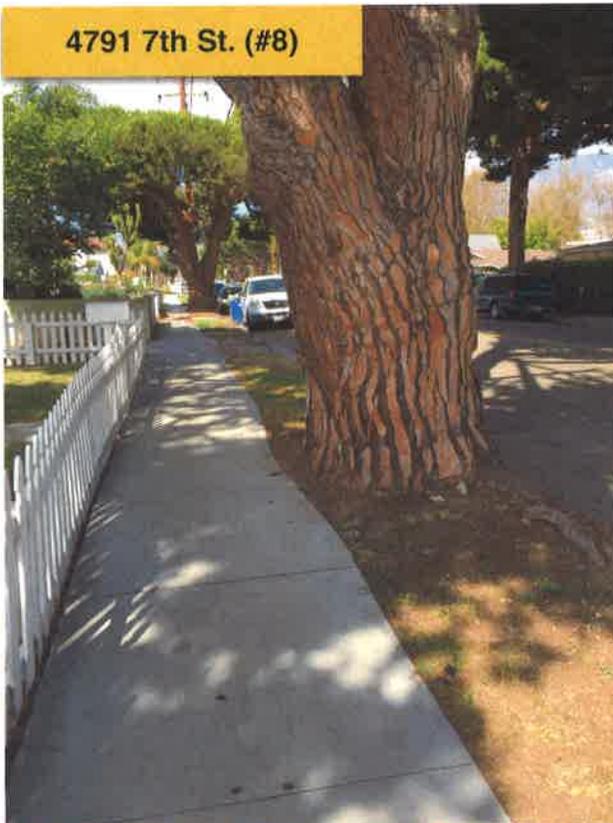
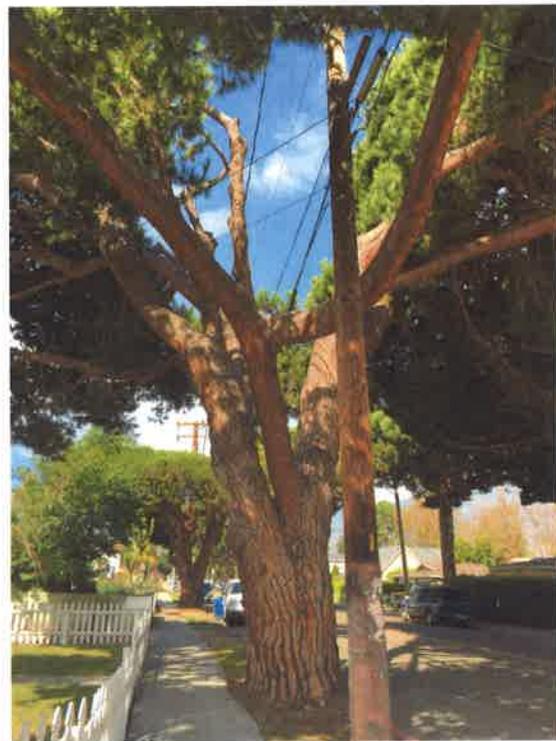
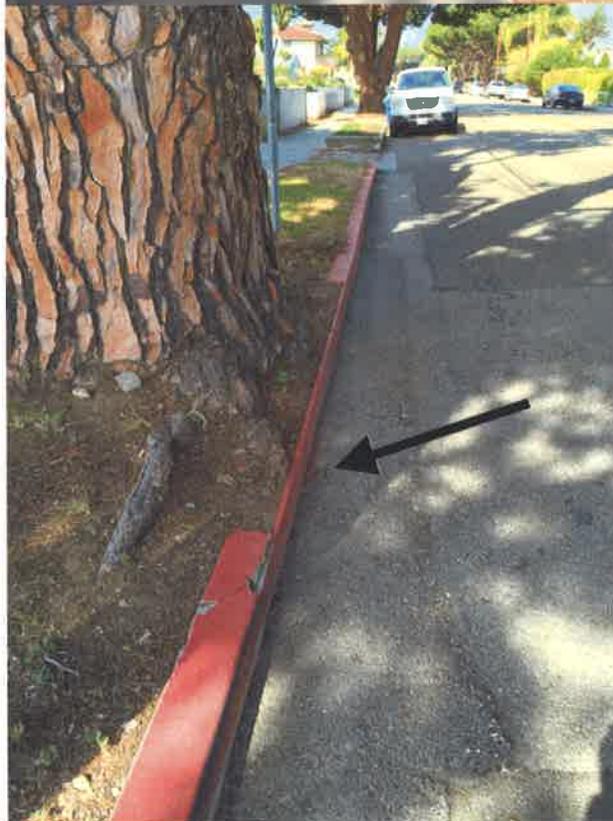
HIGH RISK TREE

Curb was nicely repaired with a steel curb, which appears to be holding up although the adjacent concrete is cracked. Due to the poor form, this tree could be considered for removal. Otherwise, it warrants a high degree of pruning to reduce weight and spread of all lateral limbs.

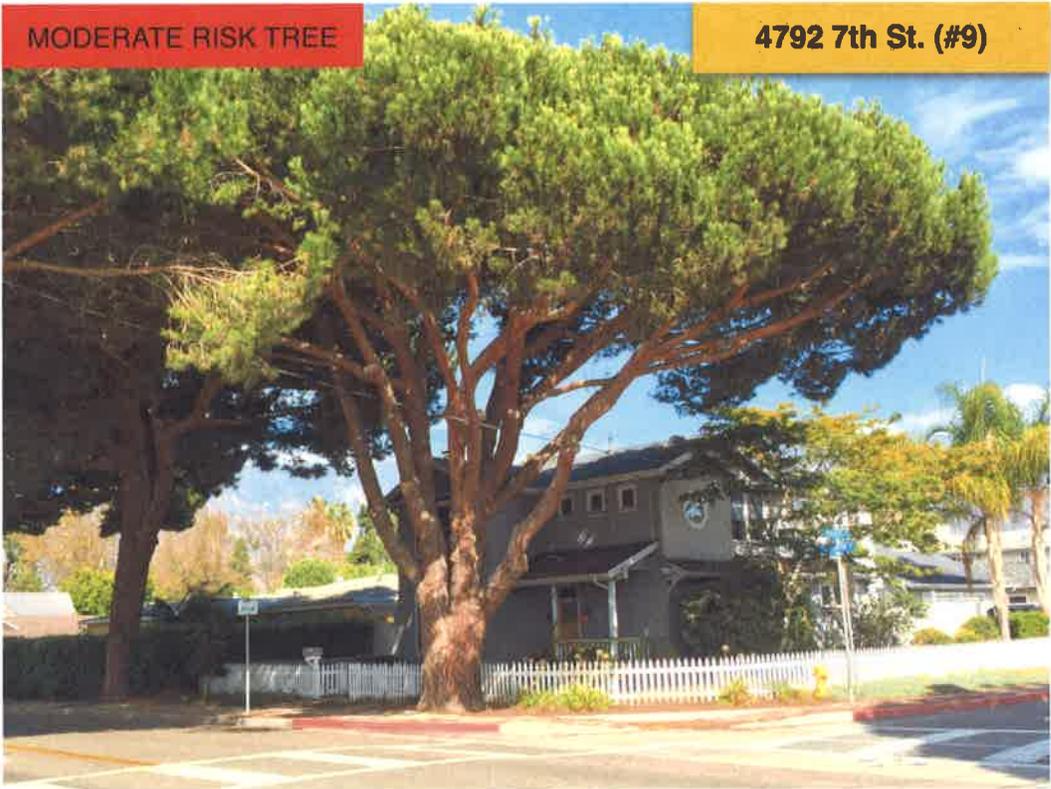
4792 7th St. (#9)

Limbs are heavy on leader toward house. Tree is on corner and bulb out option in future not likely.

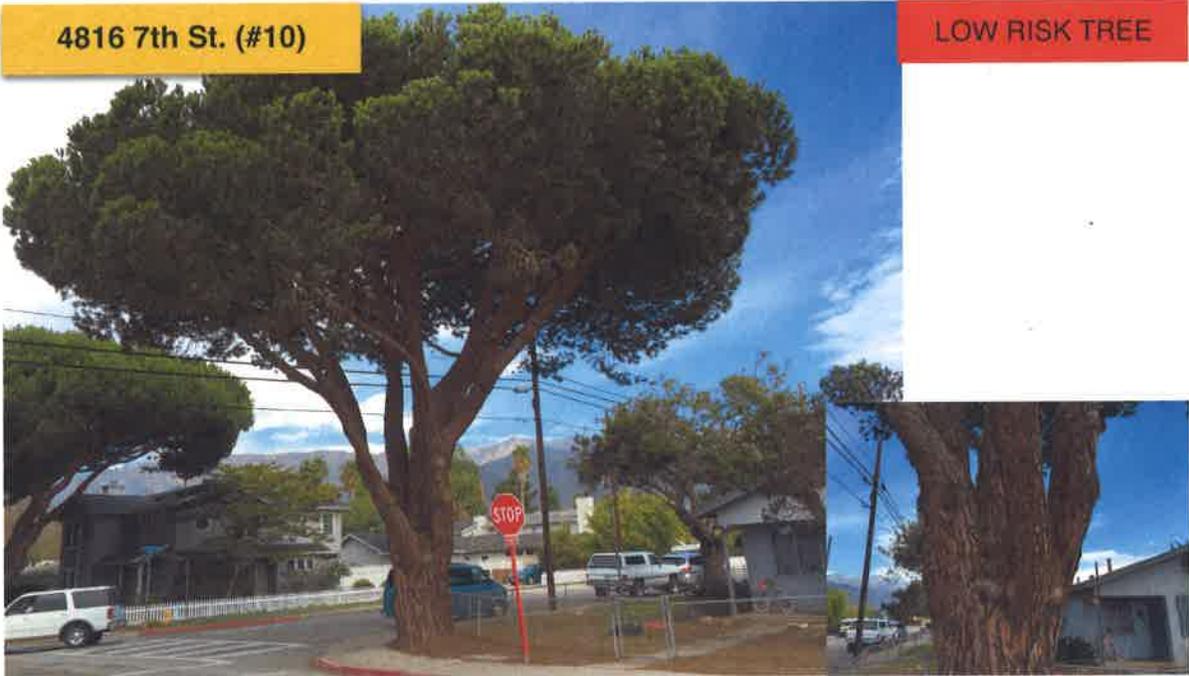
Appears well pruned in recent history. Not much problem now except for curb and sidewalk close to needing repairs.

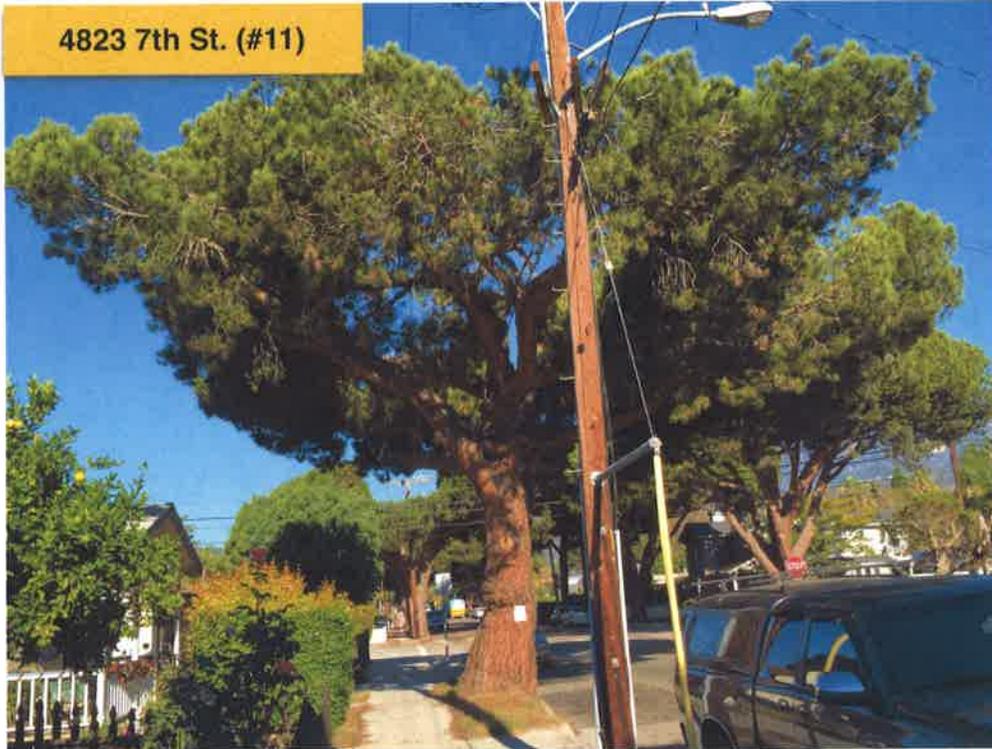
Owner has requested removal due to damage. Tree has no real canopy due to extreme utility pruning and is significantly dense and heavy on the laterals. The base has outgrown the planter. Removal and replacement is appropriate (more photos next page).

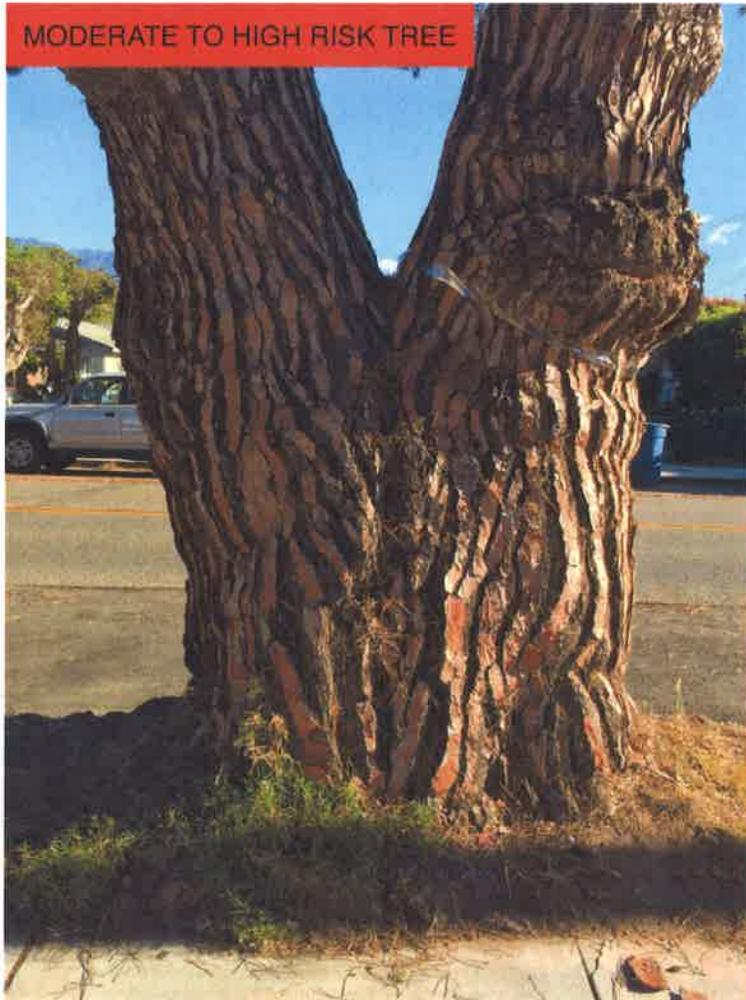
4823 7th St. (#11)

The two trunks are major co-dominant stems and prone to splitting. Also note the trunk overhanging the curb at the base.

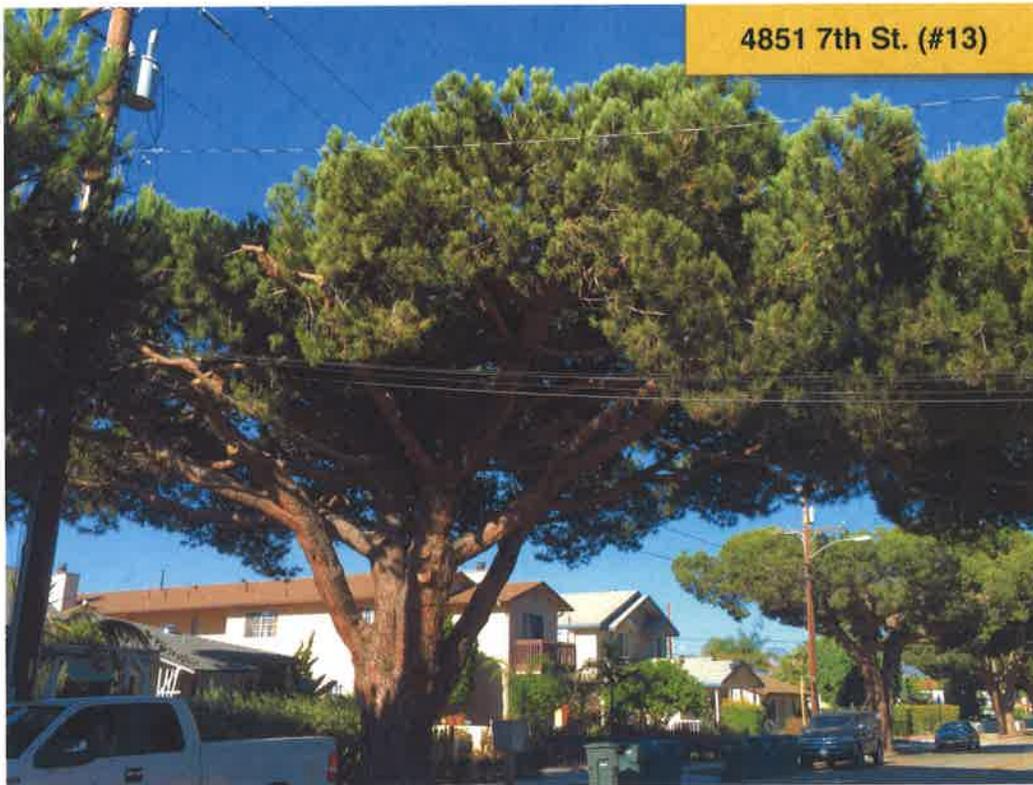
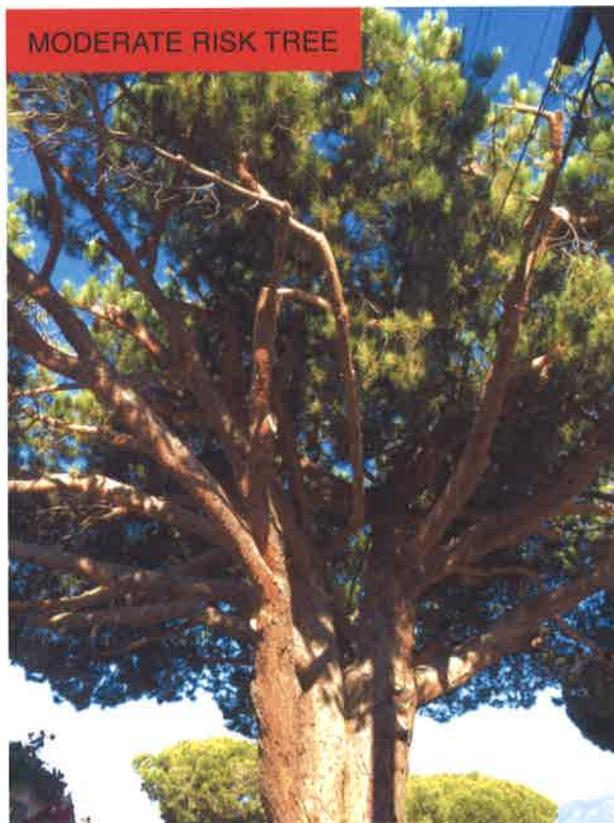
Utility cables provide some support to street side, but crown is dense and residence is potential target. Infrastructure was replaced and is holding up. Remove several large limbs over house and street when thinning (more photos next page).

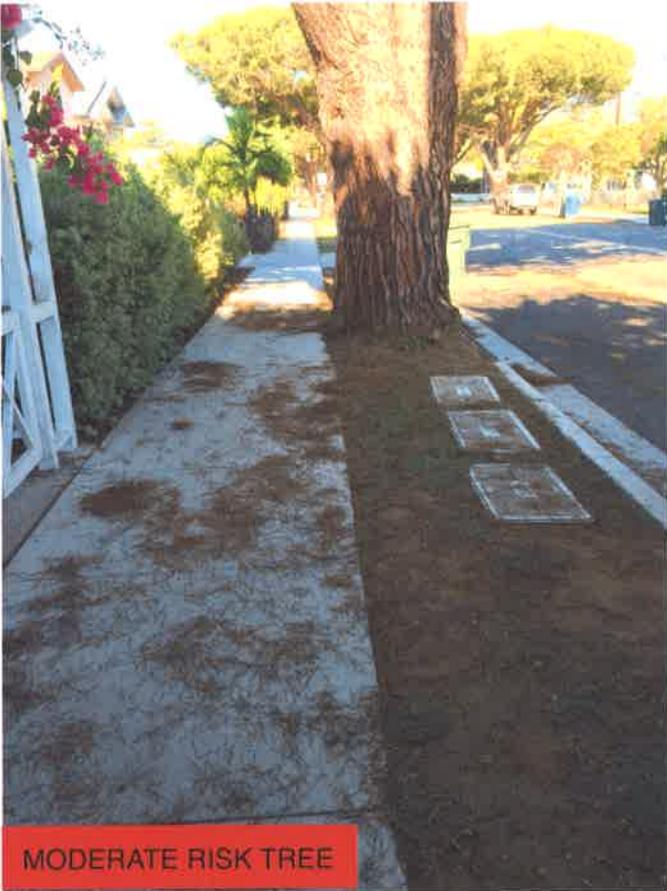
4851 7th St. (#13)

Note the replaced sidewalk and the steel curb.

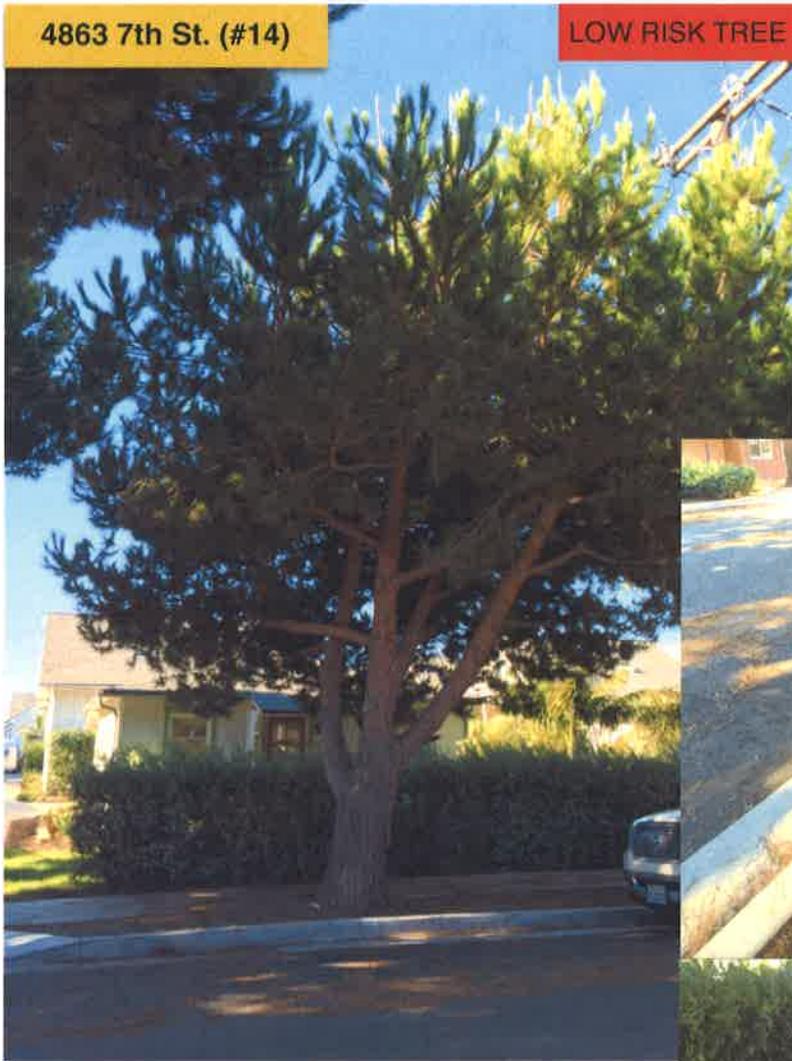
Young tree beneath utility wires that warrants structural pruning. New cracks in curb and gutter (arrow) suggest aggressive root growth.

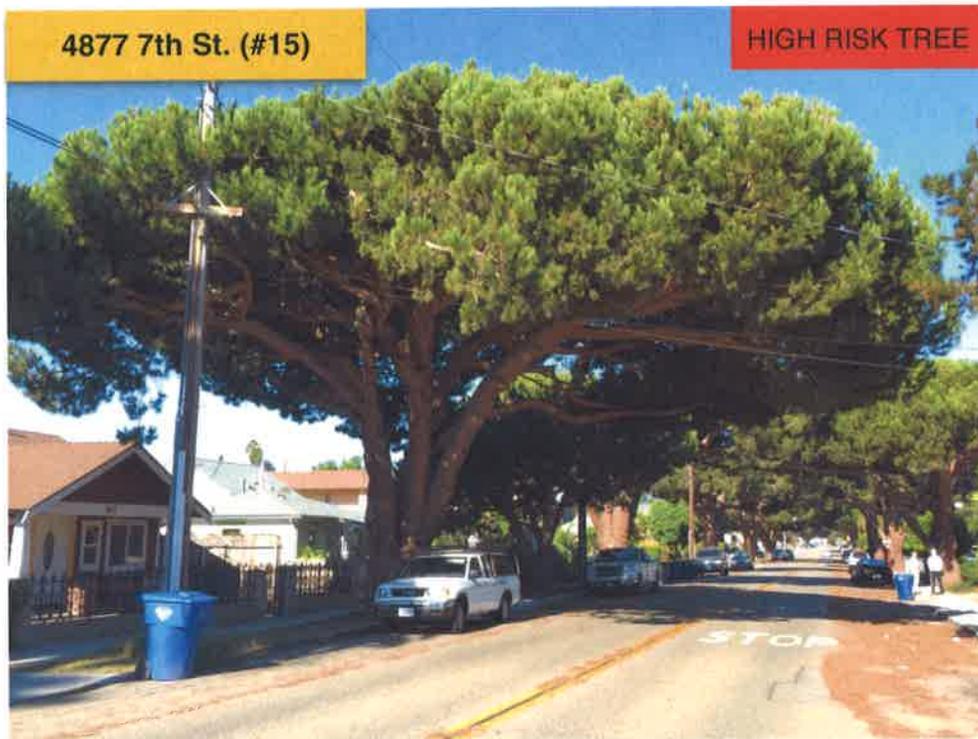
Large tree with high potential to split over road and sidewalk. Either remove northern leader or majorly thin over road. Cable could help retain northern leader. Southern half of crown needs major thinning (more photos on next two pages).

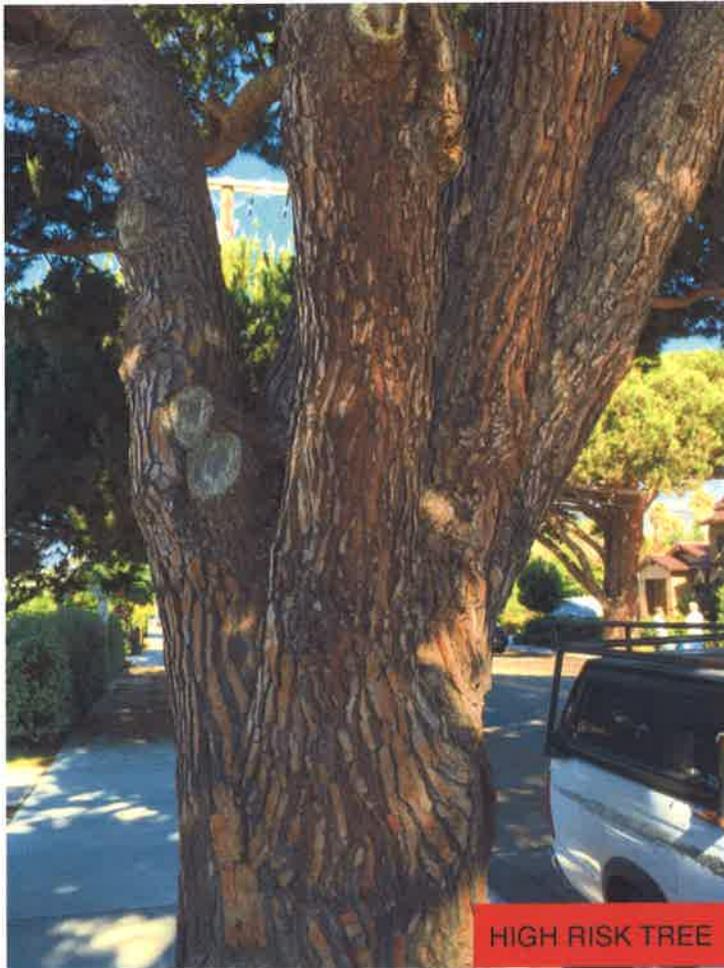
4877 7th St. (#15)

Note large trunk in small space and damage to curb sidewalk.

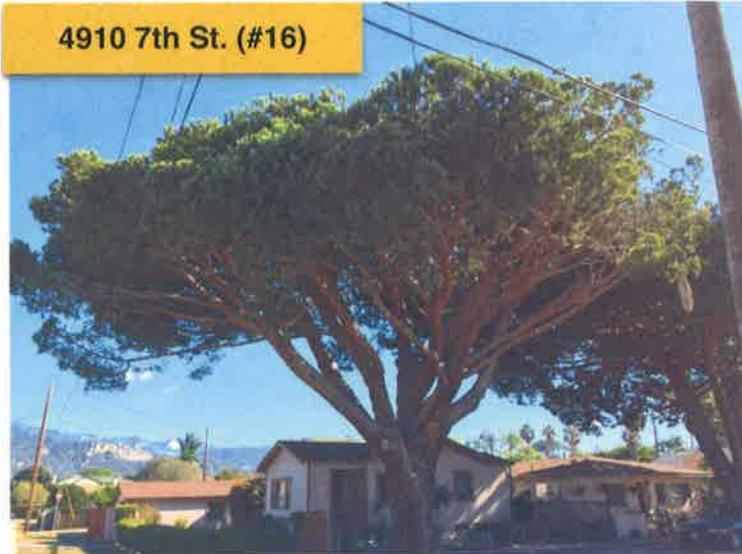
Dense and heavy. Warrants crown thinning. Consider removing northeastern and northwestern leaders. Replacement sidewalk is ADA undersized but allows passage without obstacles. Bulb out may be an option.

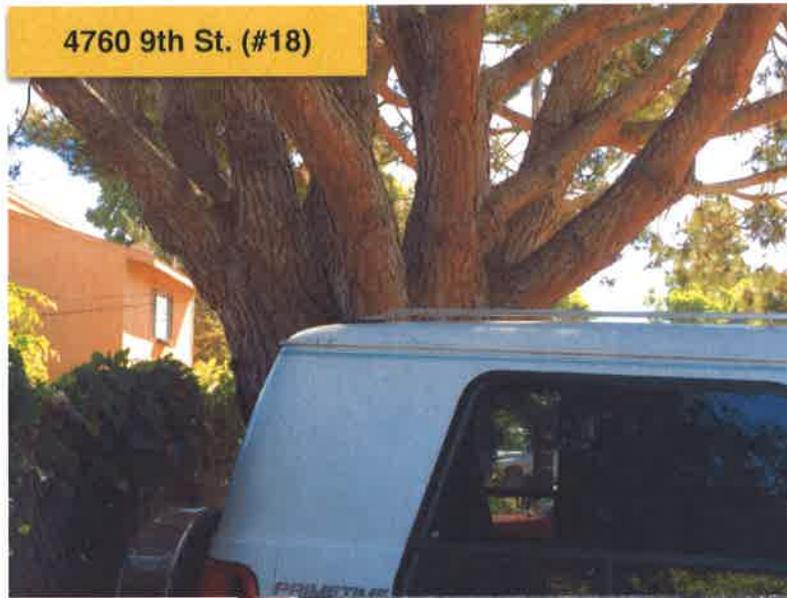
Low skirt needs raising, low over road and apartment. Could use thinning to reduce weight and improve structure. Some cracking of resident patio but great shade.

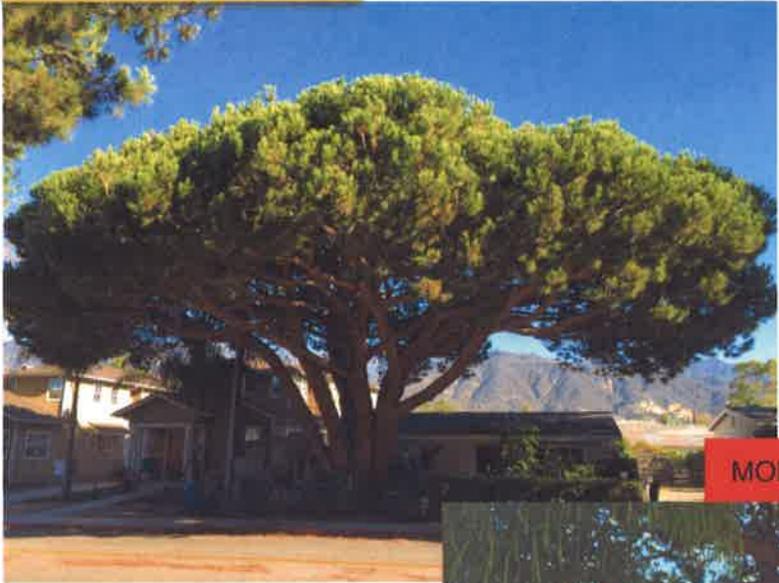
4292 Carp Ave. (#19)

A great tree with multiple leaders. Nothing to buffer failure and crown is dense and heavy. Pruning is needed to reduce risk. Sidewalk not currently a problem as tree is more on residential lot (more photos next page).

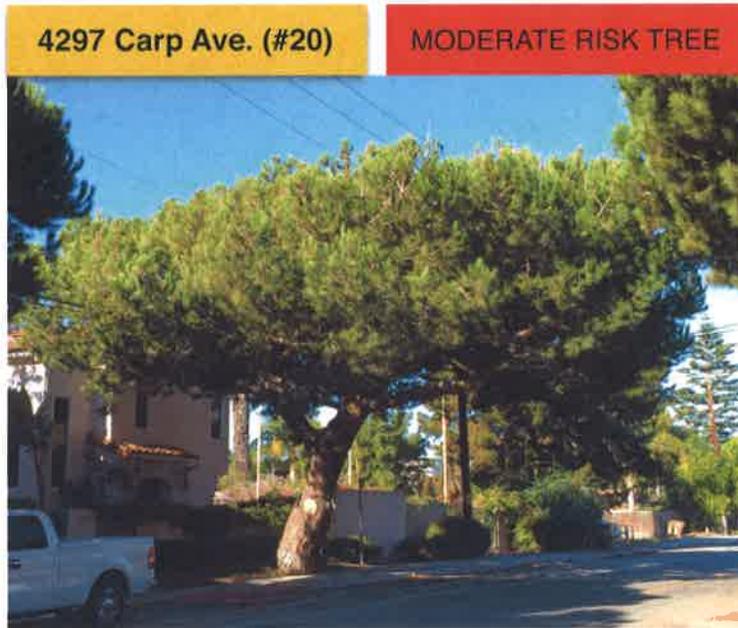
Lower utility cables provide a buffer from the street, but crown can still break free in severe weather. Trunk obstructs passage on sidewalk. Bulb out an option. Asphalt repairs warranted.

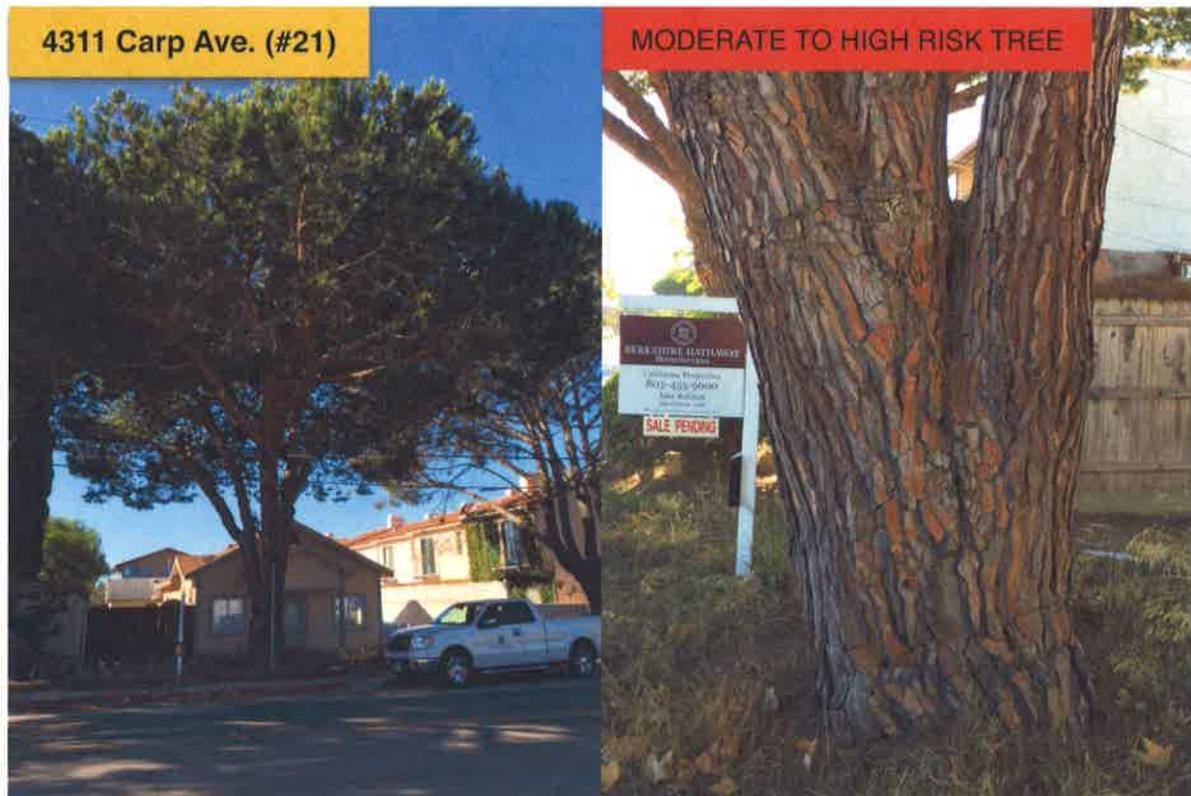
Thinner crown but overhangs house. Asphalt damage is severe but sidewalk is already bulbed outward.

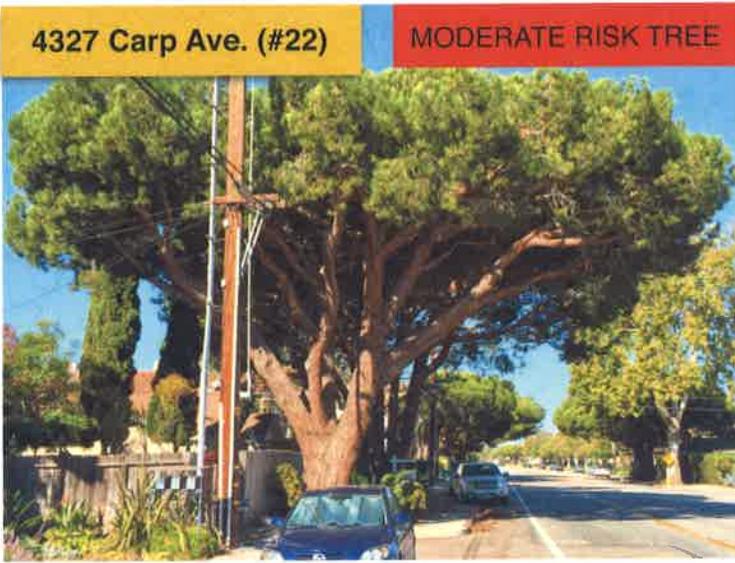
Dense and heavy crown over residence and warrants pruning. Note water meters in close proximity. Homeowner upset about damage to driveway. Consider removing some of the leaders. Also significant damage to asphalt.

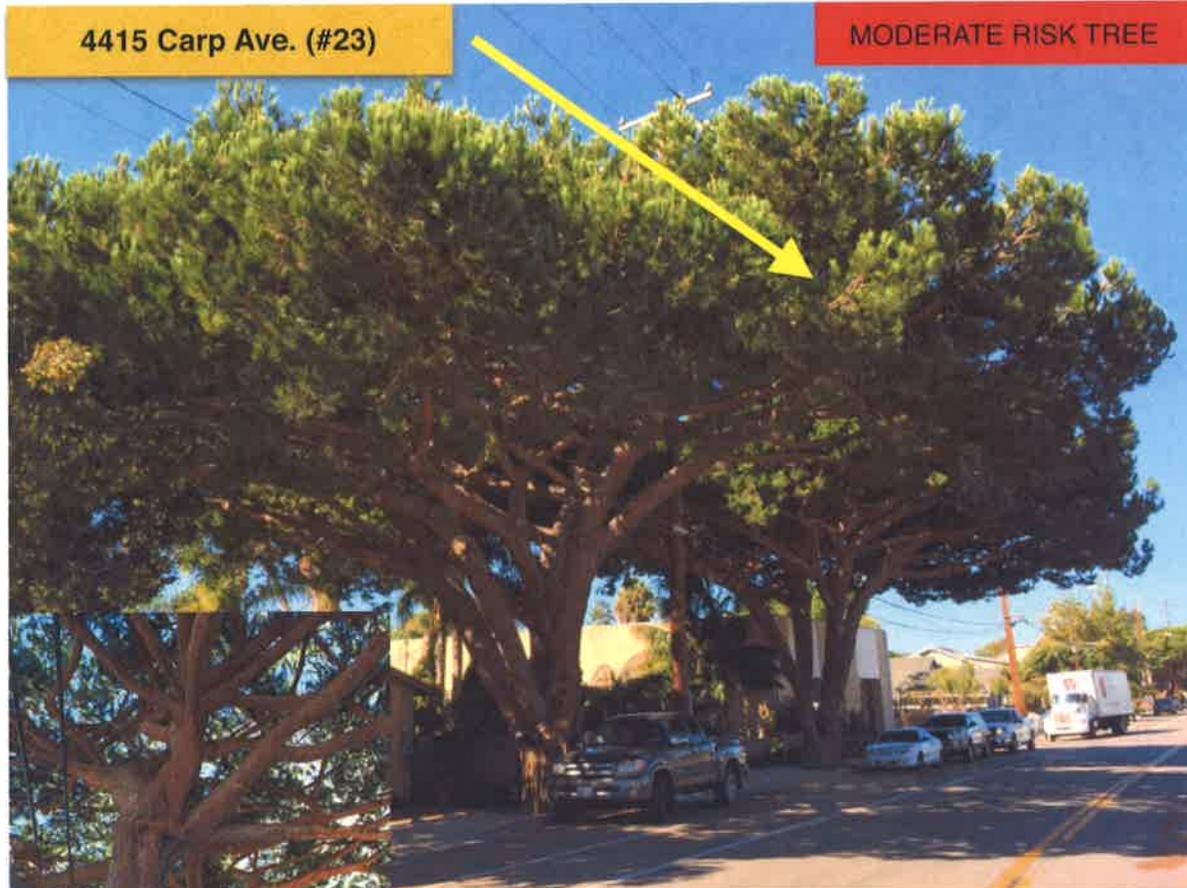
A view of #23 and #24. Arrow points to #23. Intertwining limbs help hold tree together. Tree is obstructing sidewalk. Repaired concrete beginning to fail. Bulb out is an option.

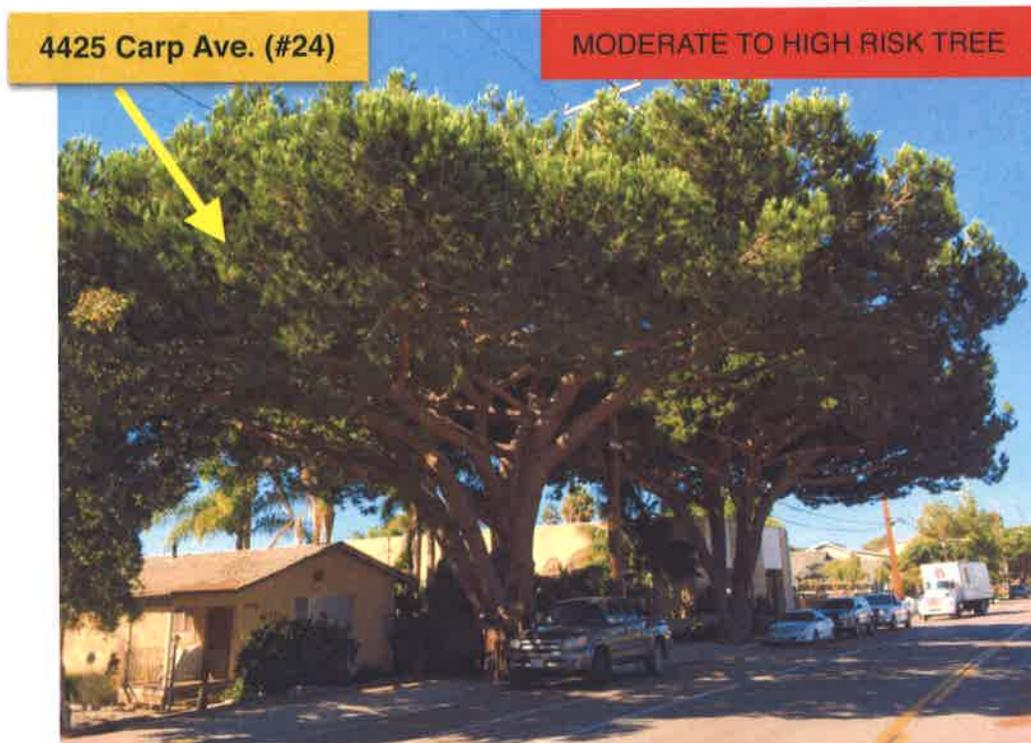
Arrow points to #24. Mitigate risk with pruning. Tree overhangs sidewalk creating an obstacle for pedestrians as witnessed by homeowner, but he also loves the tree, not the roots. Bulb out is an option (more photos next page).

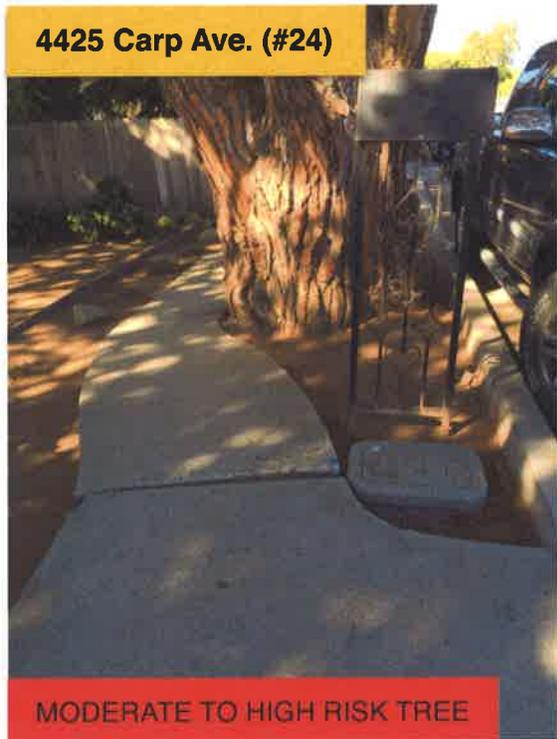
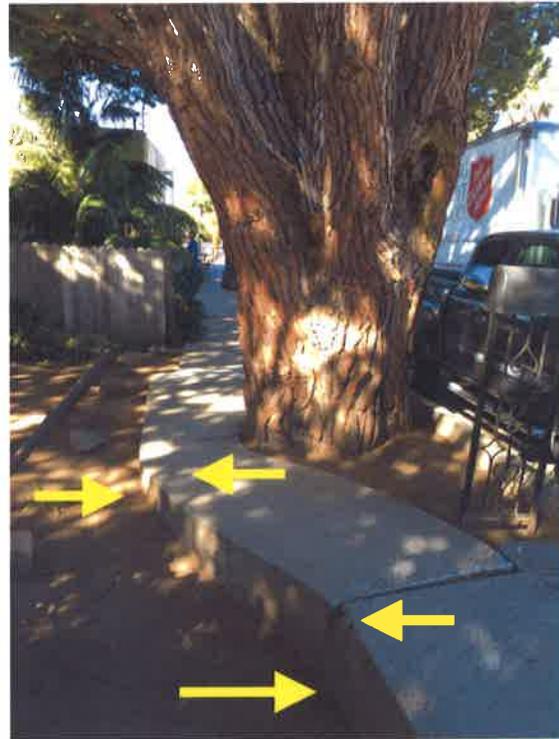
There is a drop of about 12" on the south side of the narrow sidewalk, where the trunk becomes an obstacle, creating a dangerous situation (arrows upper right). Lower right arrow points to damaged driveway.

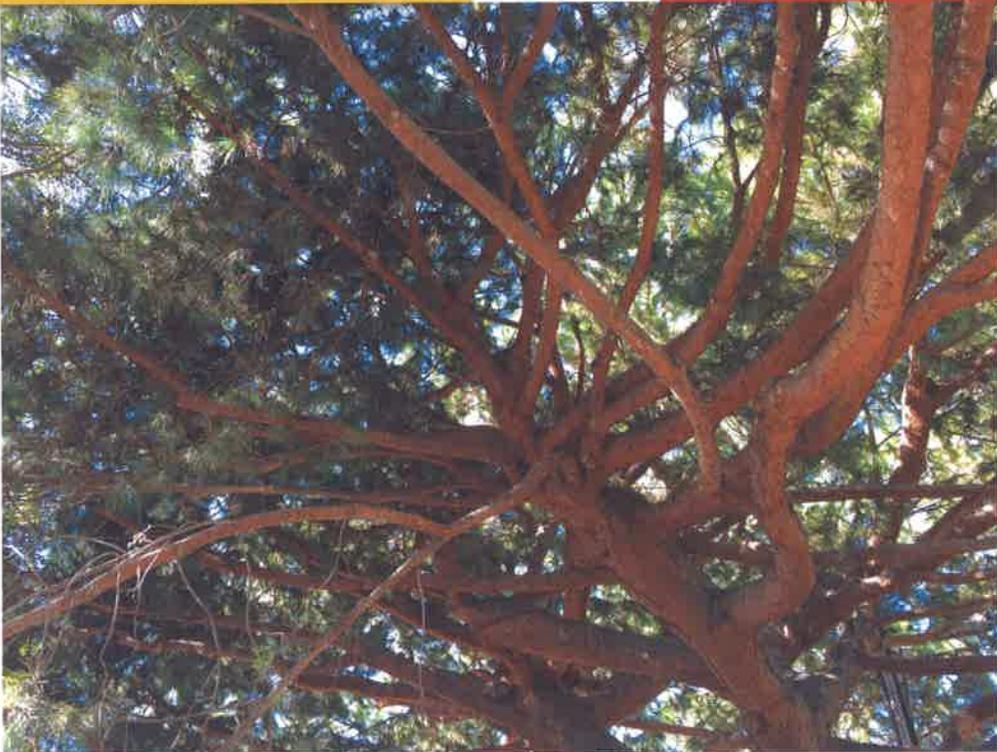
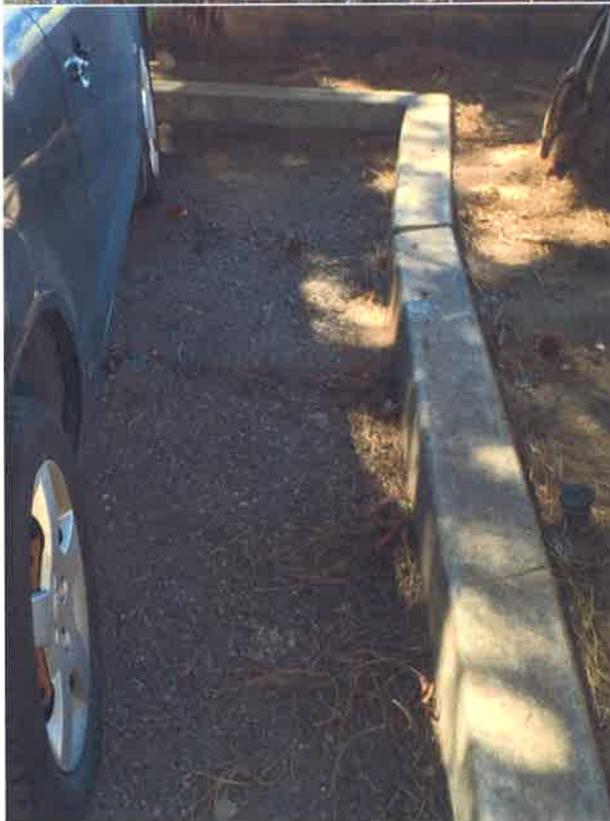
Wullbrandt Way - Parking (#27)

Note the density of the crown and the damage to the curb and asphalt.

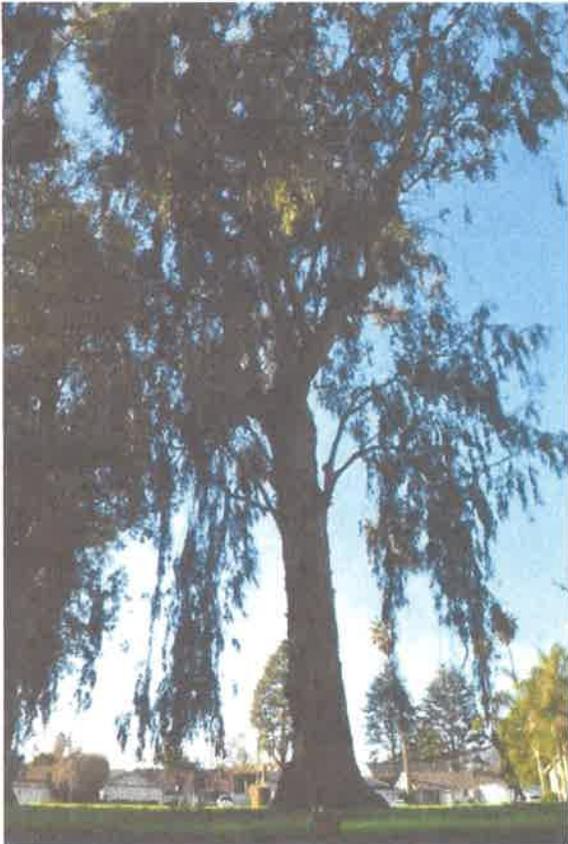
Species: Tasmanian Blue Gum (*Eucalyptus globulus*)
DSH: 69" Diameter at Standard Height
Height: 110 feet
Canopy: 95" (53' x 95')
Observations: Tree 2 appears to be in good condition. The burl on the bottom of the tree is primarily hollow and does exhibit evidence of sap ooze. This appears to be slime ooze, a harmless bacteria infection and not symptoms of damage from eucalyptus long horned beetle insect activity.
Tree Defects: The parts of the tree most at risk of failure is weak scaffold branch approximately 2/3 of the way up the tree, and two overextended branches with weak attachments. Also possible root issues with sap oozing from burl.
Targets: People walking in the Park under tree 2 and within 165' of the tree.
People walking on Eucalyptus St. sidewalks
People in cars parked along Eucalyptus St.
Likelihood of failure: Possible
Likelihood of Impact to target: High
Likelihood Matrix: Somewhat likely

Consequences of failure: Severe
Tree 2 Risk Rating: Moderate
Mitigation Options: Reduce two overextended branches in the upper canopy, no parking on west side of Eucalyptus St. within target area, warning signage
Residual risk: Moderate

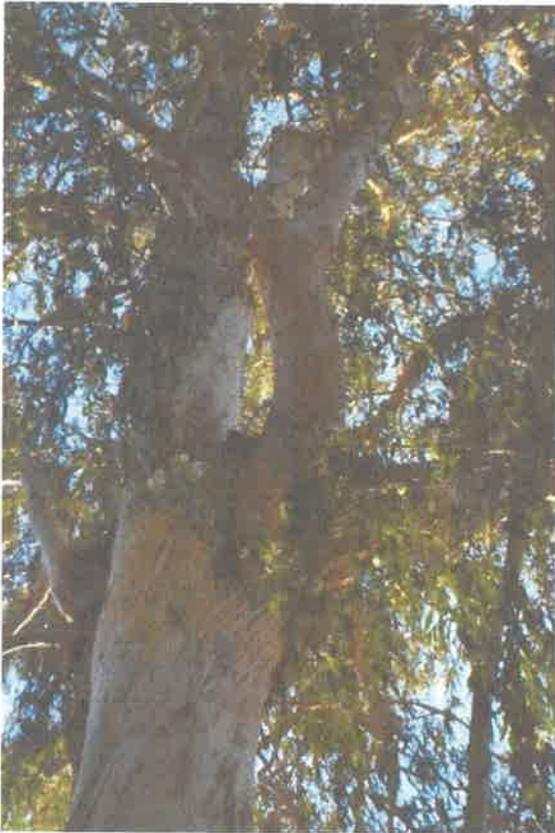
Tree 4
Species: Tasmanian Blue Gum (*Eucalyptus globulus*)
DSH: 64" Diameter at Standard Height
Height: 120 feet
Canopy: 85" (89' x 80')
Observations: Tree 4 appears to be in good condition.
Tree Defects: There are two parts of the tree most at risk of failure. The first is a approximately ¼ up the trunk where three 25"+ scaffolds have V-joints extending from the main trunk. Although the scaffolds are large in relation to the main trunk, the joints do not have included bark.
The second risk area is approximately half way up the trunk with three 25-30" scaffolds are within one foot of each other. The scaffold joints do not exhibit included bark, and the scaffolds are tapered, but overextended.
Targets: People walking in the Park under tree 4 and within 180' of the tree.
People walking on Eucalyptus St. sidewalks
People in cars parked along Eucalyptus St.
Likelihood of failure: Possible
Likelihood of Impact to target: High

Likelihood Matrix: Somewhat likely
Consequences of failure: Severe
Tree 4 Risk Rating: Moderate
Mitigation Options: Reduce length of overextended branches in middle and upper canopy
Residual risk: Moderate

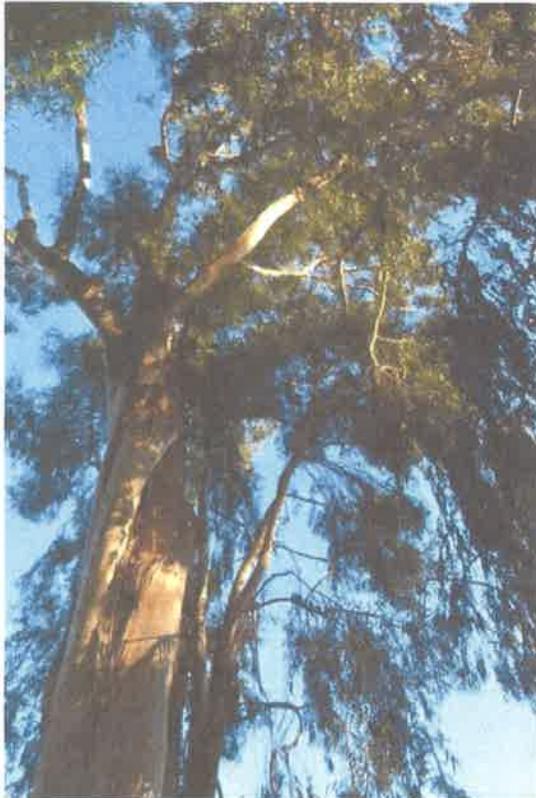
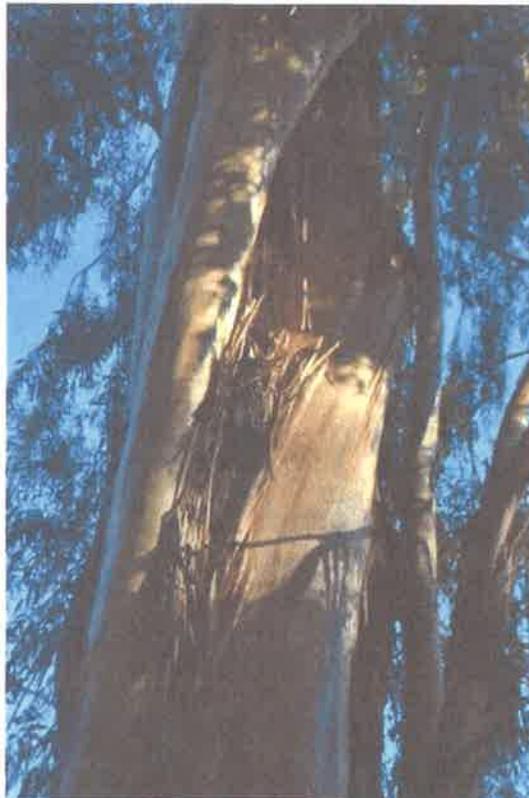
Tree 5
Species: Tasmanian Blue Gum (*Eucalyptus globulus*)
DSH: 125" Diameter at Standard Height
Height: 125 feet
Canopy: 93" (92' x 93')
Observations: Tree 5 appears to be in good condition. Areas of white fungus are located on the north east side of the burl, which sounds mostly hollow
Tree Defects: The parts of the tree most at risk of failure are 1) the 30"+ scaffold branch half way up the tree on the northwest side that is overextended and lion-tailed. 2) The scaffold one quarter of the way up on the west side with a poor junction with the trunk. 3) The two over-extended branches three-quarter of the way up the tree on the east side
Targets: People walking in the Park under tree 5 and within 188' of the tree.
 People walking on Eucalyptus St. sidewalks
 People in cars parked along Eucalyptus St.
 People in houses along Eucalyptus St.
Likelihood of failure: Possible
Likelihood of Impact to Target: High

Likelihood Matrix: Somewhat likely
Consequences of failure: Severe
Tree 5 Risk Rating: Moderate
Mitigation Options: Reduction of scaffolds, no parking on west side of Eucalyptus St. within target area, warning signage,
Residual risk: Moderate

Tree 5 potential scaffold reduction
