**CITY OF CARPINTERIA
TREE ADVISORY BOARD
Thursday, February 18, 2016**

1. Stone Pine Assessment & Management Plan Discussion
2. Heath Ranch Park Tree Matters

MEETING MINUTES OF THE TREE ADVISORY BOARD
THURSDAY, NOVEMBER 5, 2015

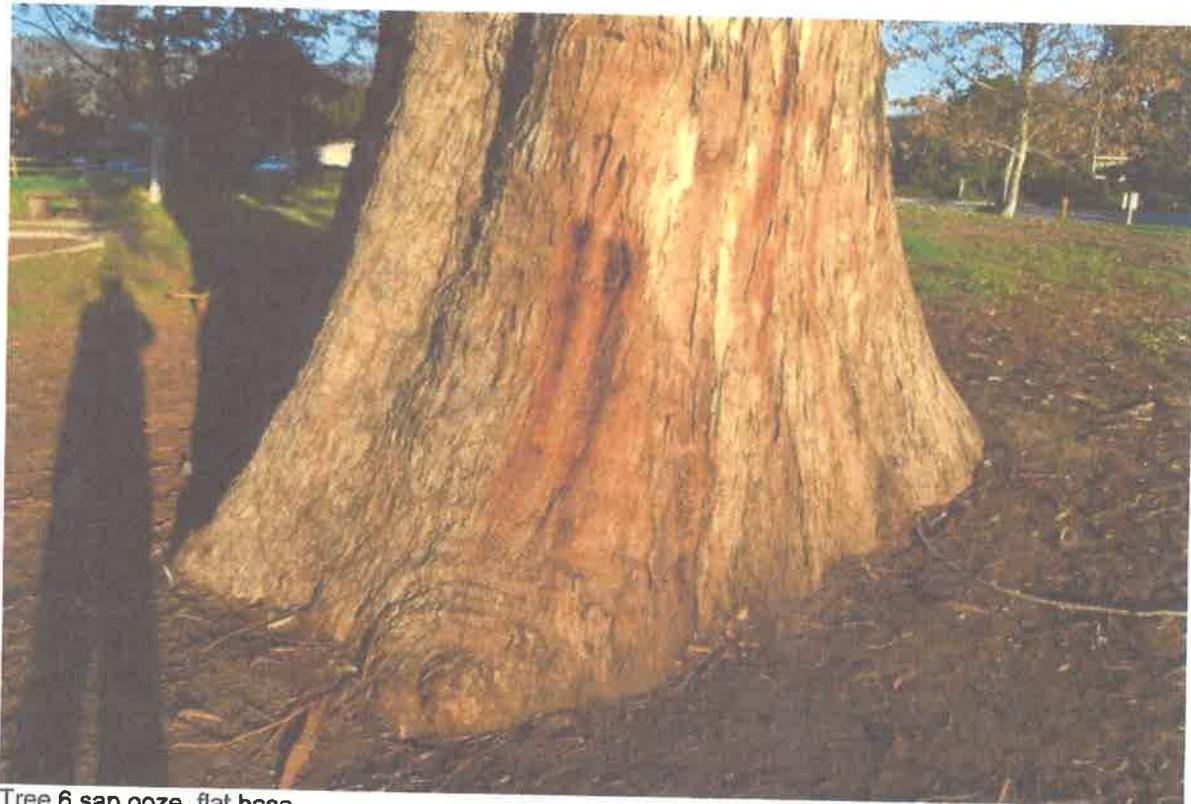
Species: Tasmanian Blue Gum (*Eucalyptus globulus*)
DSH: 93" Diameter at Standard Height
Height: 95 feet
Canopy: 75"
Observations: Tree 6 appears to be in fair condition. The bottom of the tree is partially hollow, with a flat edge on the southeast side indicating root issues, and sap ooze. The sap appears to be slime ooze, a harmless bacteria infection and not symptoms of damage from eucalyptus long horned beetle insect activity.
Tree Defects: The parts of the tree most at risk of failure are 1) the overextended branches on the north side of tree, 2) the three scaffolds next to each other about one quarter up the tree on the west side. 3) The scaffold on the southeast side. 4) The base of the tree and possible insect/root issues
Targets: People walking in the Park under tree 2 and within 143' of the tree.
People in playground
People in houses within target zone on south side Chaparral Dr.
Likelihood of failure: Possible

Likelihood of Impact to target: High
Likelihood Matrix: Somewhat likely
Consequences of failure: Severe
Tree 6 Risk Rating: High
Mitigation Options: Reduce two overextended branches on north side of tree, or consider moving playground 143' from trunk, level three analyses of sap wounds and root collar
Residual risk: Moderate

Tree 6 sap ooze, flat base

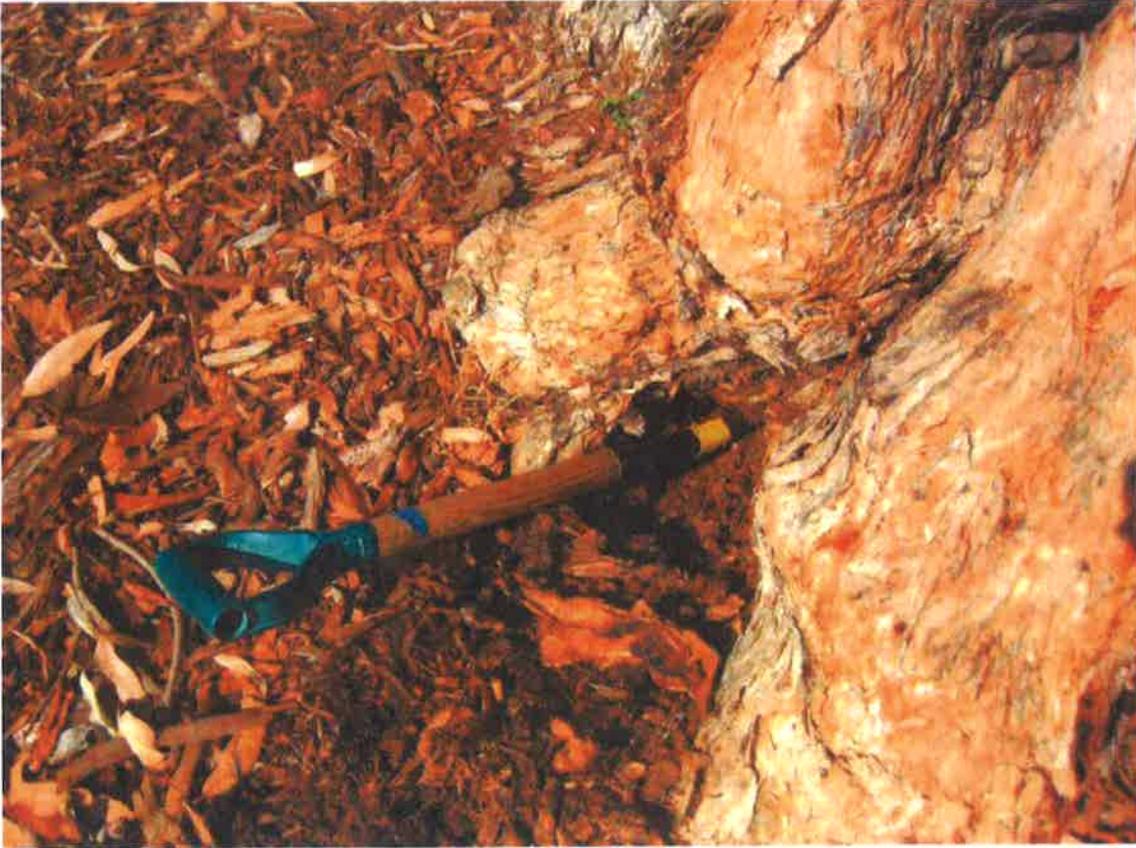
Figure 1. Photo shows a basal burl on the west side of tree #2 which has decayed away. Note the depth to which decay has advanced into its center. Decay of this kind can provide a point of entry for the very destructive Brown Cubicle Rot.

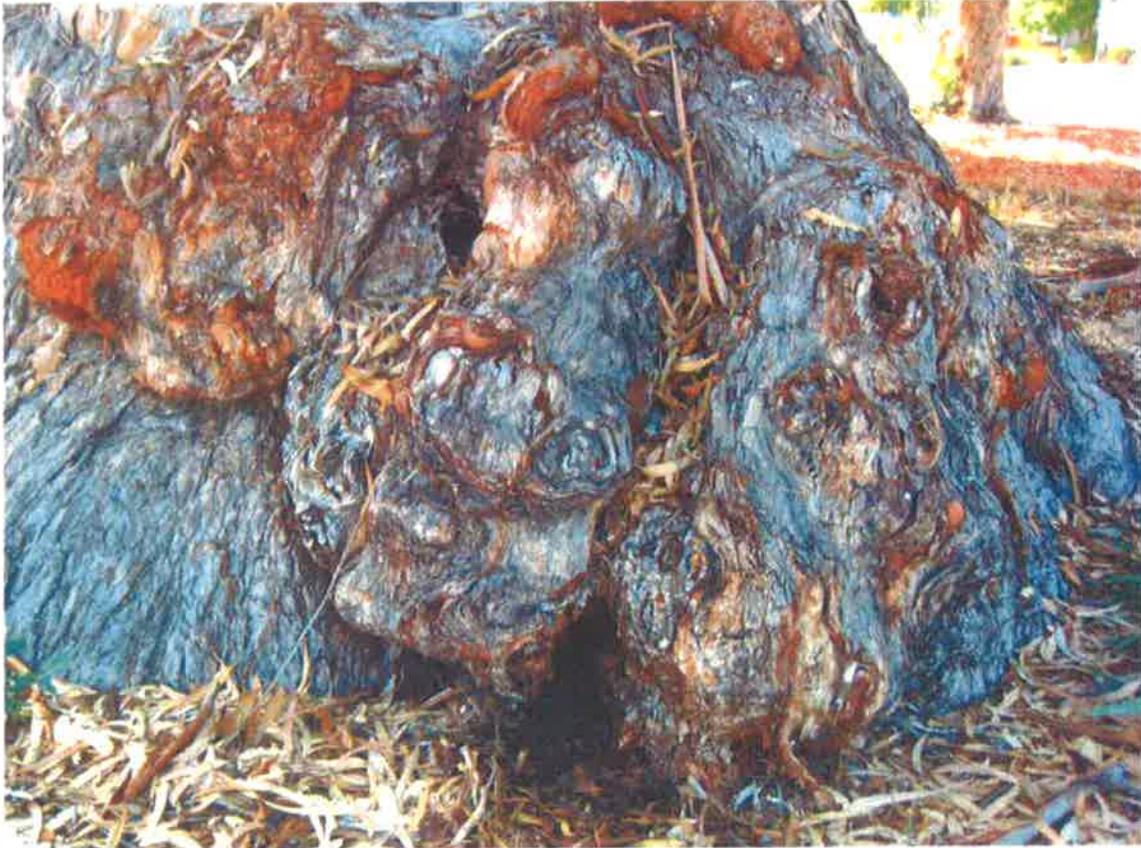
Figure 2. Photo shows burl decay in two places at the base of tree #5.

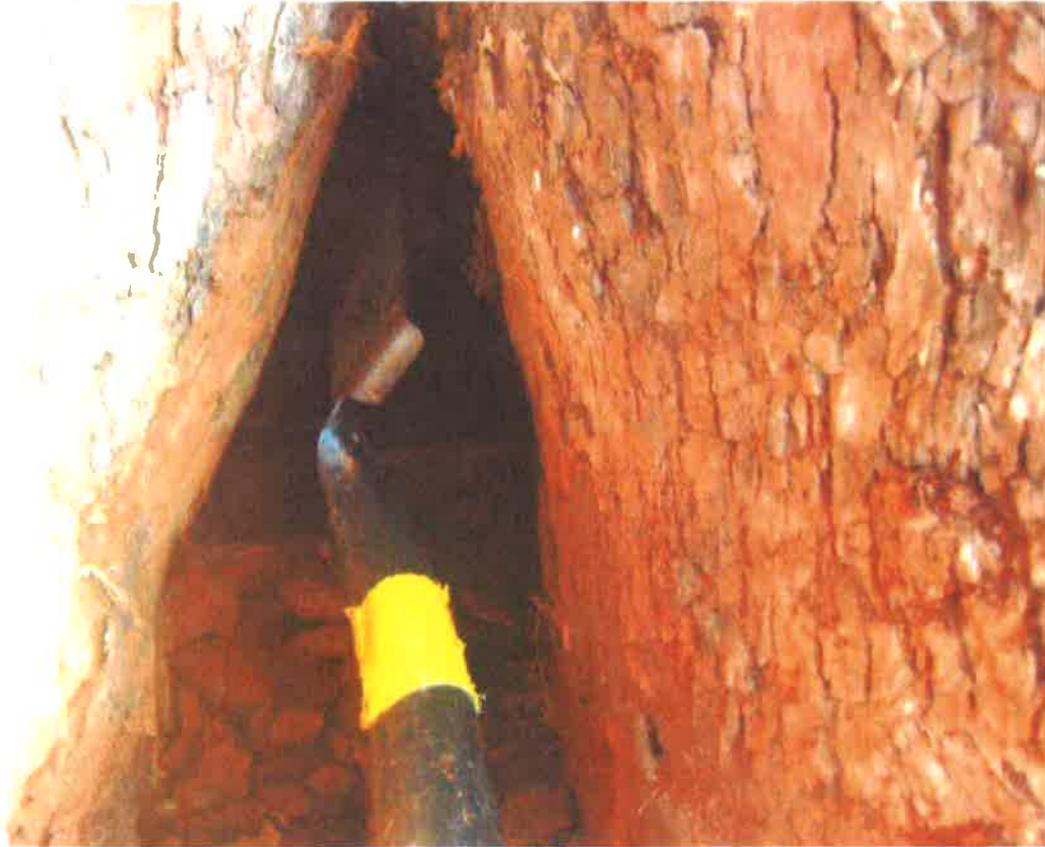
Figure 3. Photo shows a deep cavity on the north side of tree #7 in which Brown Cubicle Rot is abundantly present.

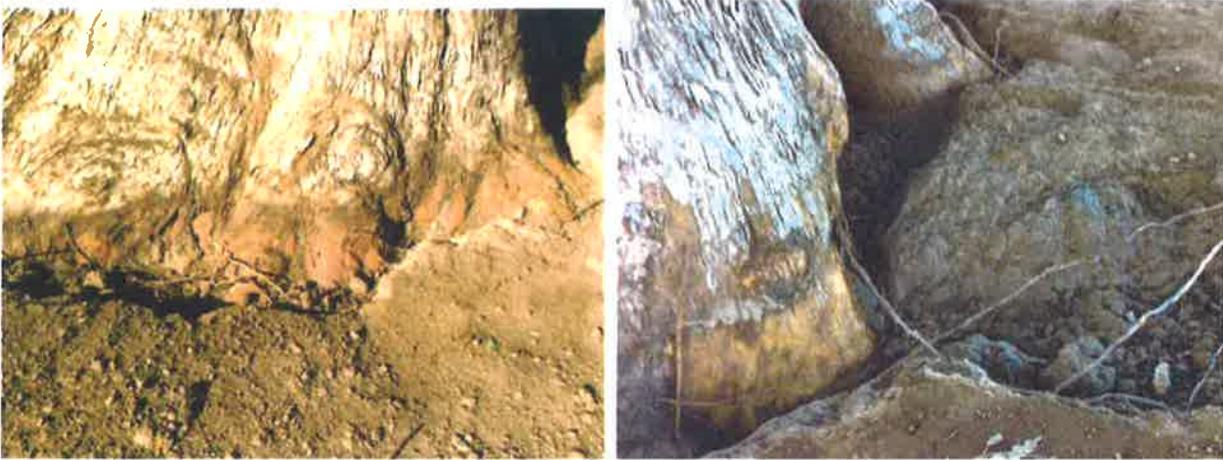
Duke McPherson's August 20, 2015 Arborist Report called for a closer inspection of the cavity on the north side of the tree. The cavity extends approximately 2 feet into the tree and about two feet high. While there is Brown Cubical Rot in the deadwood of the cavity, the remaining wood when probed by hand and with a five-foot probe is relatively solid. The tree is seven feet wide at this point, so there is approximately 5 feet of good wood on the southern side that will continue to support the tree.

Above-Cavity on north side, Right-decayed pieces, below looking up from inside cavity

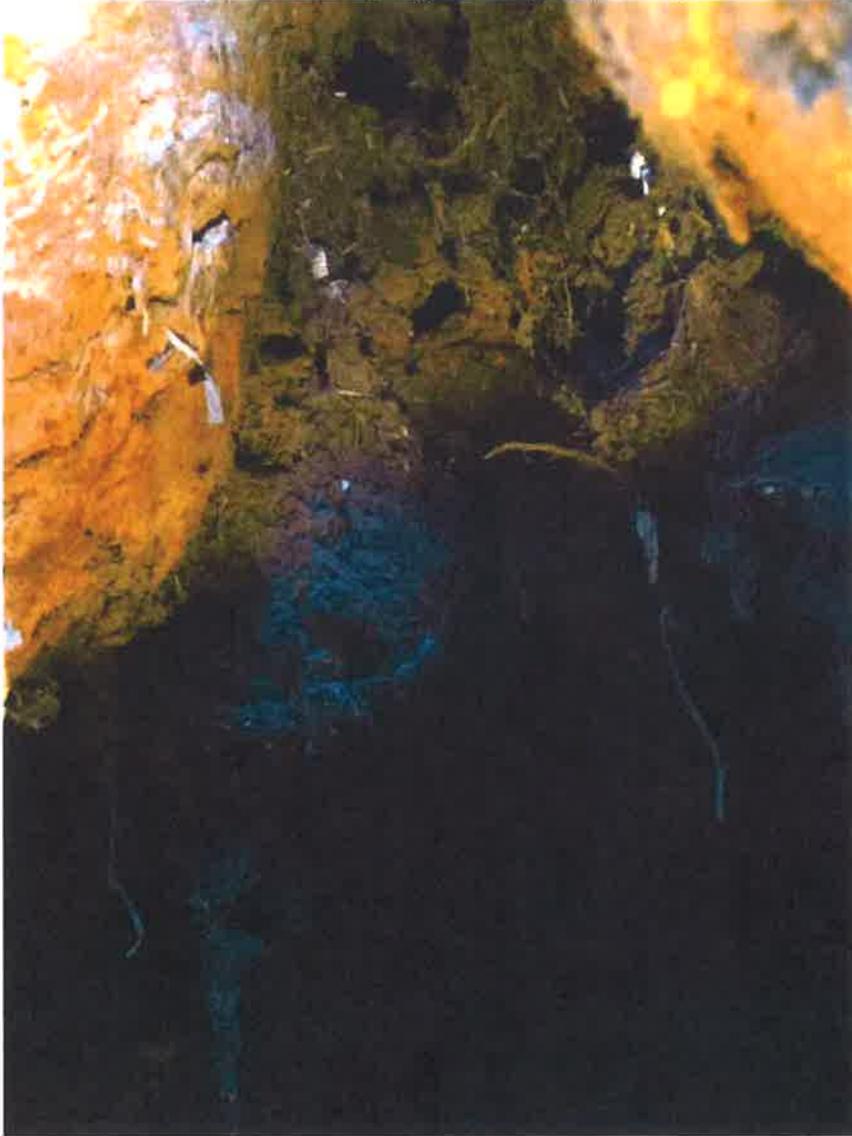
The air spade did uncover a 7' to 9" diameter girdling root on the south side of the tree. The flat shape of the southern side of the trunk indicated that this was likely.

Above -girdling root on the south side. Below – girdling root extending east along trunk

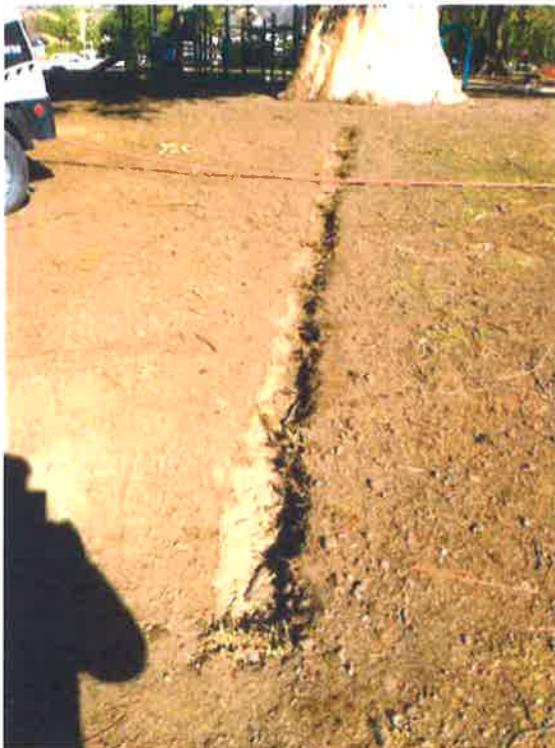
Above -trench radiating from tree. Right- cell phone idincates depth of trench, note soil is dry about 3 inches below surface

West Coast Arborist staff used the air spade to create eight trenches around the tree, each one about six inches deep and one foot wide. Each trench started about ten feet from the tree and extended about 25 feet to the edge of the canopy. Each trench was then backfilled with one two cubic foot bag of compost mixed in with the original soil. The purpose of the trenches is to loosen the compacted soil, add some organic material to the soil, and improve the ability of the tree roots to receive air and water.
