**CITY OF CARPINTERIA
TREE ADVISORY BOARD
Thursday, April 7, 2016
(Special Meeting)**

Heath Ranch Park Eucalyptus Trees

Recommend the phased removal and replacement of four Eucalyptus trees and continued maintenance of one other at Heath Ranch Park.

Tree Evaluation Report: Blue Gums at Heath Ranch Park, City of Carpinteria

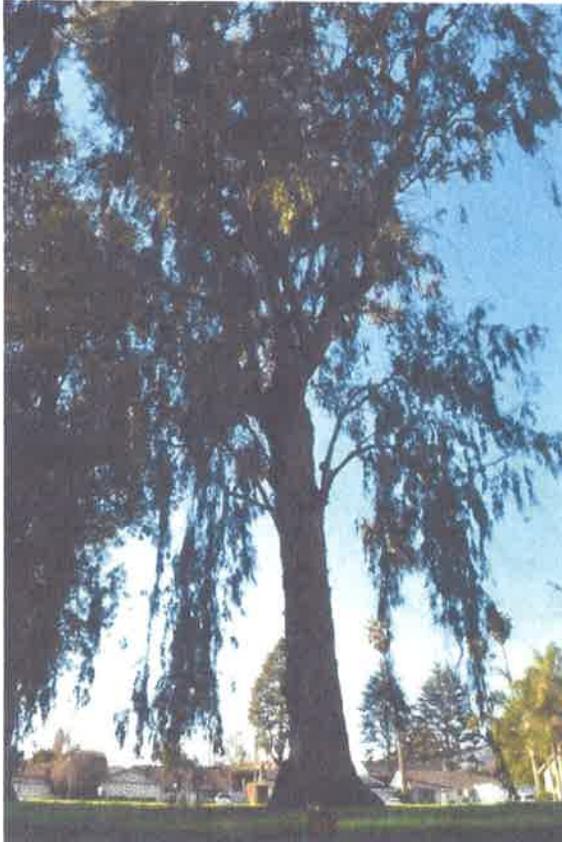
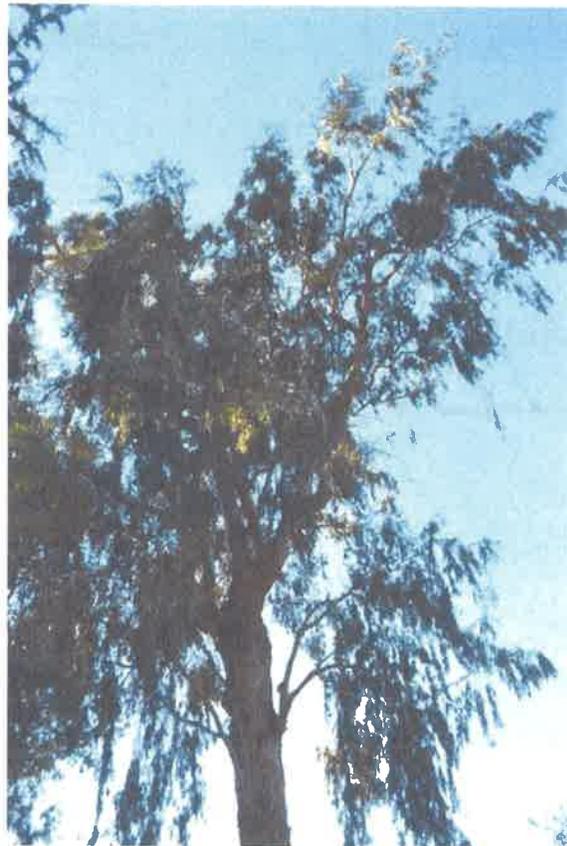
Species: Tasmanian Blue Gum (*Eucalyptus globulus*)
DSH: 69" Diameter at Standard Height
Height: 110 feet
Canopy: 95" (53' x 95')
Observations: Tree 2 appears to be in good condition. The burl on the bottom of the tree is primarily hollow and does exhibit evidence of sap ooze. This appears to be slime ooze, a harmless bacteria infection and not symptoms of damage from eucalyptus long horned beetle insect activity.
Tree Defects: The parts of the tree most at risk of failure is weak scaffold branch approximately 2/3 of the way up the tree, and two overextended branches with weak attachments. Also possible root issues with sap oozing from burl.
Targets: People walking in the Park under tree 2 and within 165' of the tree.
People walking on Eucalyptus St. sidewalks
People in cars parked along Eucalyptus St.
Likelihood of failure: Possible
Likelihood of Impact to target: High
Likelihood Matrix: Somewhat likely

Consequences of failure: Severe
Tree 2 Risk Rating: Moderate
Mitigation Options: Reduce two overextended branches in the upper canopy, no parking on west side of Eucalyptus St. within target area, warning signage
Residual risk: Moderate

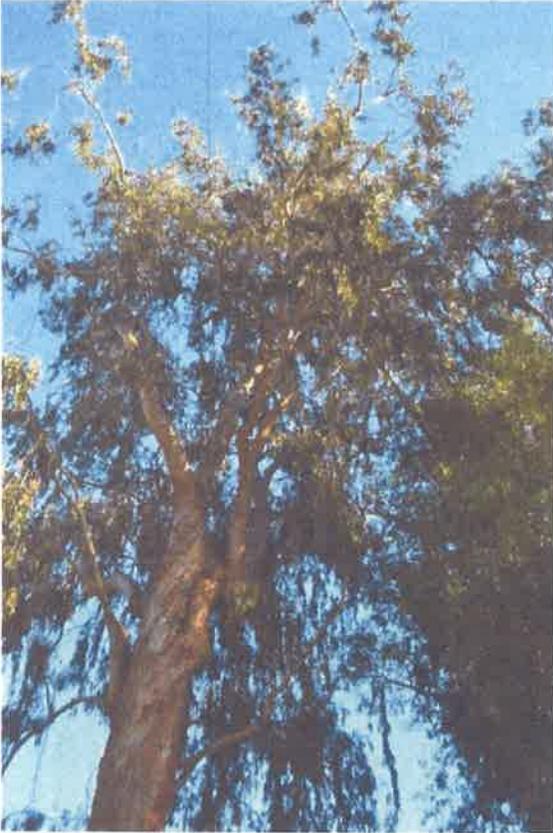
Potential scaffold reductions on north east side

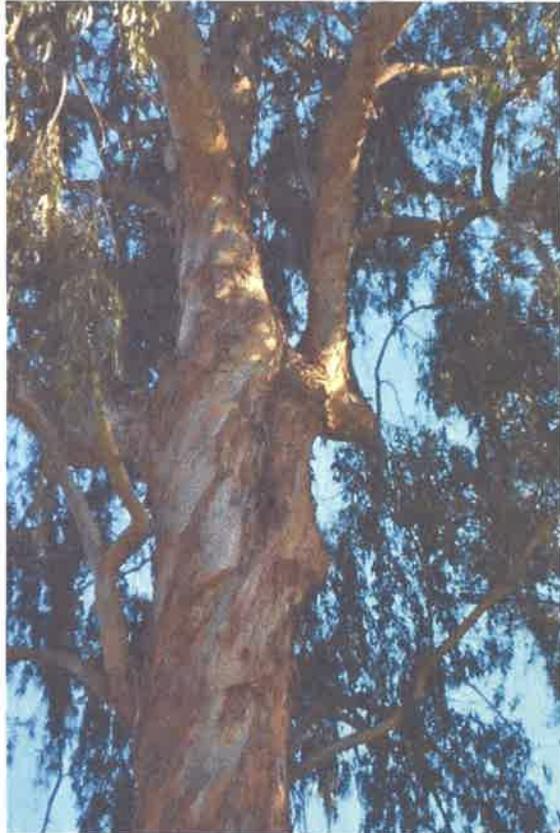
Weak attachment

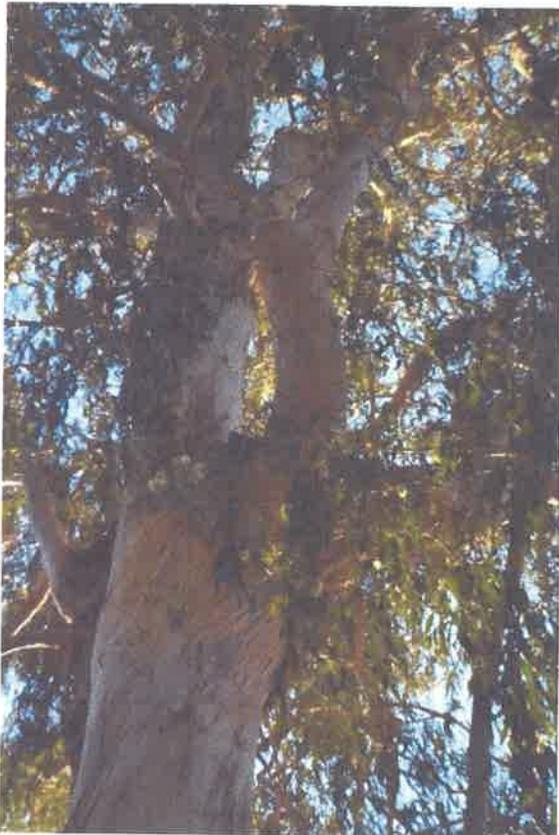
Tree 4
Species: Tasmanian Blue Gum (*Eucalyptus globulus*)
DSH: 64" Diameter at Standard Height
Height: 120 feet
Canopy: 85" (89' x 80')
Observations: Tree 4 appears to be in good condition.
Tree Defects: There are two parts of the tree most at risk of failure. The first is a approximately ¾ up the trunk where three 25"+ scaffolds have V-joints extending from the main trunk. Although the scaffolds are large in relation to the main trunk, the joints do not have included bark.
The second risk area is approximately half way up the trunk with three 25-30" scaffolds are within one foot of each other. The scaffold joints do not exhibit included bark, and the scaffolds are tapered, but overextended.
Targets: People walking in the Park under tree 4 and within 180' of the tree.
People walking on Eucalyptus St. sidewalks
People in cars parked along Eucalyptus St.
Likelihood of failure: Possible
Likelihood of Impact to target: High

Likelihood Matrix: Somewhat likely
Consequences of failure: Severe
Tree 4 Risk Rating: Moderate
Mitigation Options: Reduce length of overextended branches in middle and upper canopy
Residual risk: Moderate

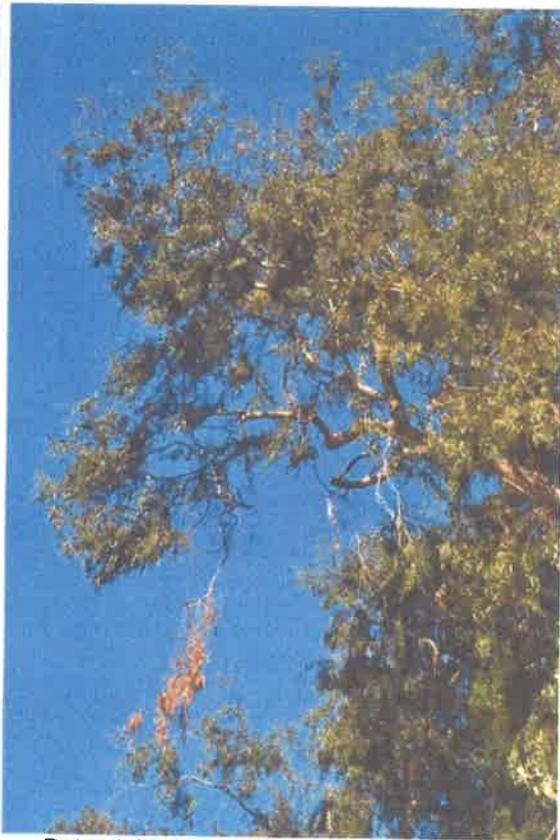
Potential scaffold reduction

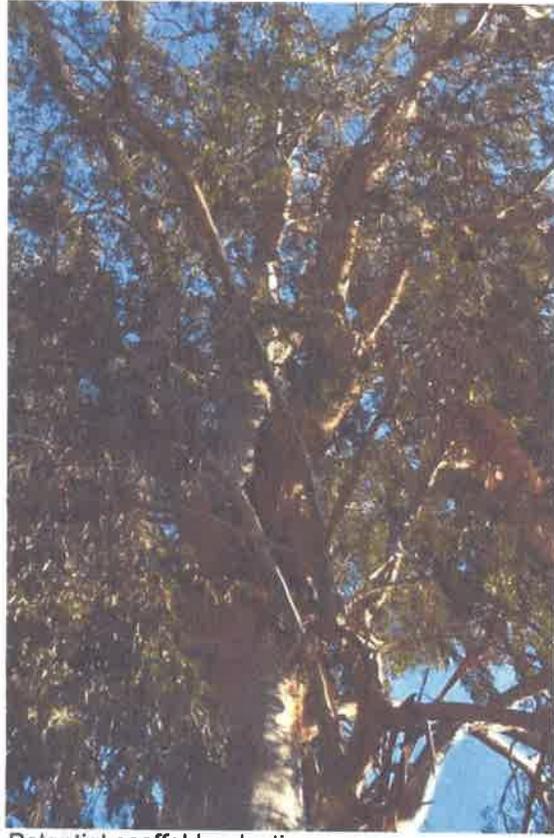
Potential scaffold reductions

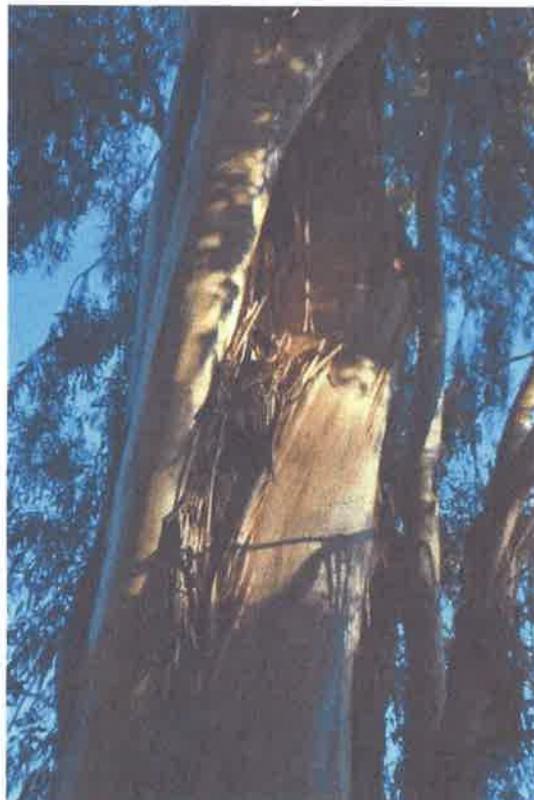
Tree 5
Species: Tasmanian Blue Gum (*Eucalyptus globulus*)
DSH: 125" Diameter at Standard Height
Height: 125 feet
Canopy: 93" (92' x 93')
Observations: Tree 5 appears to be in good condition. Areas of white fungus are located on the north east side of the burl, which sounds mostly hollow
Tree Defects: The parts of the tree most at risk of failure are 1) the 30"+ scaffold branch half way up the tree on the northwest side that is overextended and lion-tailed. 2) The scaffold one quarter of the way up on the west side with a poor junction with the trunk. 3) The two over-extended branches three-quarter of the way up the tree on the east side
Targets: People walking in the Park under tree 5 and within 188' of the tree.
 People walking on Eucalyptus St. sidewalks
 People in cars parked along Eucalyptus St.
 People in houses along Eucalyptus St.
Likelihood of failure: Possible
Likelihood of Impact to Target: High

Likelihood Matrix: Somewhat likely
Consequences of failure: Severe
Tree 5 Risk Rating: Moderate
Mitigation Options: Reduction of scaffolds, no parking on west side of Eucalyptus St. within target area, warning signage,
Residual risk: Moderate

Tree 5 potential scaffold reduction

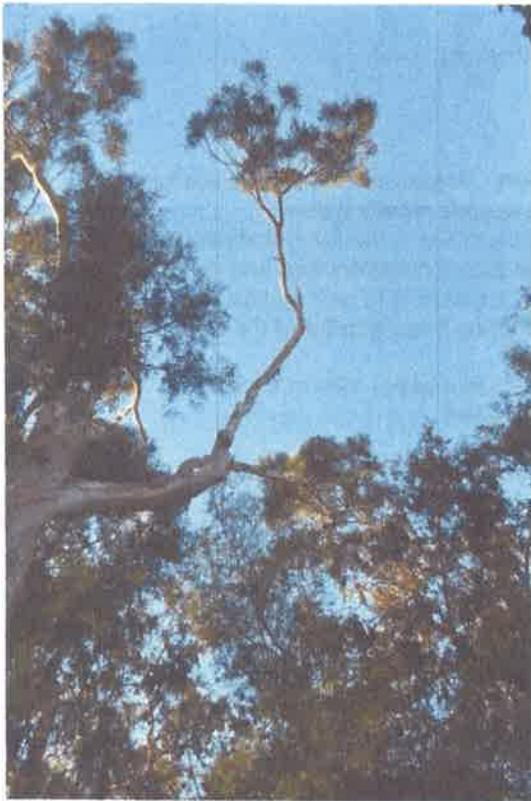
Tree 5 potential scaffold reduction

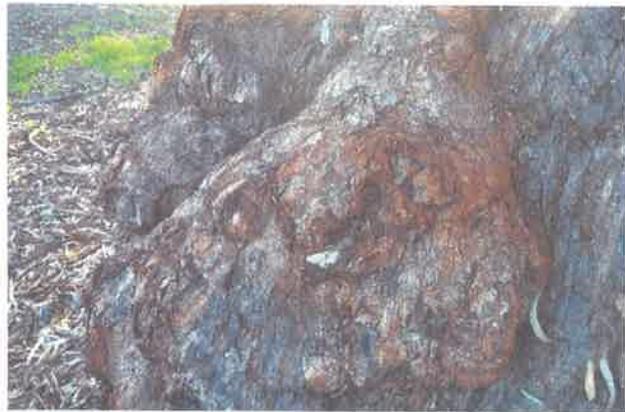
Fungus on burl

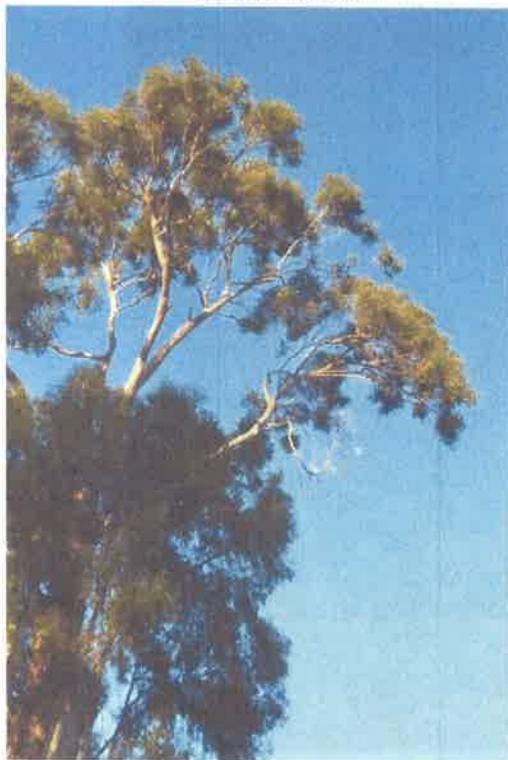
Potential scaffold reduction

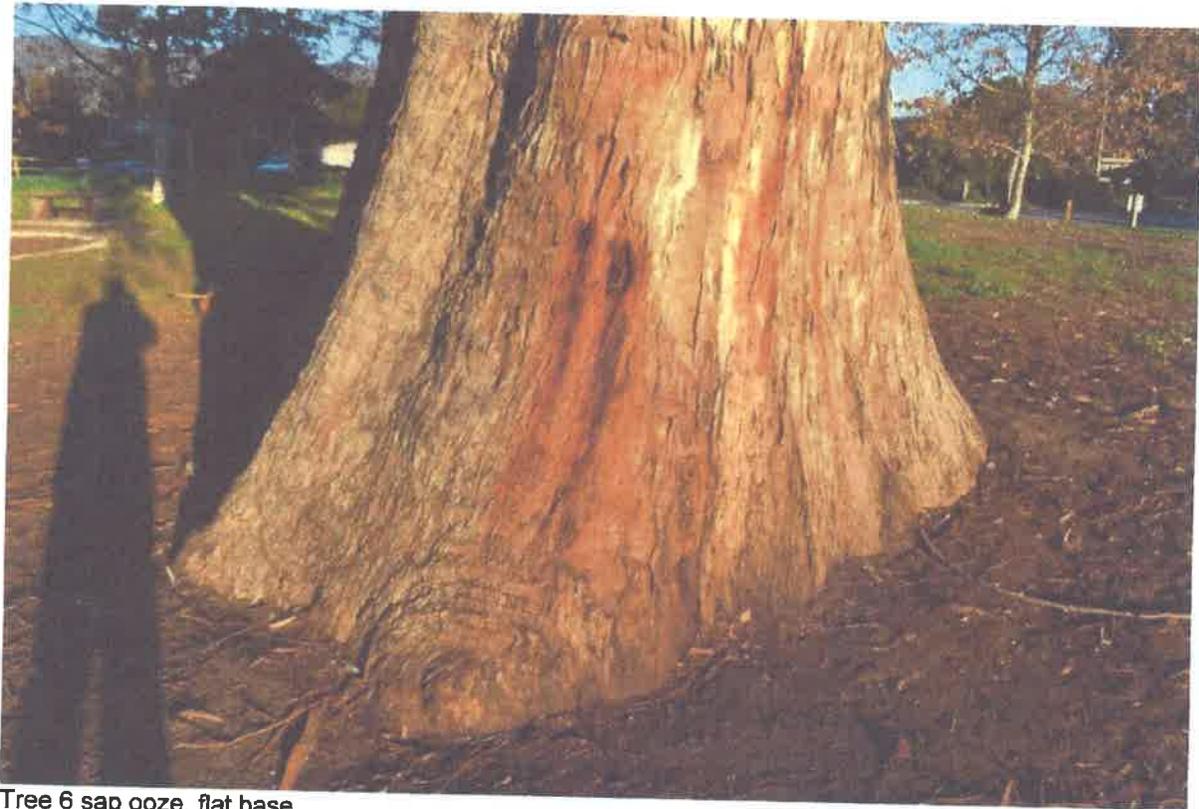
Tree 6
Species: Tasmanian Blue Gum (*Eucalyptus globulus*)
DSH: 93" Diameter at Standard Height
Height: 95 feet
Canopy: 75"
Observations: Tree 6 appears to be in fair condition. The bottom of the tree is partially hollow, with a flat edge on the southeast side indicating root issues, and sap ooze. The sap appears to be slime ooze, a harmless bacteria infection and not symptoms of damage from eucalyptus long horned beetle insect activity.
Tree Defects: The parts of the tree most at risk of failure are 1) the overextended branches on the north side of tree, 2) the three scaffolds next to each other about one quarter up the tree on the west side. 3) The scaffold on the southeast side. 4) The base of the tree and possible insect/root issues
Targets: People walking in the Park under tree 2 and within 143' of the tree.
 People in playground
 People in houses within target zone on south side Chaparral Dr.

Likelihood of failure: Possible
Likelihood of Impact to target: High
Likelihood Matrix: Somewhat likely
Consequences of failure: Severe
Tree 6 Risk Rating: High
Mitigation Options: Reduce two overextended branches on north side of tree, or consider moving playground 143' from trunk, level three analyses of sap wounds and root collar
Residual risk: Moderate

Tree 6 sap ooze, flat base

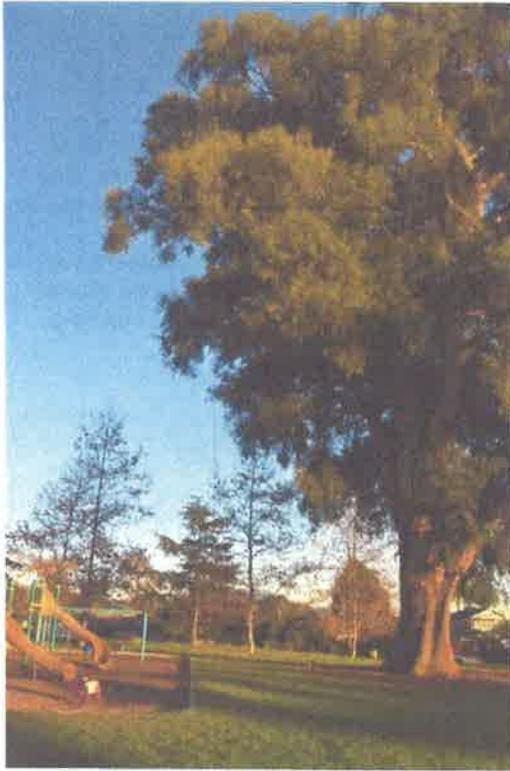
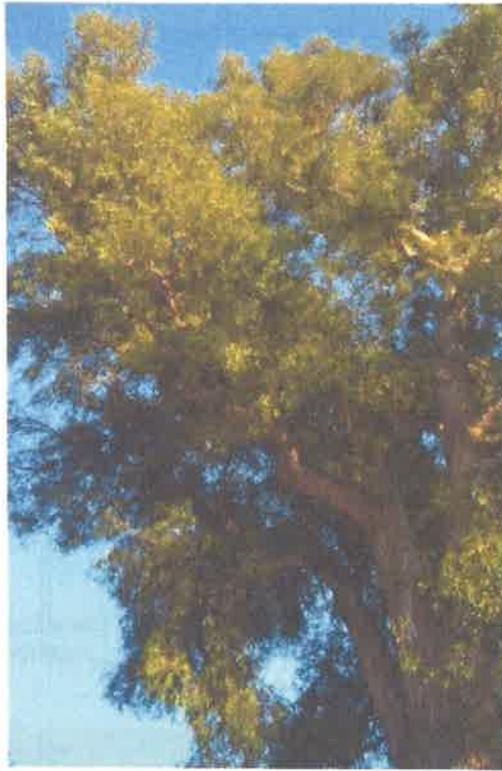
Tree 6 – Scaffold reduction on playground side

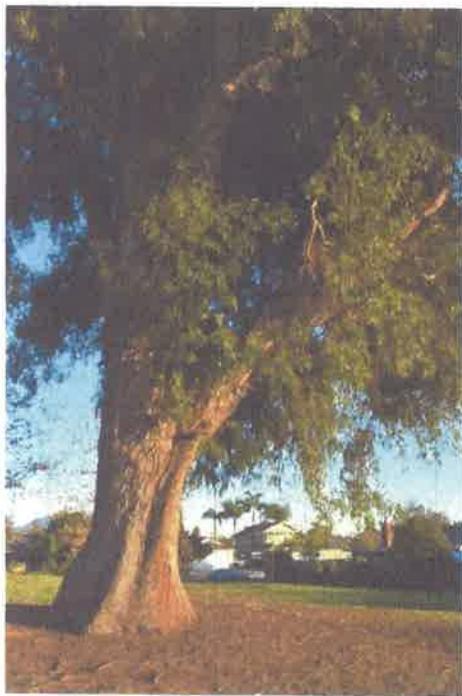
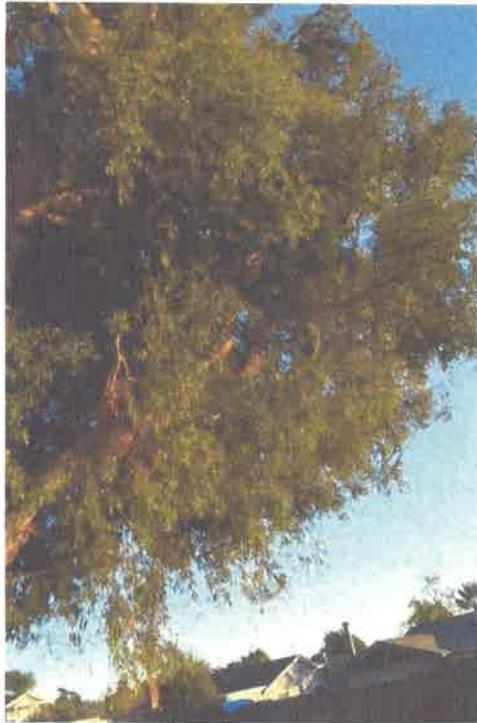
Tree 6 scaffold reduction

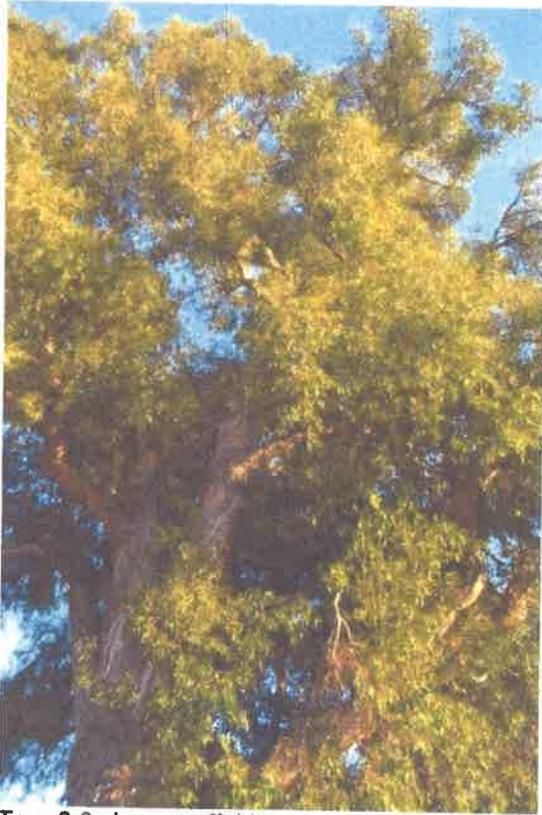
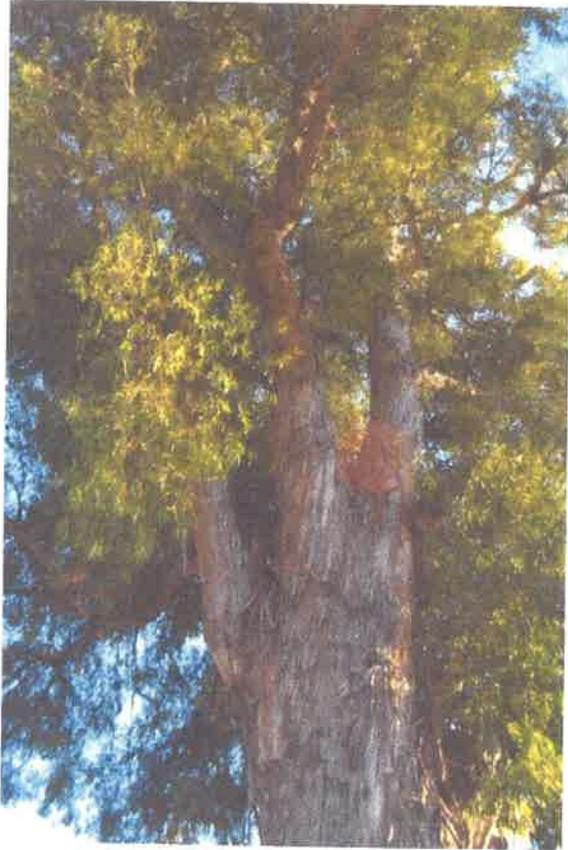
Tree 6 3 close scaffolds

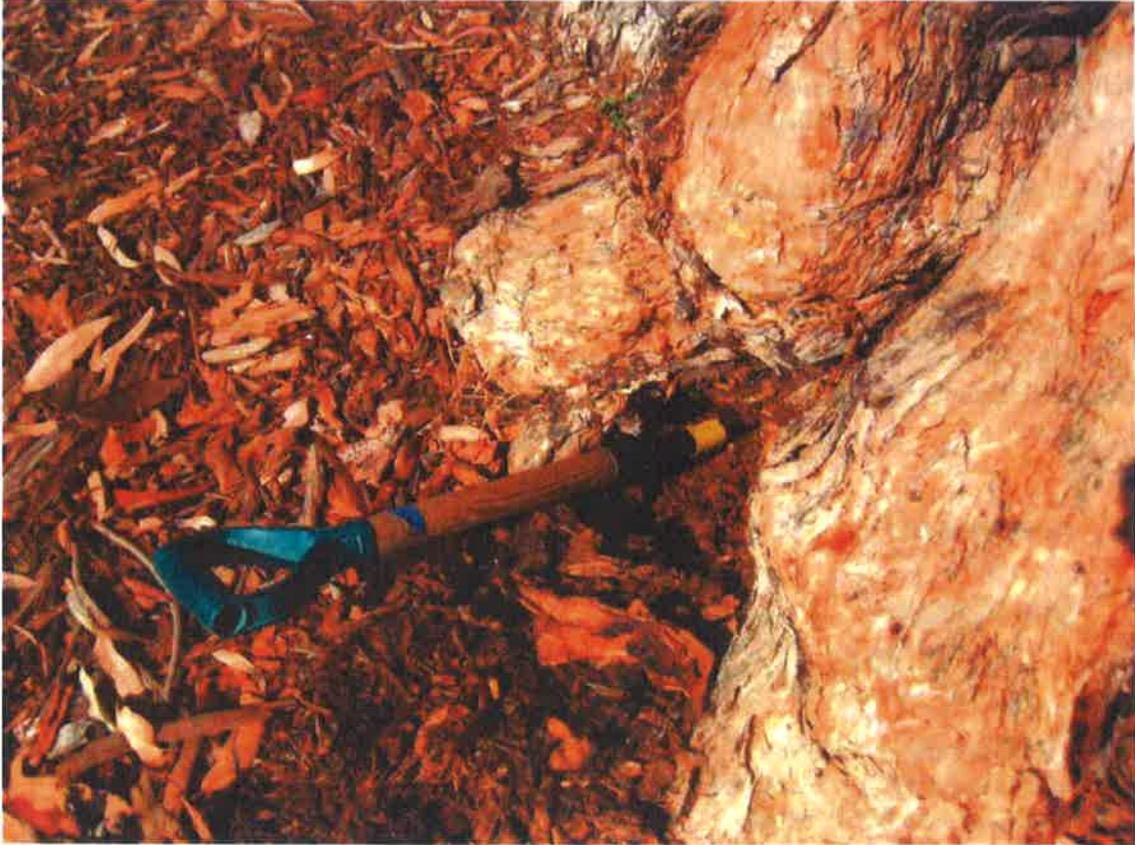
Appendix A

a. In the photos presented on pages 4-6 visually observed decay is occurring in three of the five trees under study. In trees 2 and 5, the decay at this point appears not to have invaded wood deeply. More research needs to be done with tree number 7 to determine the extent of decay and hollowing out. The same process may now be in progress in the existing trees which caused toppling in those which were described in #3 above.

Figure 1. Photo shows a basal burl on the west side of tree #2 which has decayed away. Note the depth to which decay has advanced into its center. Decay of this kind can provide a point of entry for the very destructive Brown Cubicle Rot.

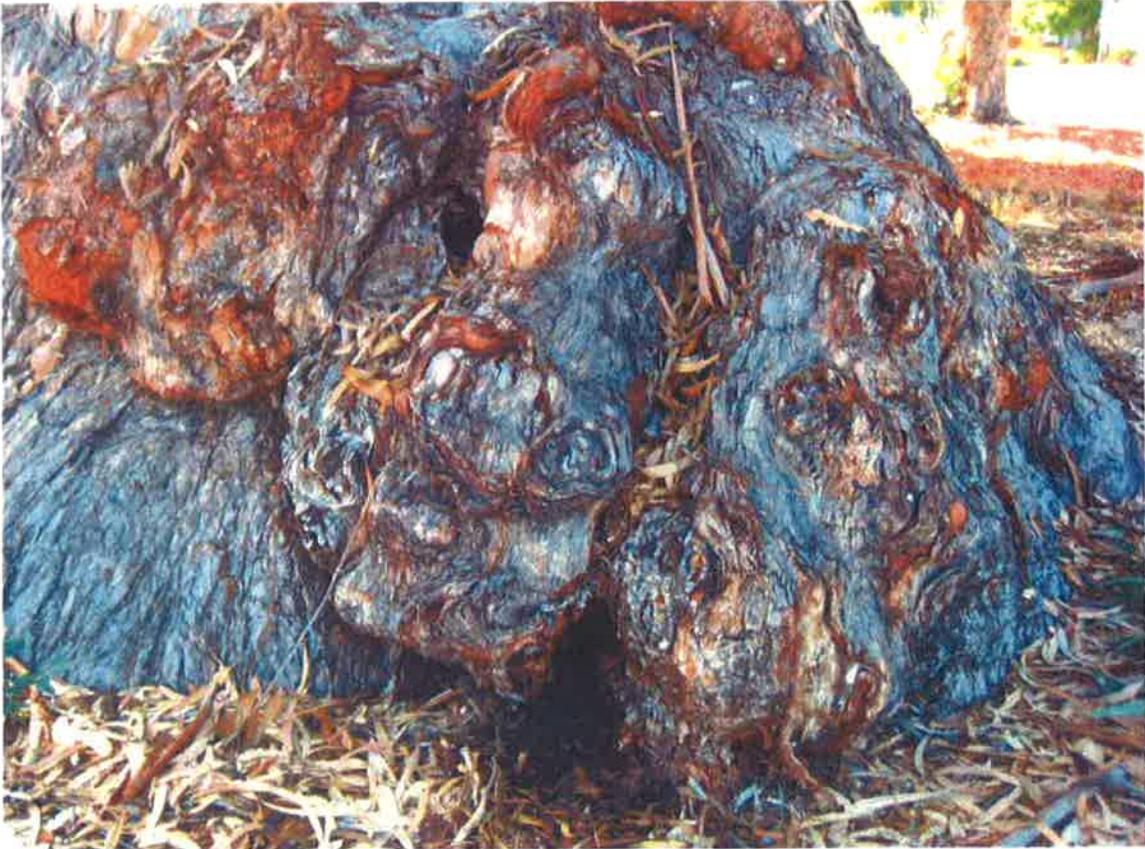
Appendix B

Figure 2. Photo shows burl decay in two places at the base of tree #5.

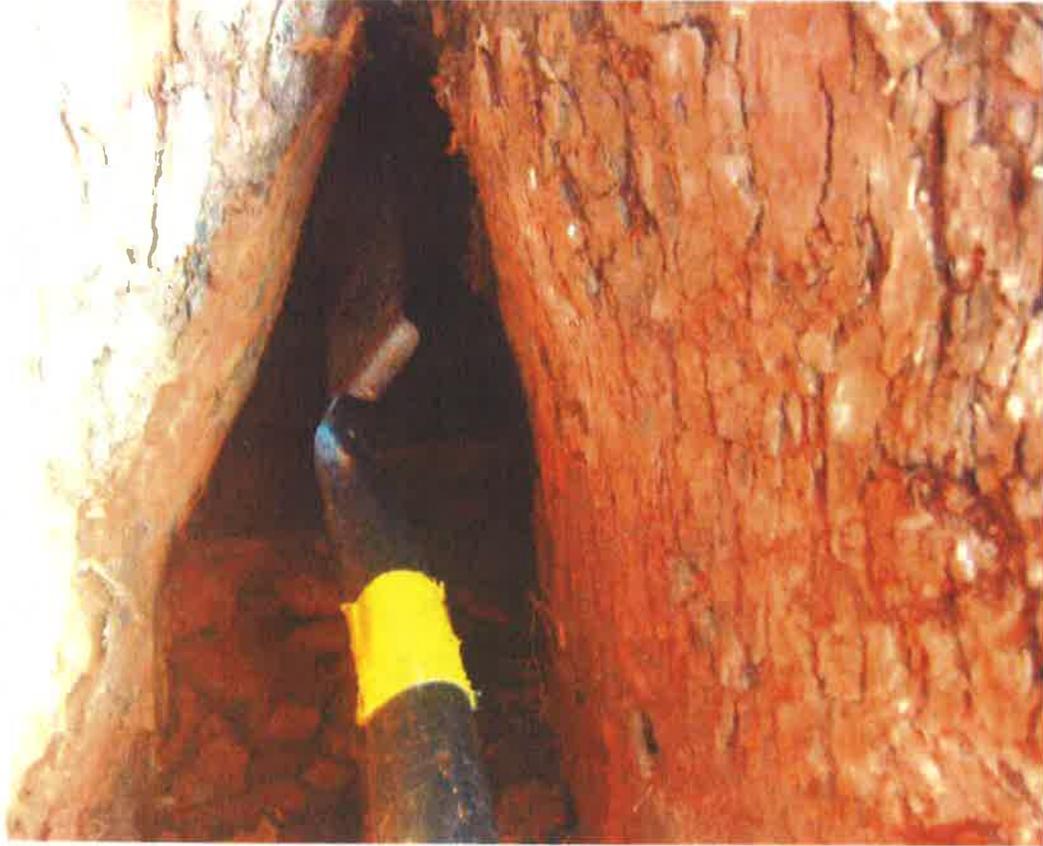
Appendix C

Figure 3. Photo shows a deep cavity on the north side of tree #7 in which Brown Cubicle Rot is abundantly present.

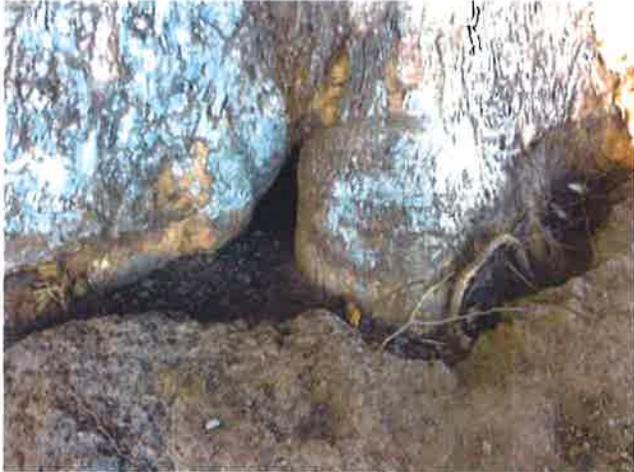
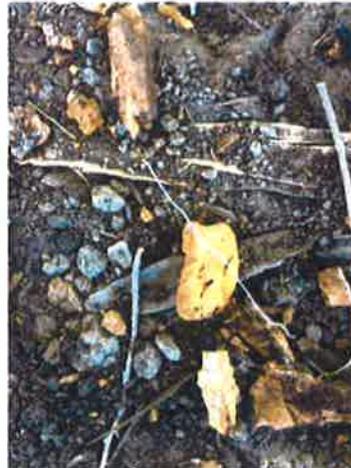
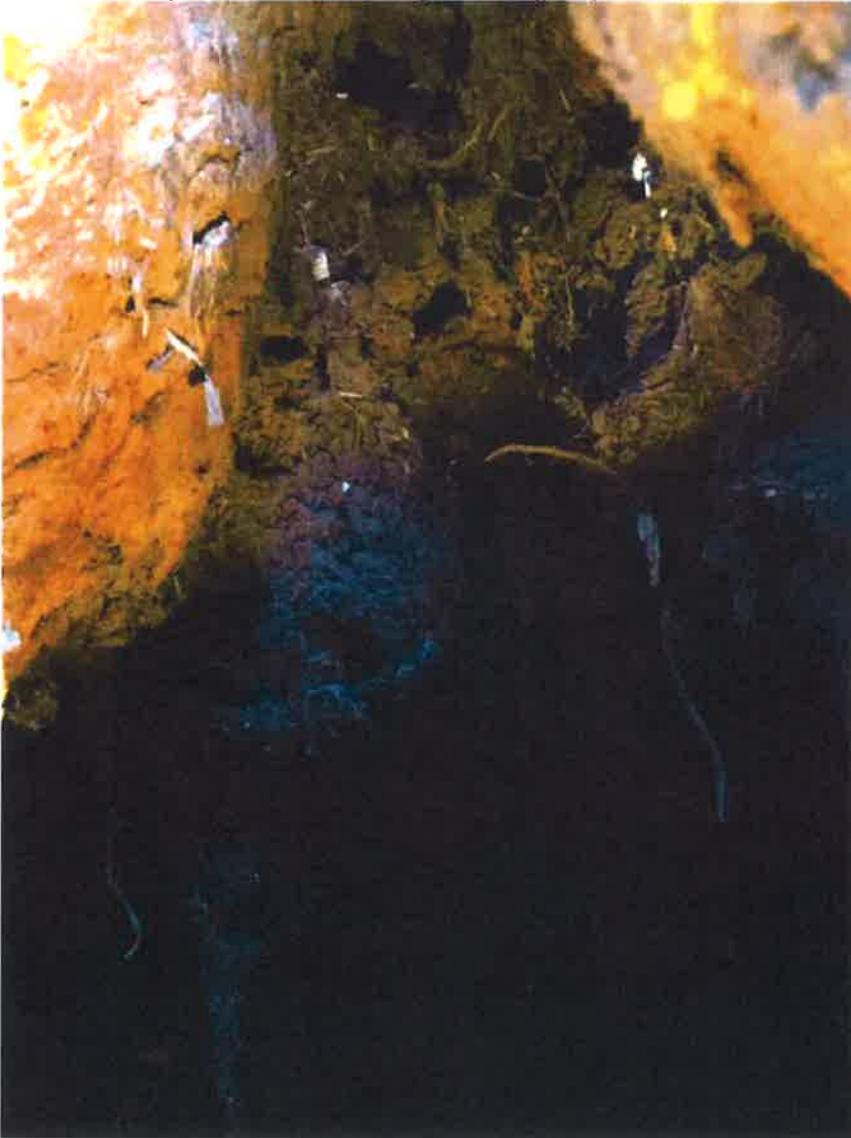
Duke McPherson's August 20, 2015 Arborist Report called for a closer inspection of the cavity on the north side of the tree. The cavity extends approximately 2 feet into the tree and about two feet high. While there is Brown Cubical Rot in the deadwood of the cavity, the remaining wood when probed by hand and with a five-foot probe is relatively solid. The tree is seven feet wide at this point, so there is approximately 5 feet of good wood on the southern side that will continue to support the tree.

Above-Cavity on north side, Right-decayed pieces, below looking up from inside cavity

1. There is some decay in the northern base of tree seven, but this decay is not present around the exterior root collar. There appears to be sufficient good, structurally sound wood to support the main trunk of tree seven under normal conditions.
2. Under the current drought conditions, the irrigation system for the grass is not penetrating deep enough to provide irrigation to tree seven.
3. Although the radial trenching will assist the ability of tree seven roots to secure water and minerals, the majority of the ground around tree seven remains heavily compacted clay.

1. To slow the progress of decay, the area around the cavity and the tree seven dripline should remain dry and not irrigated. Should the drought continue, the tree's periodic irrigation needs should be reevaluated in summer of 2016.

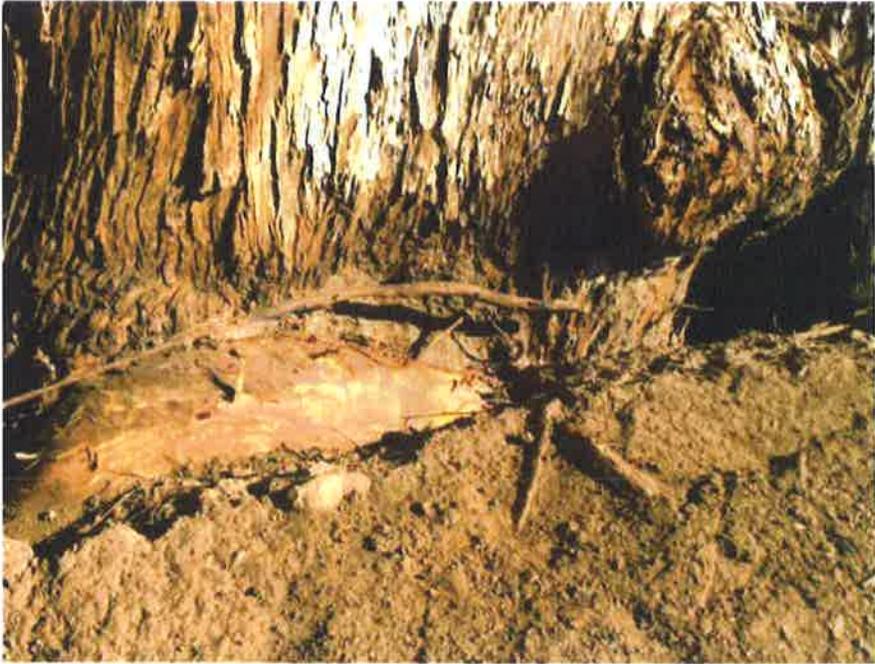
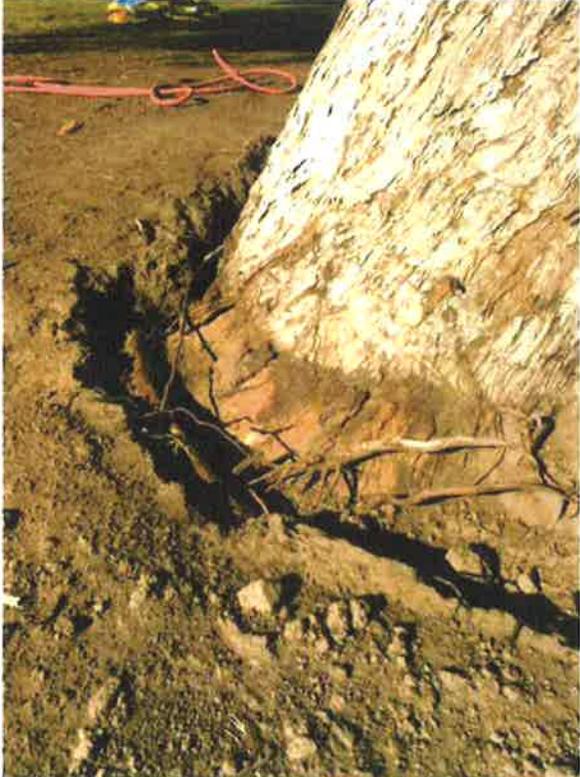
The air spade did uncover a 7' to 9" diameter girdling root on the south side of the tree. The flat shape of the southern side of the trunk indicated that this was likely.

Above -girdling root on the south side. Below – girdling root extending east along trunk

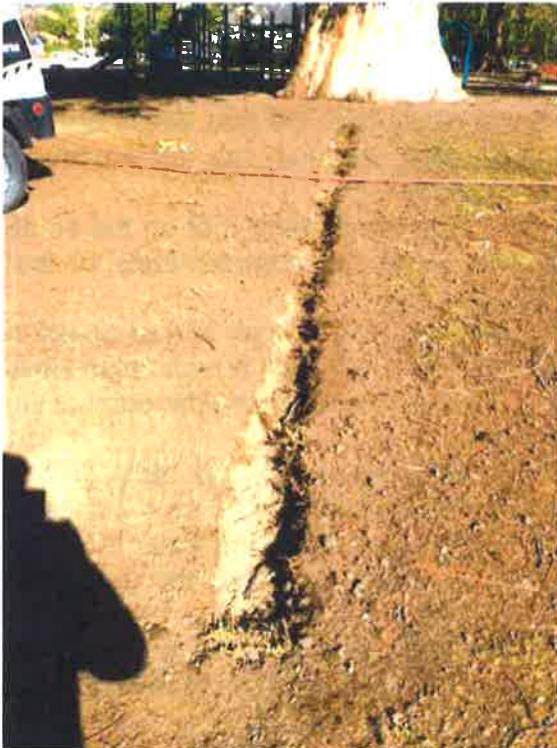
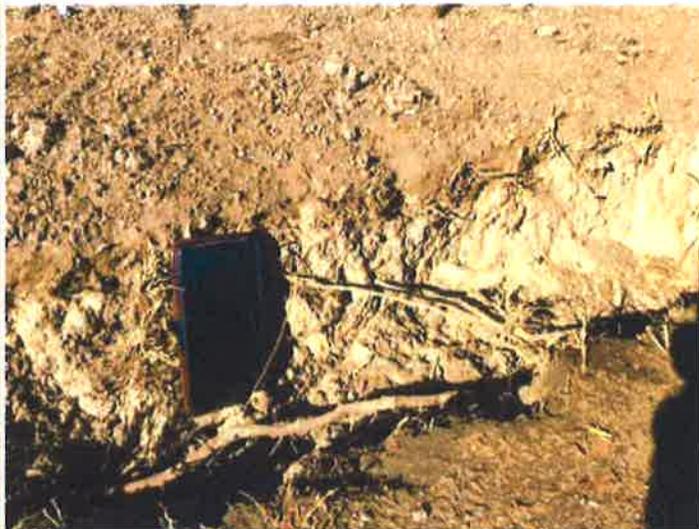
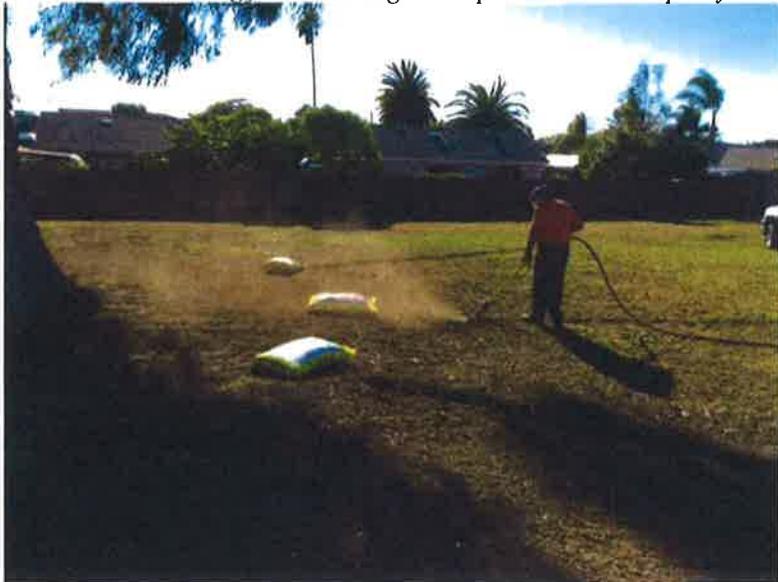
West Coast Arborist staff used the air spade to create eight trenches around the tree, each one about six inches deep and one foot wide. Each trench started about ten feet from the tree and extended about 25 feet to the edge of the canopy. Each trench was then backfilled with one two cubic foot bag of compost mixed in with the original soil. The purpose of the trenches is to loosen the compacted soil, add some organic material to the soil, and improve the ability of the tree roots to receive air and water.

Above -trench radiating from tree. Right- cell phone idincates depth of trench, note soil is dry about 3 inches below surface

3. The City should consider annually loosening the soil under the canopy of tree seven in different locations than done in 2015. Since the City has a number of high value trees where this soil loosening would be beneficial, the City may want to consider purchasing their own heavy duty Air Spade or Supersonic Air Knife.

4. All of the ground underneath the dripline of tree seven, especially the radial trench areas where the soil was recently loosened, should be covered with 3 to 4 inches of organic bark mulch. The grass does not have to be removed, but if the water is turned off, and the mulch is in place under the tree seven shady canopy, the grass will minimally active.

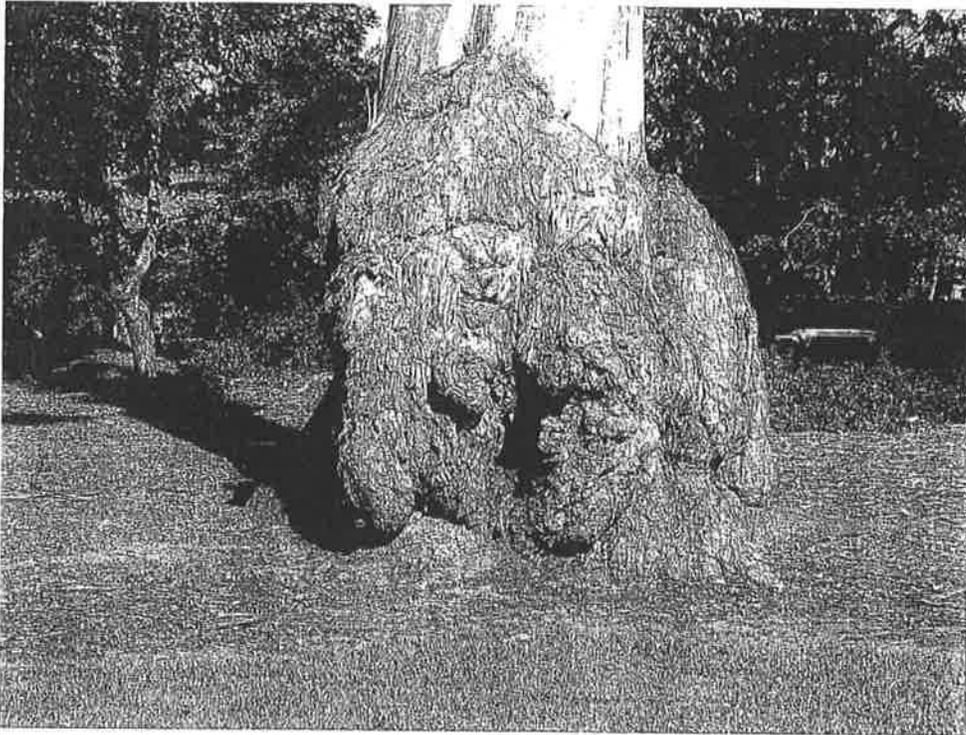
— Tree #1: This tree is located the farthest north in the park (see Figure 1.1, tree on left). It has a rather sparse canopy, with most of its growth up top (see Figure 1.2). Its trunk base has a huge lignotuber (see Figure 1.3), which is a woody tuberous mass that occurs naturally in some Eucalyptus species¹. There are two small cavities within the lignotubers, and there are signs of borer infestation (see Figure 1.4). There is turf growing with six feet of one side of the trunk, and the soil around the trunk was moist the day of the inspection. RESISTOGRAPH RESULTS (see Appendix B): 4 locations tested, 1 cavity found (S).

Figure 1.3, Lignotuber with Cavity

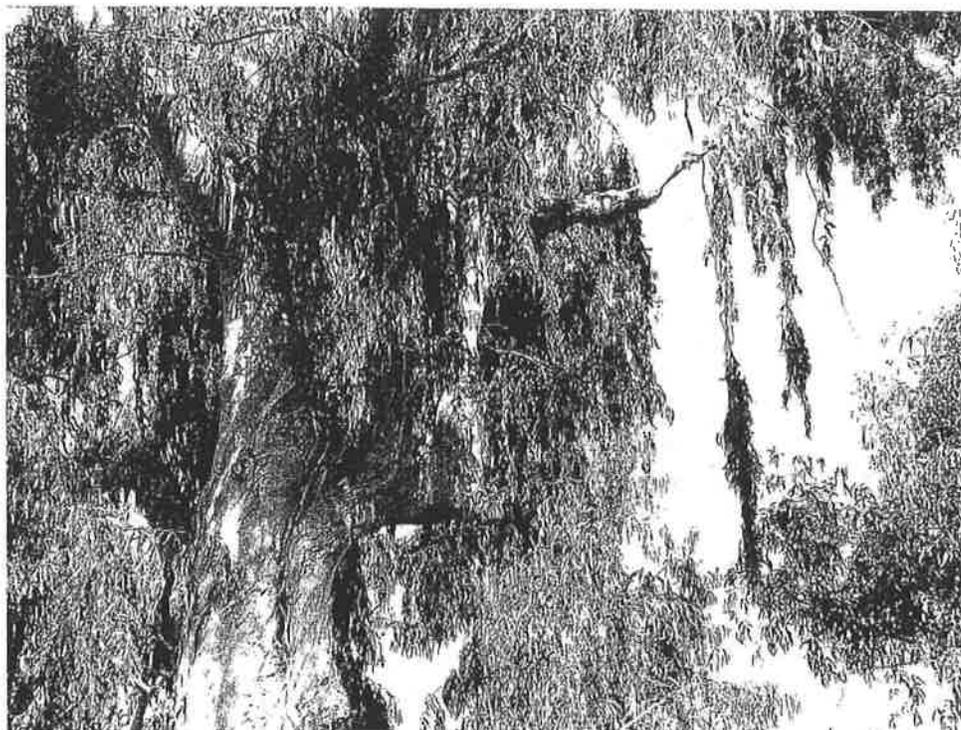
— Tree #2: This tree is next to Tree #1 (see Figure 1.1, second tree on left). It has both canopy and subcanopy growth as well as a profusion of seed caps. There is one questionable attachment of a major limb that appears to be included, which inherently are weak (see Figure 2.1). It too has a lignotuber, on which there is some decay (see Figure 2.2). The soil around the tree was moist. RESISTOGRAPH RESULTS: 4 locations tested, no cavity or significant decay detected.

Figure 2.1, Included Attachment
