**CITY OF CARPINTERIA
TREE ADVISORY BOARD
Thursday, February 18, 2016**

1. Stone Pine Assessment & Management Plan Discussion
2. Heath Ranch Park Tree Matters

MEETING MINUTES OF THE TREE ADVISORY BOARD
THURSDAY, NOVEMBER 5, 2015

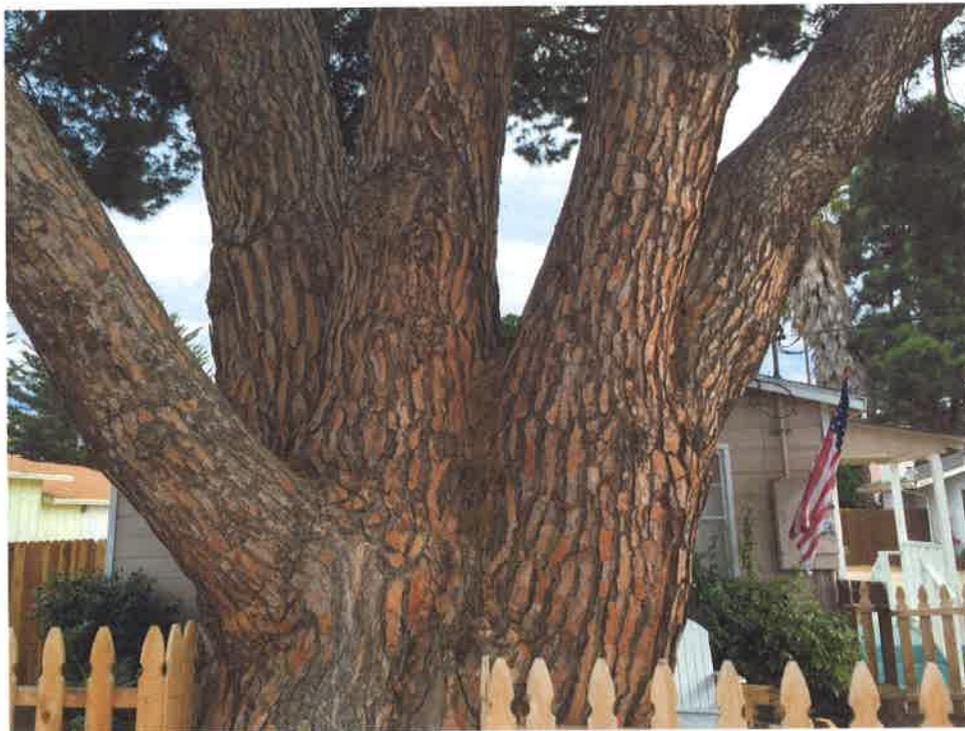
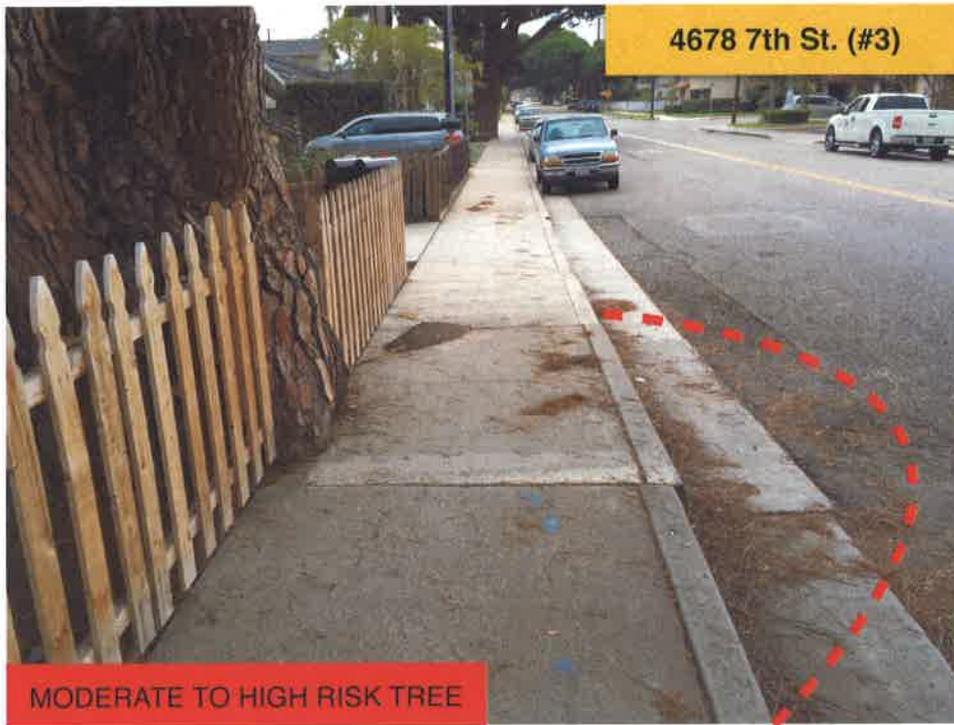
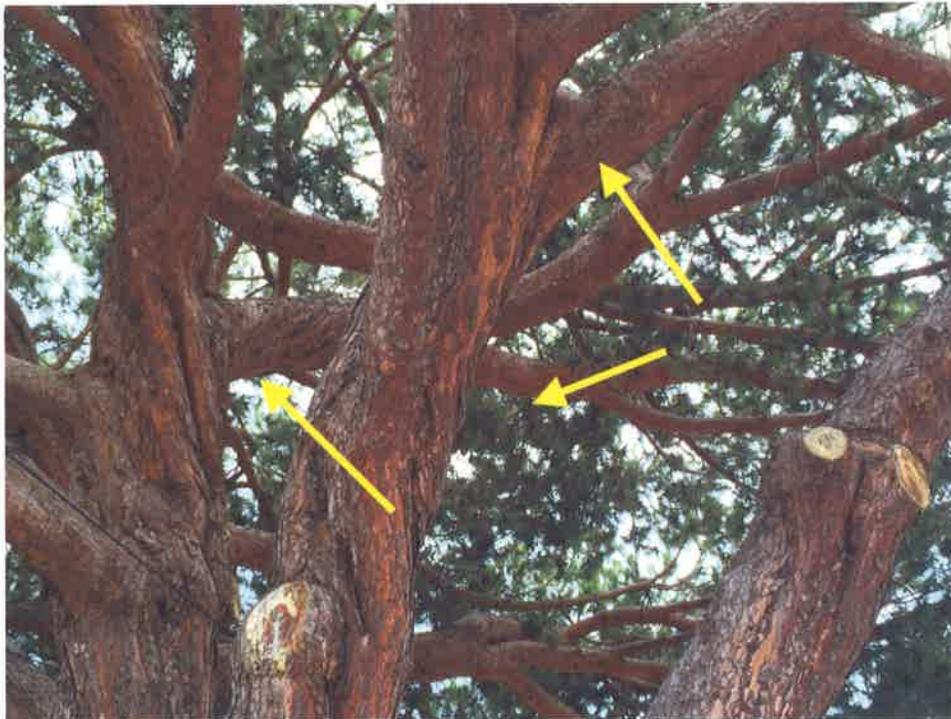
Note some deformity in southern and central leaders at 15'-20'. Bulb out sidewalk/curb as option. Gas and water meters 8' to east of trunk.

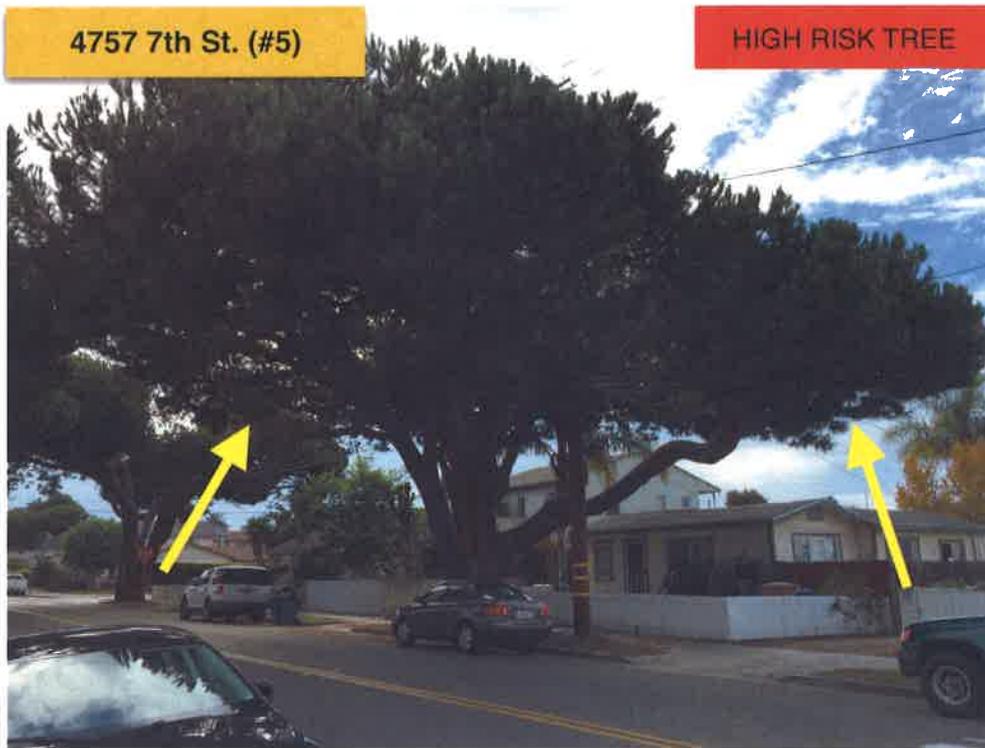
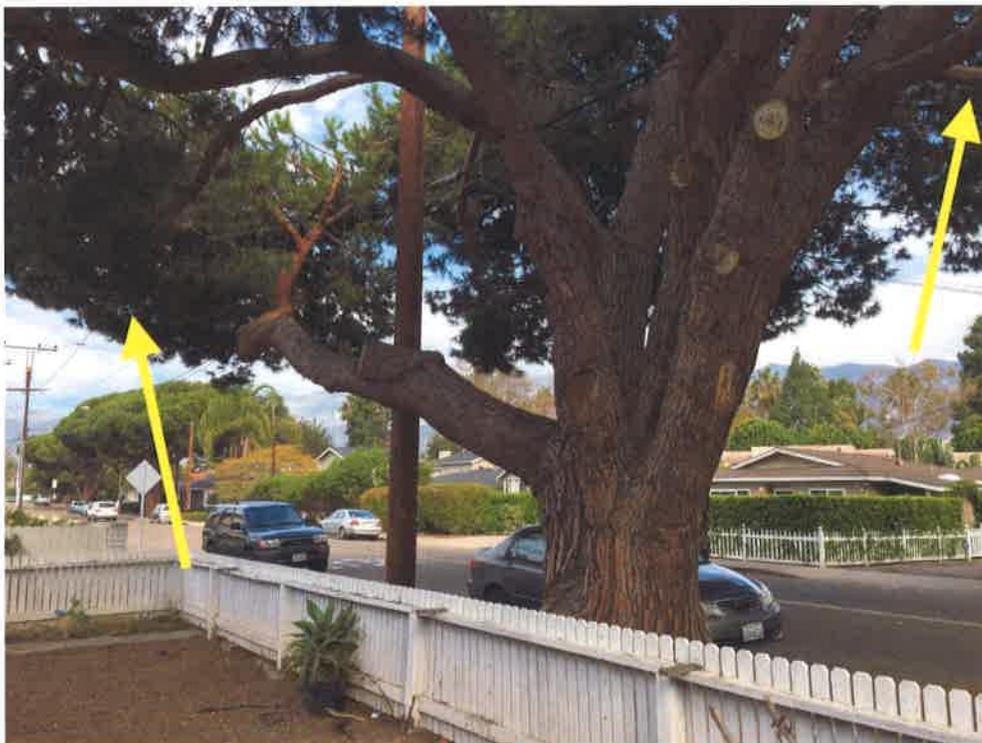
Heavy co-dominant trunks pose a high risk, particularly during severe storm events. Reduce a significant amount of weight and install cables. Several leaders and large limbs should be removed including eastern and western leaders and large limbs over road (more photos on next page).

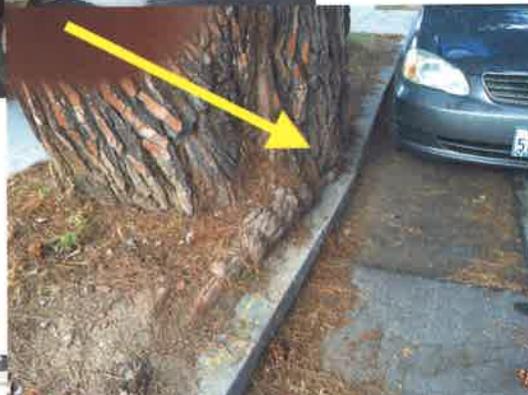
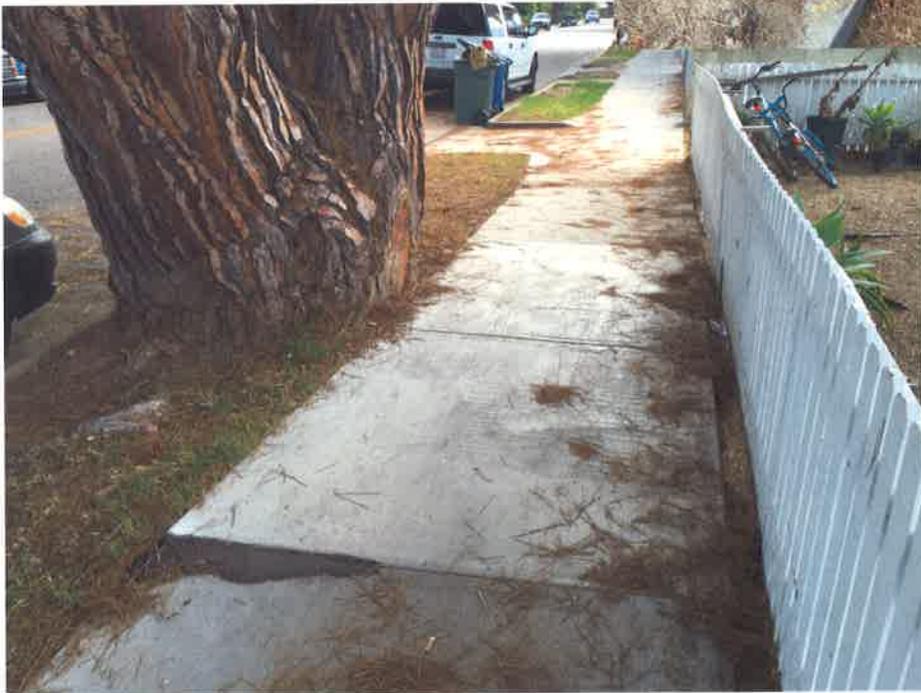
HIGH RISK TREE

Note damage to curb and gutter. Consider bulb out.

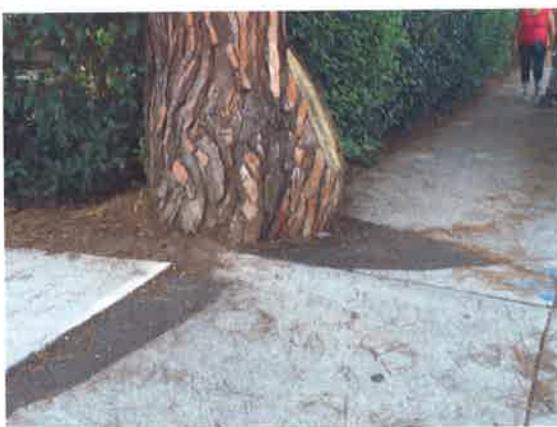
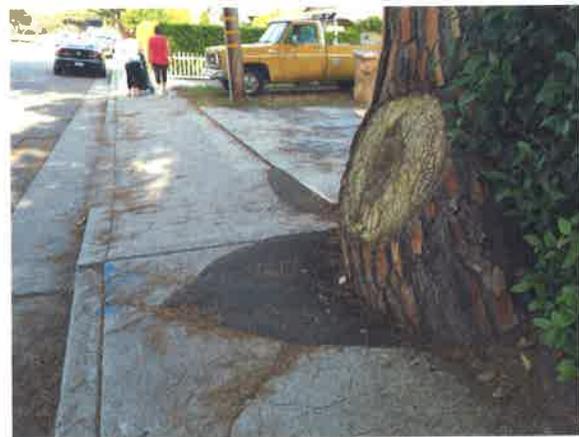
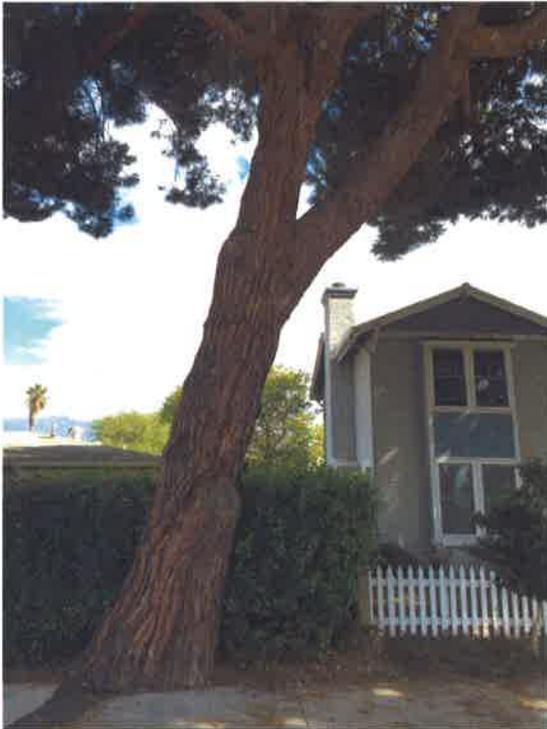
Partially on residence's property or east edge of sidewalk. Crown thin to reduce end weight. A second trunk had been removed. Bulb out is option. Note damage to sidewalk.

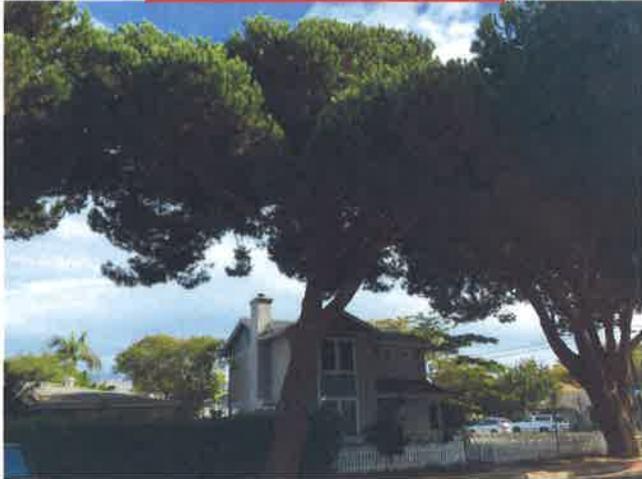
4774 7th St. (#7)

MODERATE RISK TREE

Mostly on east edge of sidewalk. Co-dominant leader is dense and warrants pruning and cabling. Could significantly reduce weight of southern leader to avoid need for cable. Bulb out is option.

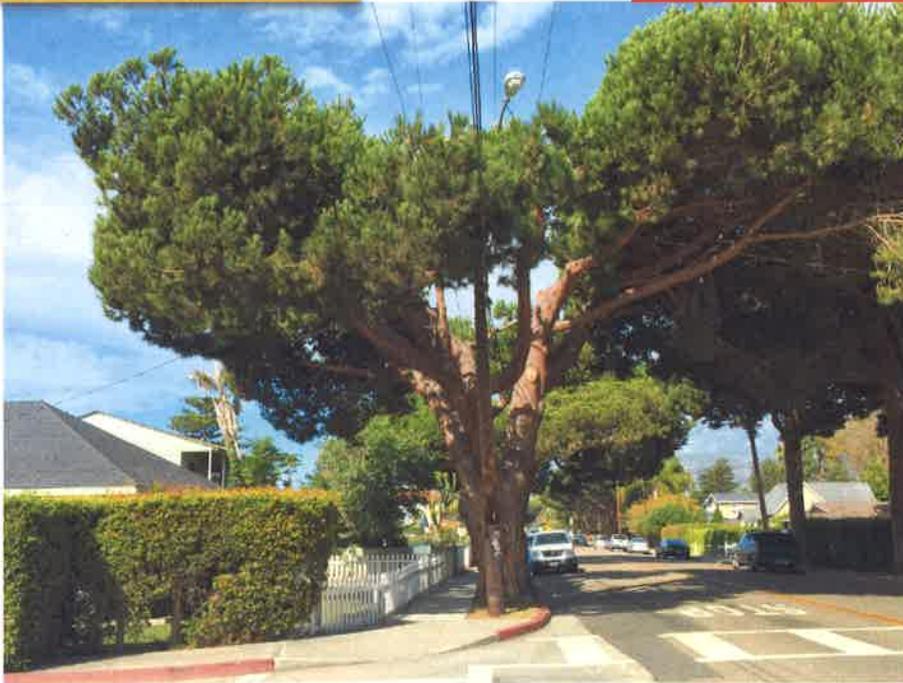
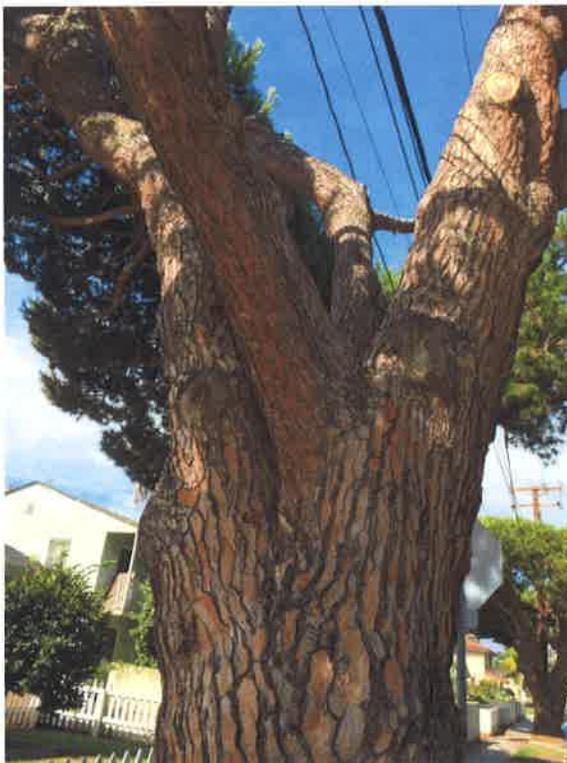
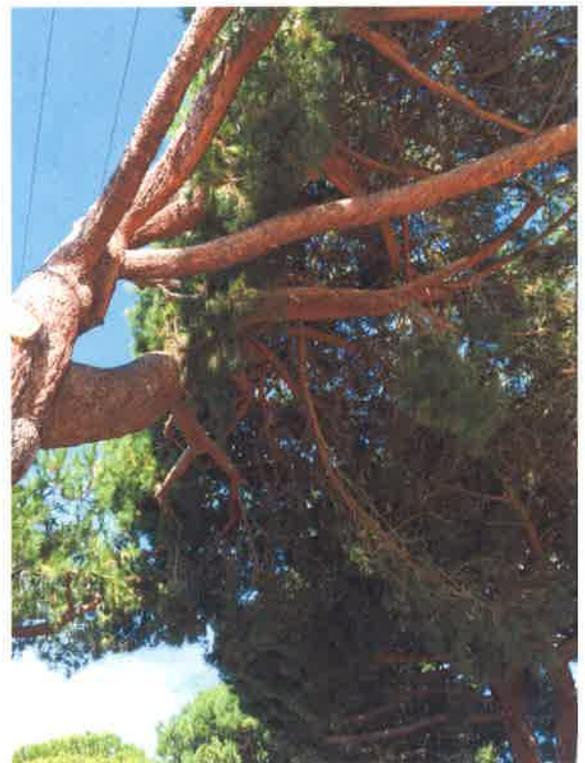
4791 7th St. (#8)

HIGH RISK TREE

Severely pruned for utility lines, leaving dense and heavy leaders on both sides of center cables. Tree also grows into canopy of two pines on other side of street (more photos next page).

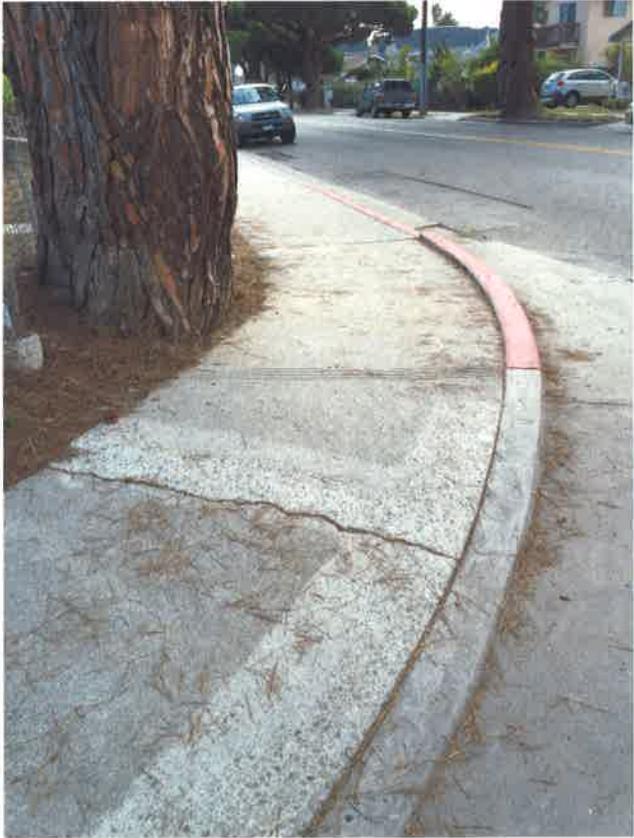
4792 7th St. (#9)

MODERATE RISK TREE

Limbs are heavy on leader toward house. Tree is on corner and bulb out option in future not likely.

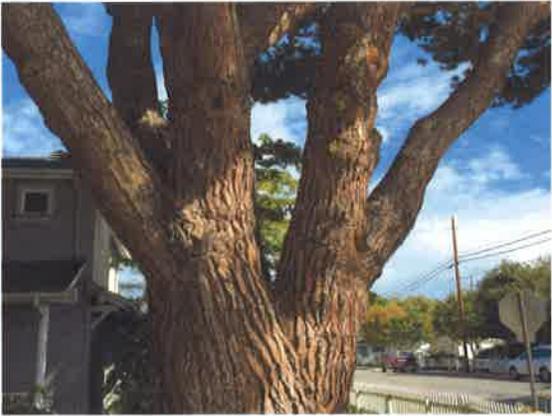
Appears well pruned in recent history. Not much problem now except for curb and sidewalk close to needing repairs.

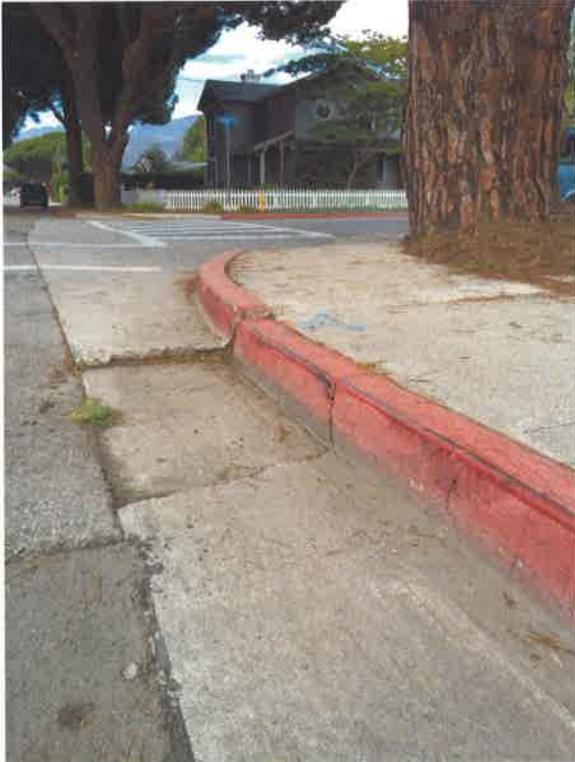
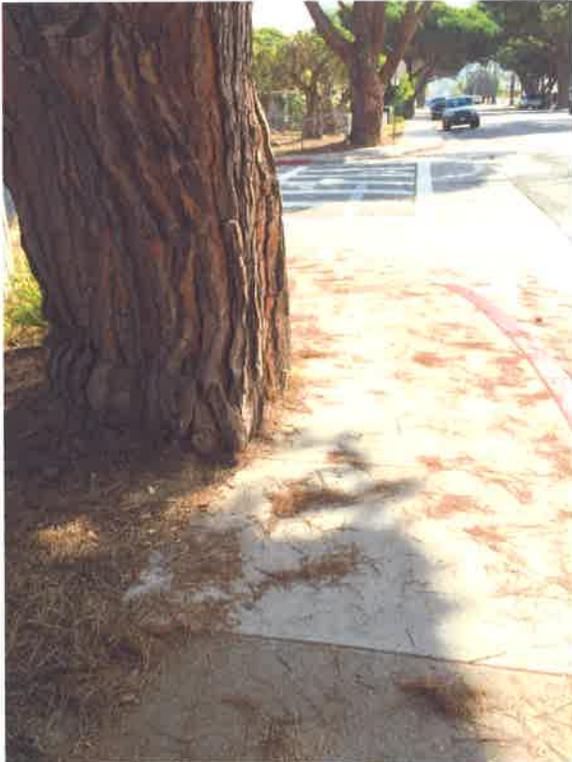
Owner has requested removal due to damage. Tree has no real canopy due to extreme utility pruning and is significantly dense and heavy on the laterals. The base has outgrown the planter. Removal and replacement is appropriate (more photos next page).

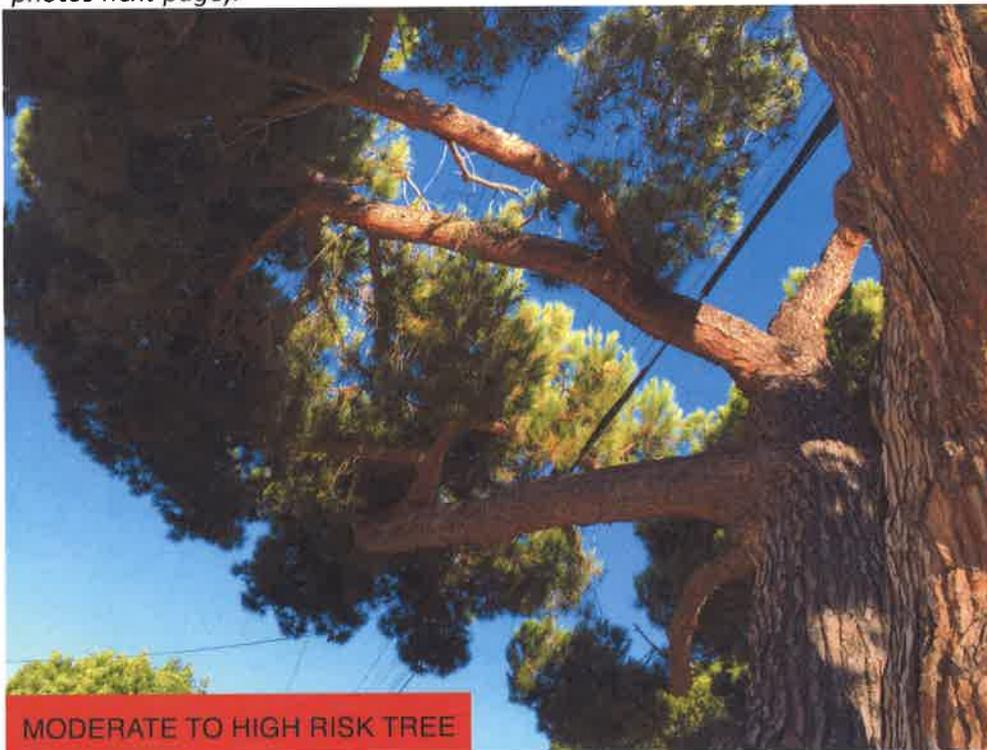
4823 7th St. (#11)

The two trunks are major co-dominant stems and prone to splitting. Also note the trunk overhanging the curb at the base.

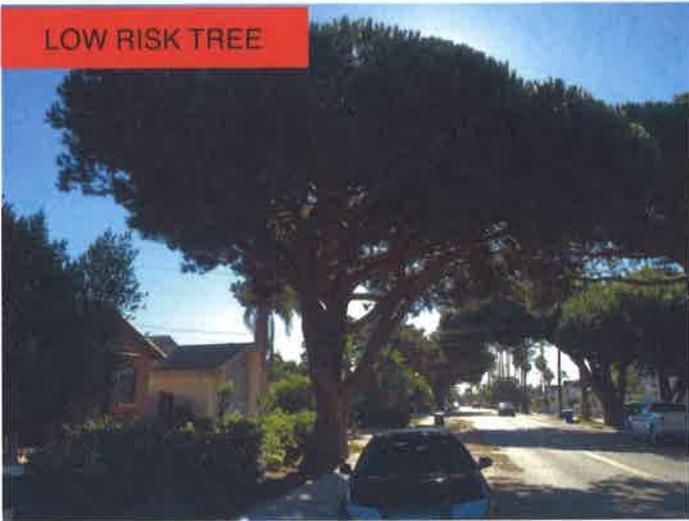
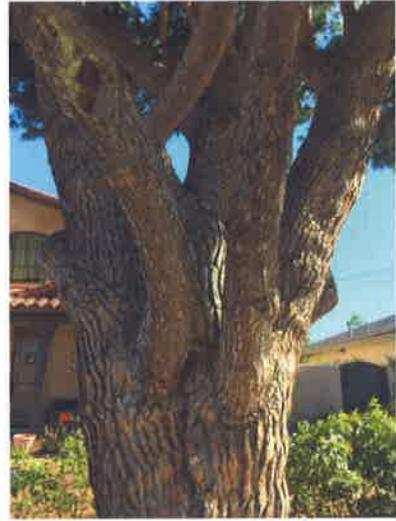
4848 7th St. (#12)

LOW RISK TREE

Crown is dense although better structured than most. Limbs also intertwine to some degree to assist in support. Leader to east is most prone to split but unlikely. Bulb out is an option to create more space for growth. Sidewalk about ready for repairs. Note water and sewer to north.

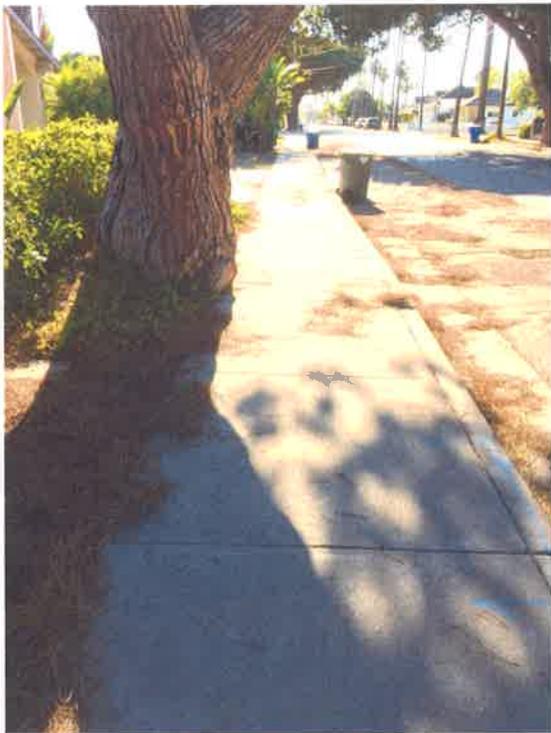
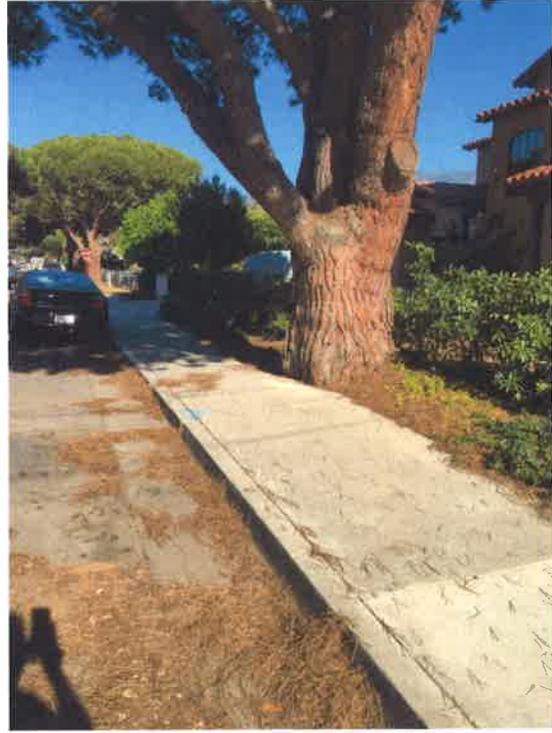
Utility cables provide some support to street side, but crown is dense and residence is potential target. Infrastructure was replaced and is holding up. Remove several large limbs over house and street when thinning (more photos next page).

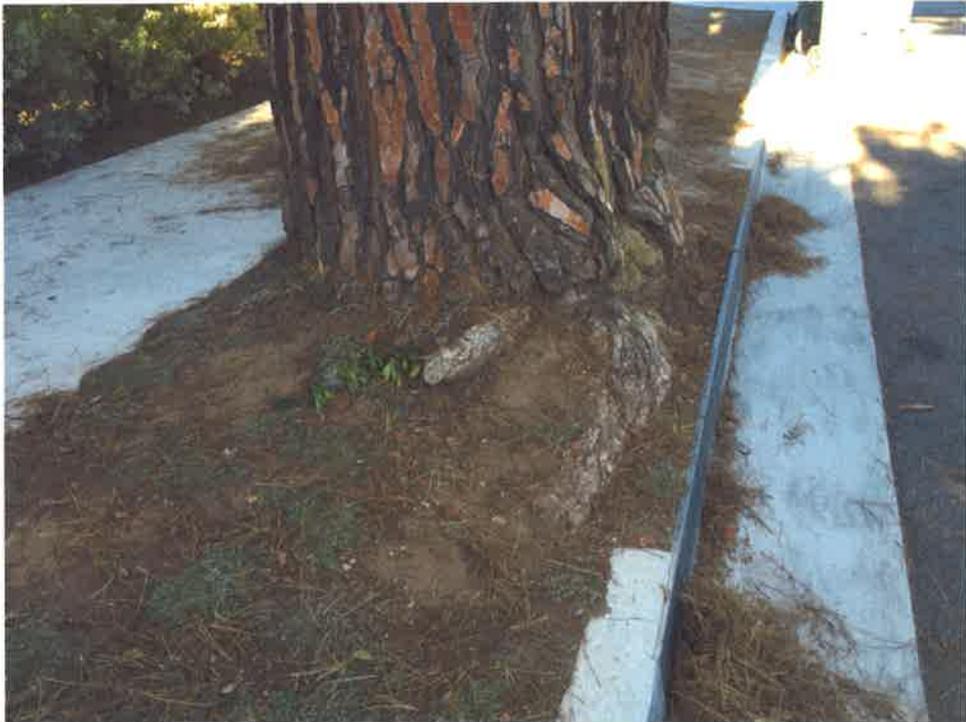
4851 7th St. (#13)

Note the replaced sidewalk and the steel curb.

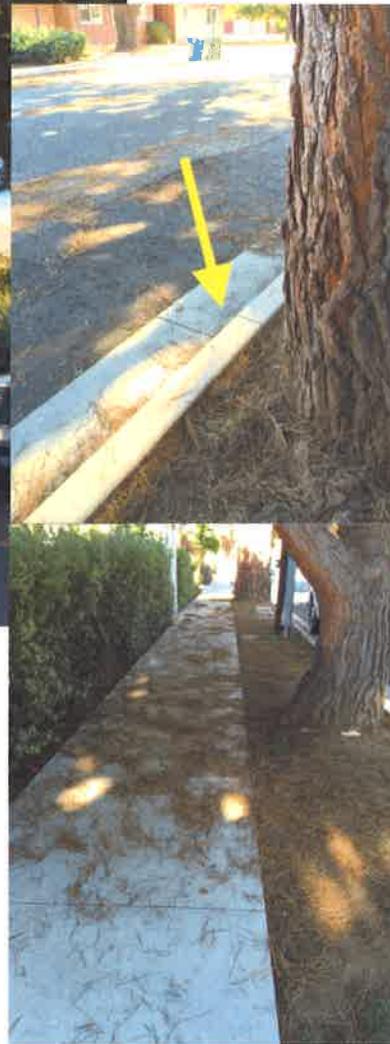
Young tree beneath utility wires that warrants structural pruning. New cracks in curb and gutter (arrow) suggest aggressive root growth.

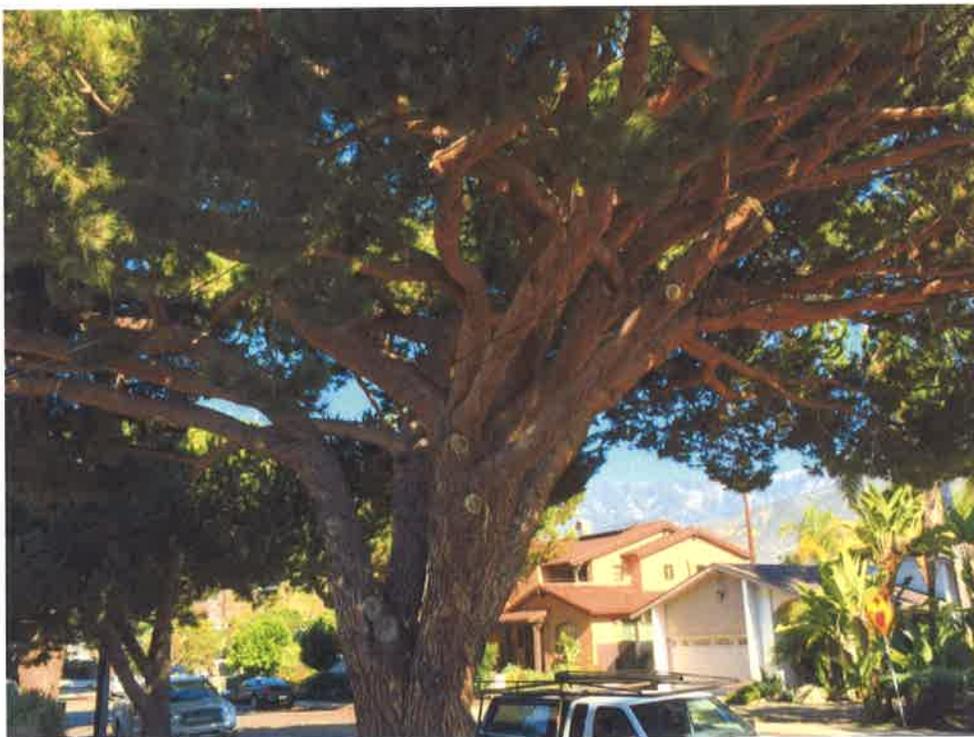
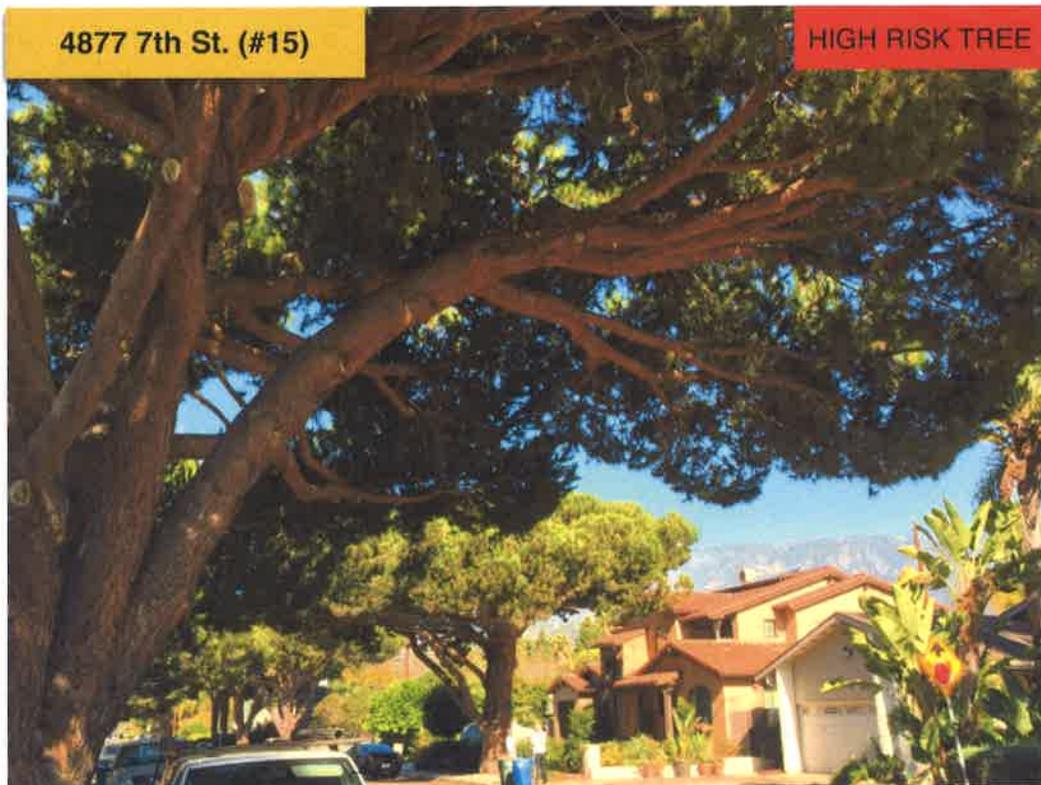
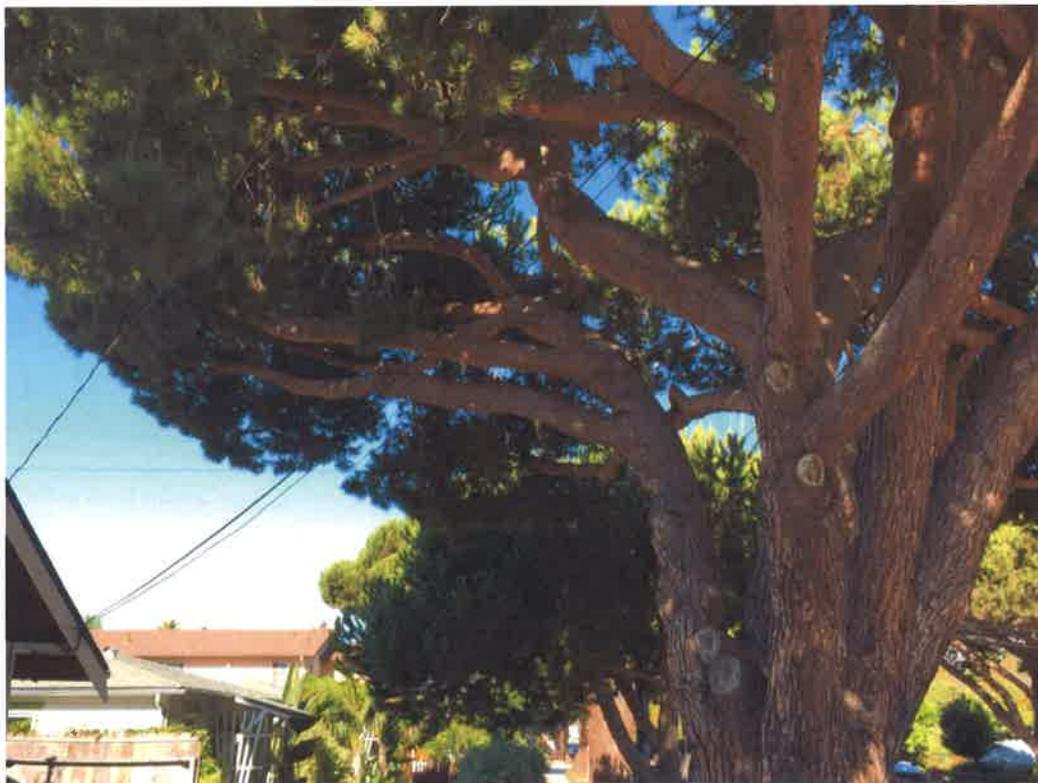
Large tree with high potential to split over road and sidewalk. Either remove northern leader or majorly thin over road. Cable could help retain northern leader. Southern half of crown needs major thinning (more photos on next two pages).

Extremely dense crown

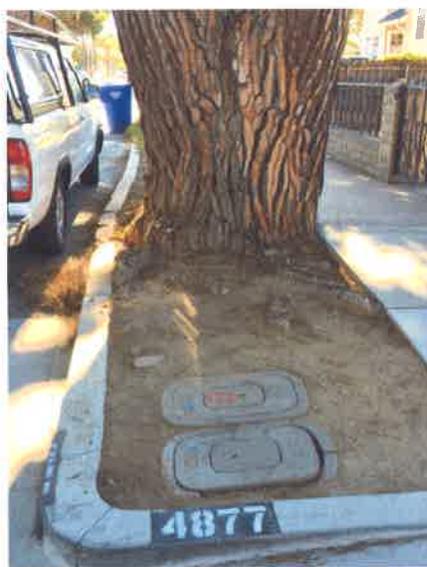
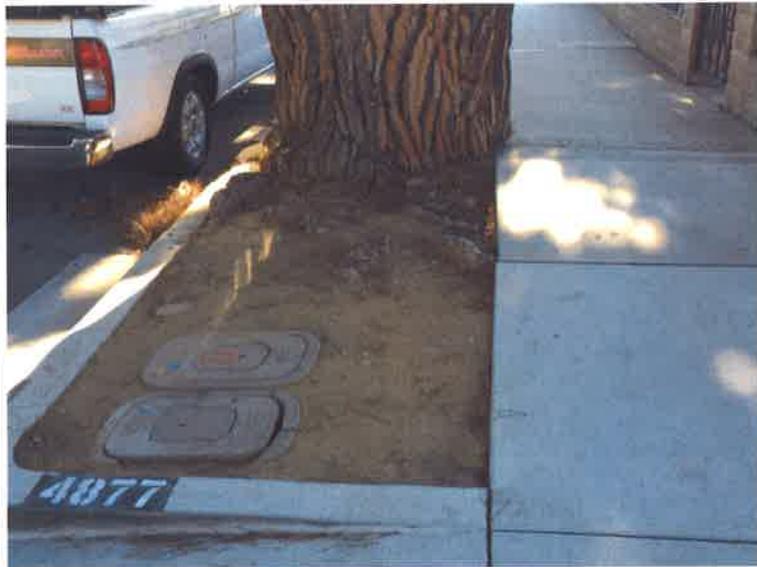
4877 7th St. (#15)

Note large trunk in small space and damage to curb sidewalk.

HIGH RISK TREE

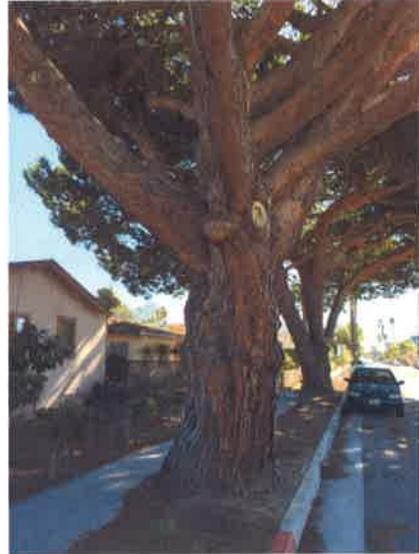
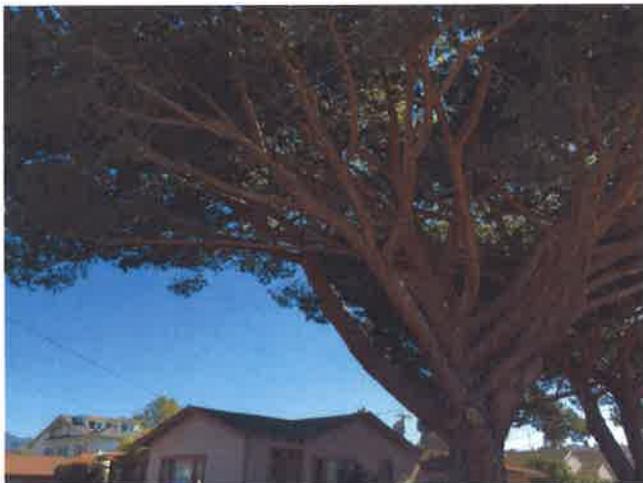
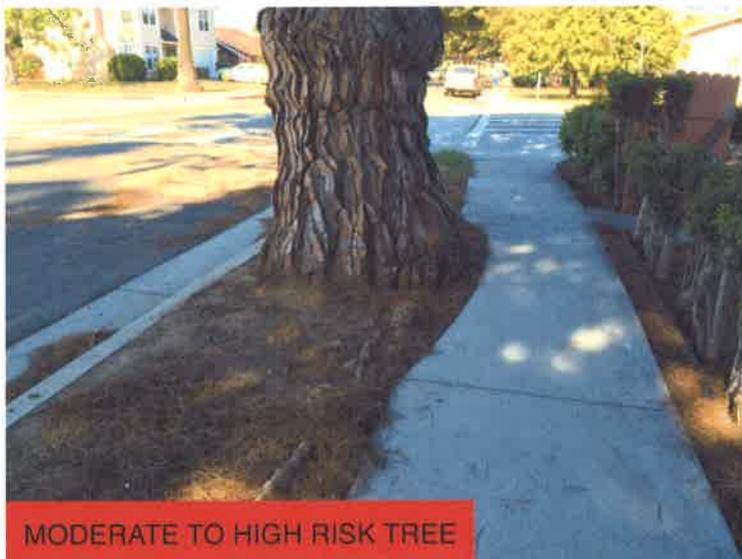
Dense and heavy. Warrants crown thinning. Consider removing northeastern and northwestern leaders. Replacement sidewalk is ADA undersized but allows passage without obstacles. Bulb out may be an option.

MODERATE TO HIGH RISK TREE

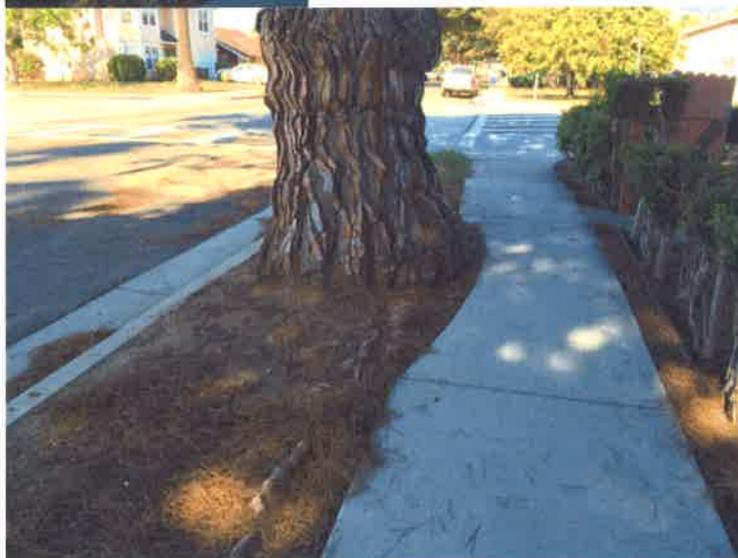
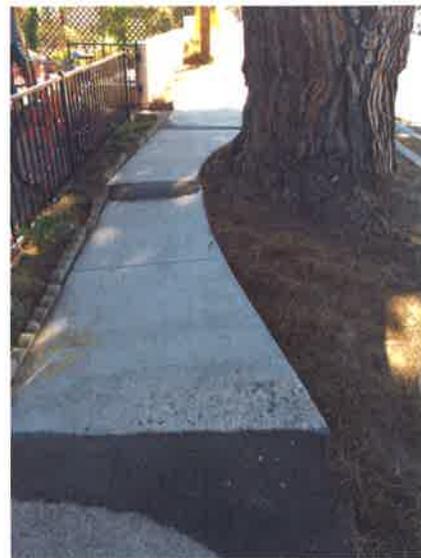
4926 7th St. (#17)

MODERATE TO HIGH RISK TREE

Dense and heavy. Warrants crown thinning by removing major limbs. Replacement sidewalk is ADA undersized and lifting is creating hazard to pedestrians. Bulb out may be an option.

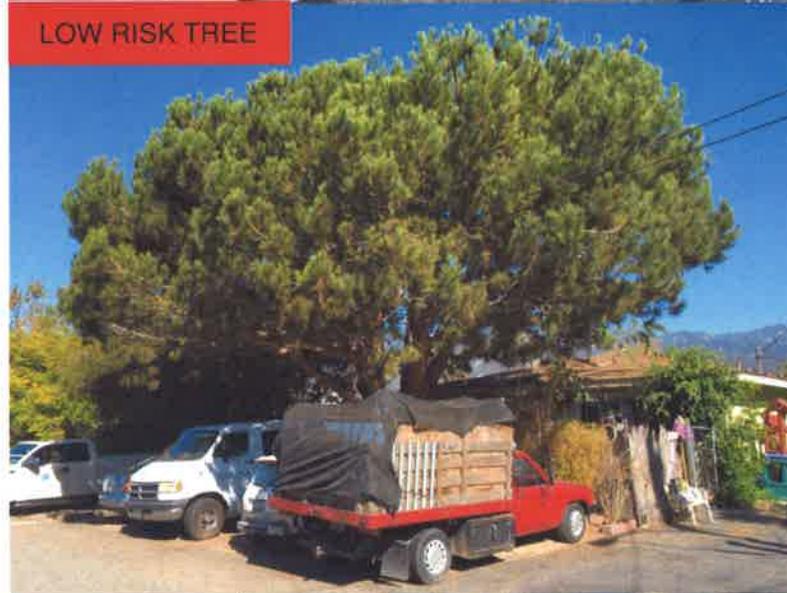
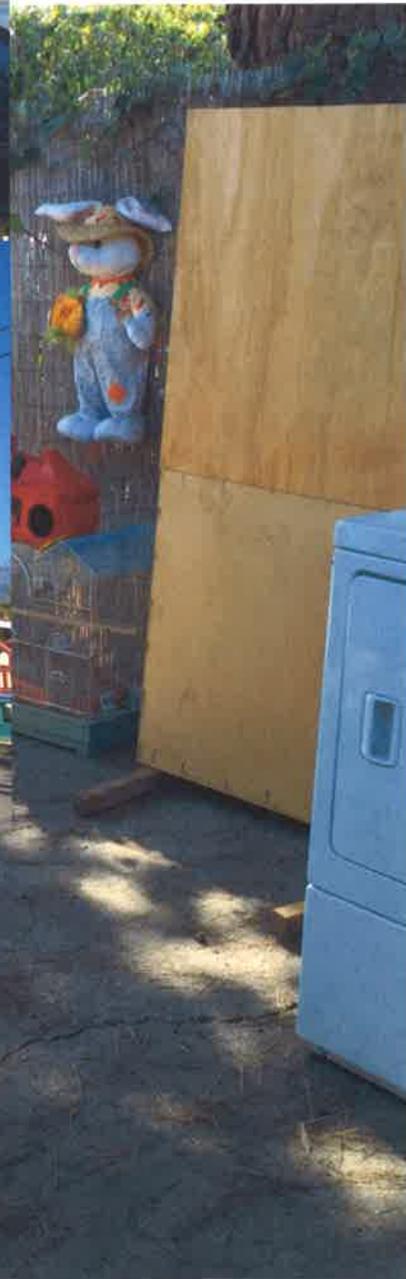
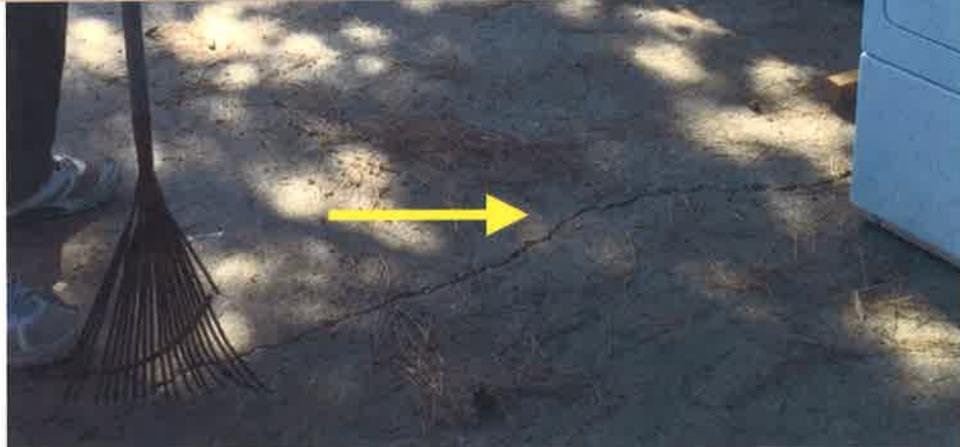
Low skirt needs raising, low over road and apartment. Could use thinning to reduce weight and improve structure. Some cracking of resident patio but great shade.

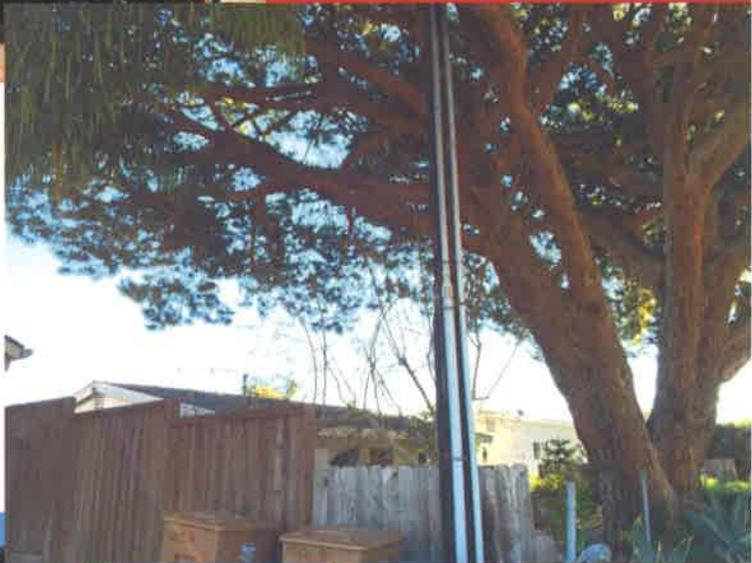
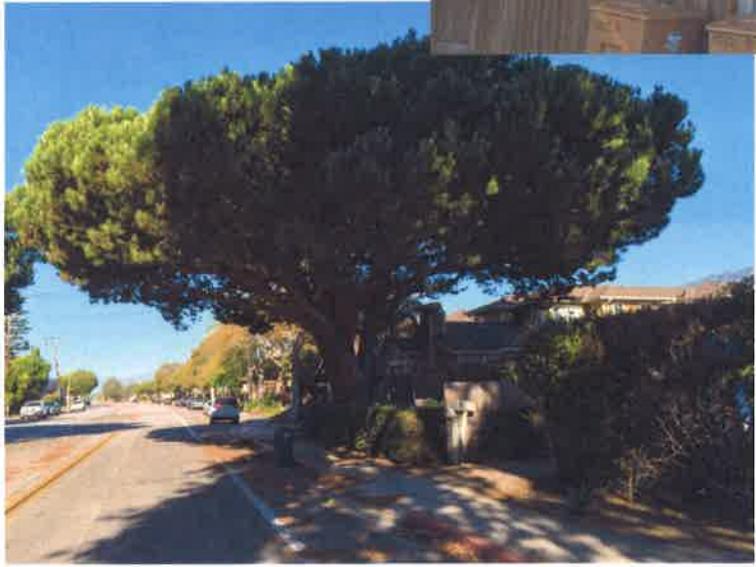
4292 Carp Ave. (#19)

MODERATE TO HIGH RISK TREE

A great tree with multiple leaders. Nothing to buffer failure and crown is dense and heavy. Pruning is needed to reduce risk. Sidewalk not currently a problem as tree is more on residential lot (more photos next page).

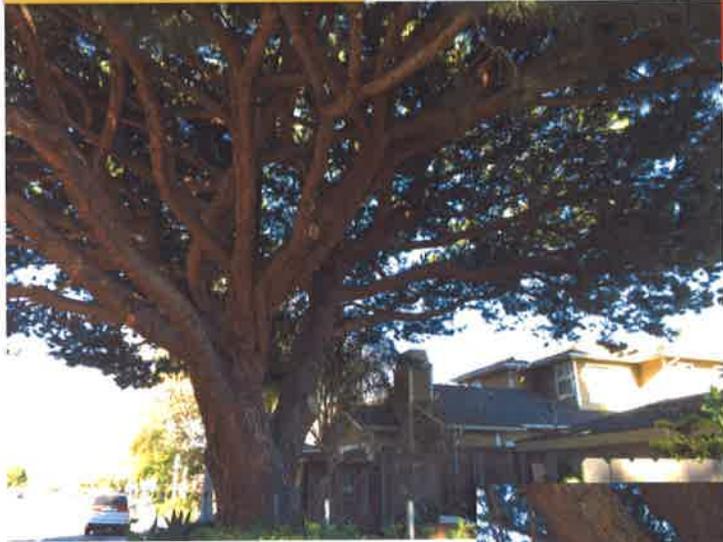
4292 Carp Ave. (#19)

MODERATE RISK TREE

Another view of the massive tree over the small house.

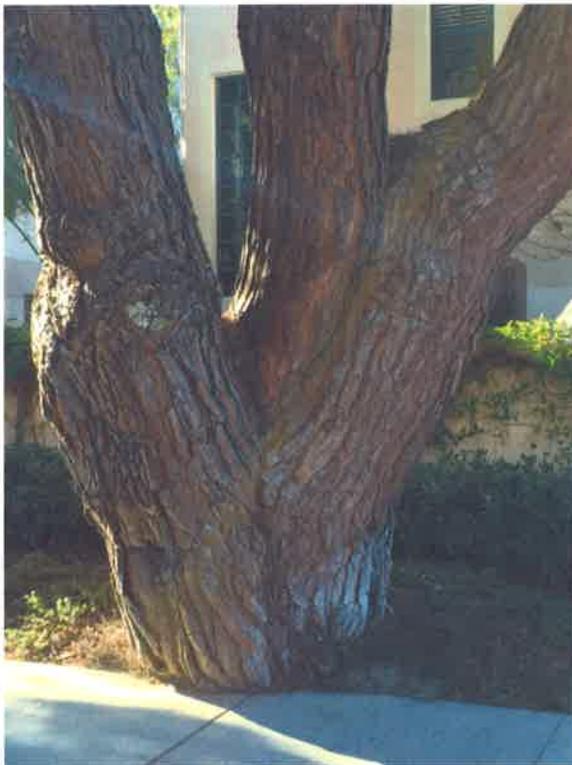
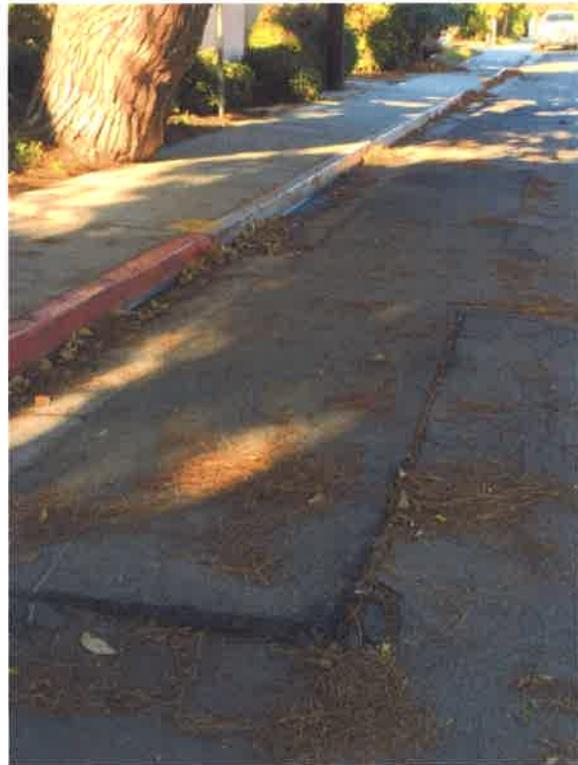
Lower utility cables provide a buffer from the street, but crown can still break free in severe weather. Trunk obstructs passage on sidewalk. Bulb out an option. Asphalt repairs warranted.

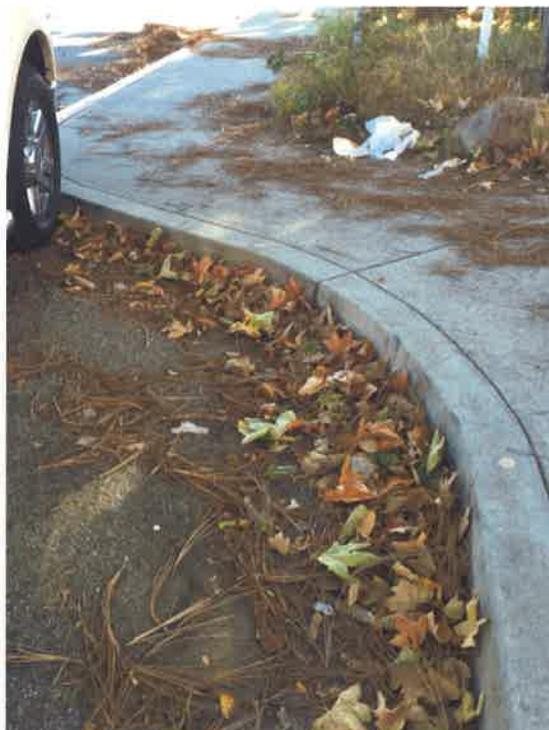
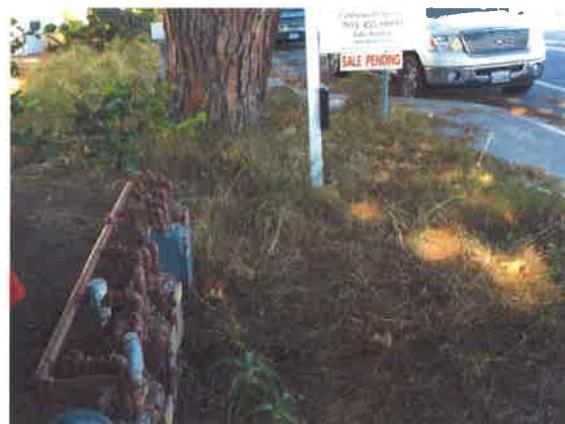
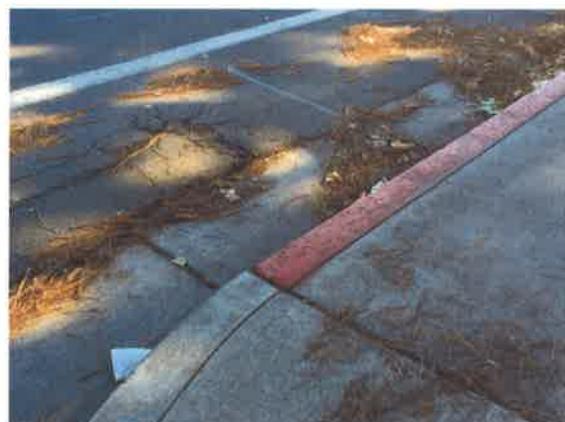
Thinner crown but overhangs house. Asphalt damage is severe but sidewalk is already bulbed outward.

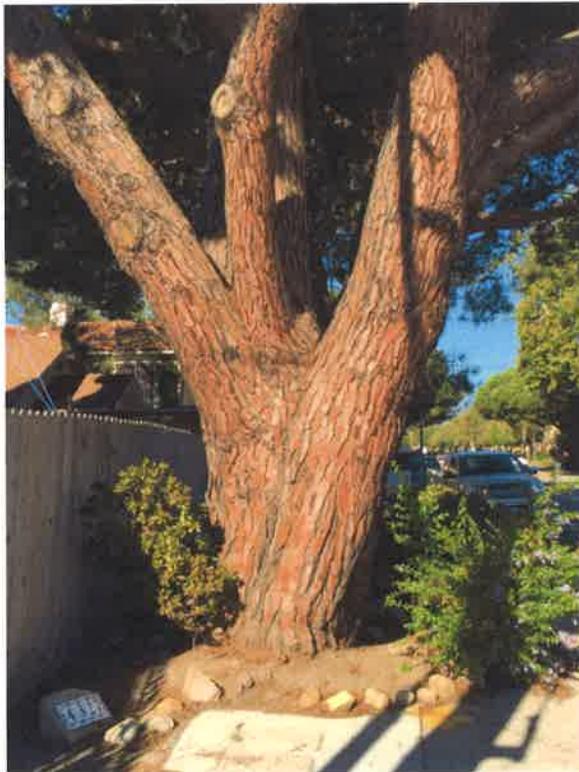
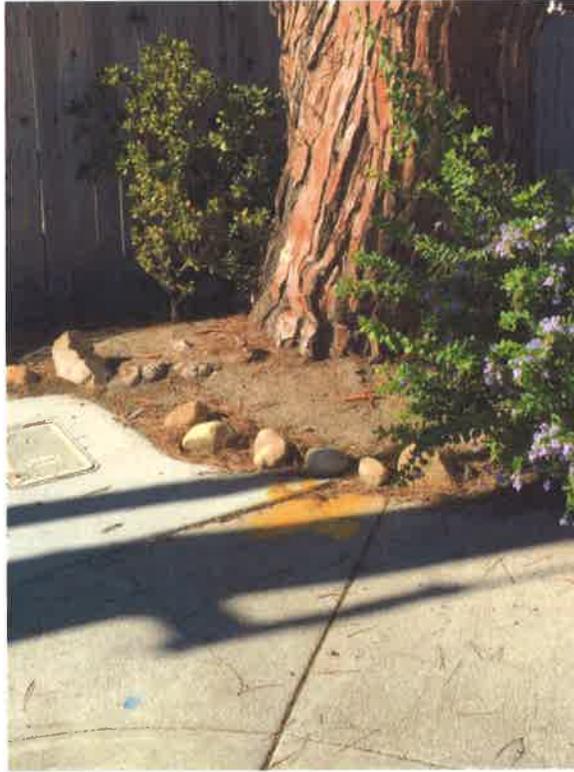
Dense and heavy crown over residence and warrants pruning. Note water meters in close proximity. Homeowner upset about damage to driveway. Consider removing some of the leaders. Also significant damage to asphalt.
