**CITY OF CARPINTERIA
TREE ADVISORY BOARD
Thursday, February 18, 2016**

1. Stone Pine Assessment & Management Plan Discussion
2. Heath Ranch Park Tree Matters

MEETING MINUTES OF THE TREE ADVISORY BOARD
THURSDAY, NOVEMBER 5, 2015

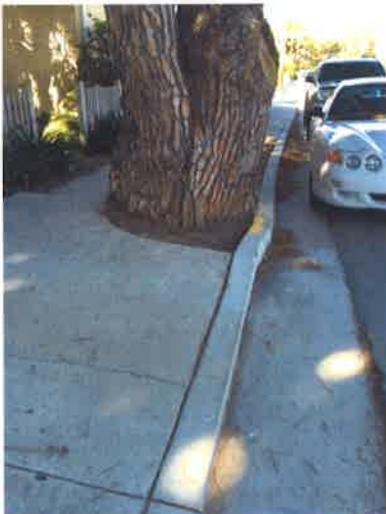
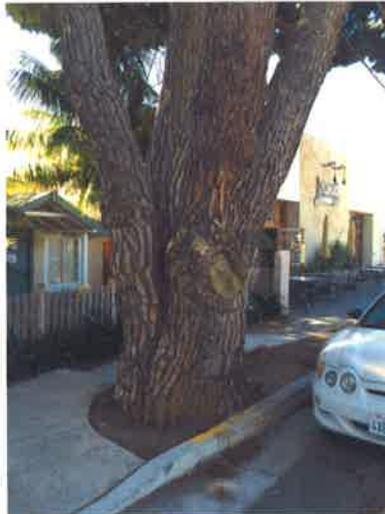
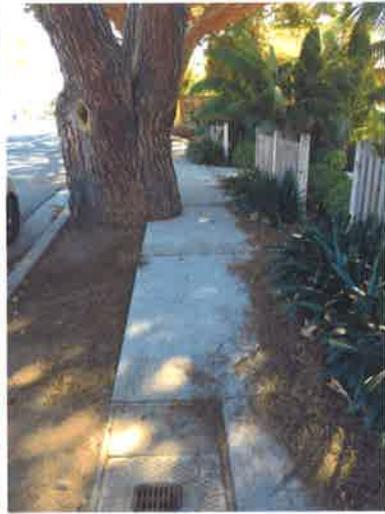
A view of #23 and #24. Arrow points to #23. Intertwining limbs help hold tree together. Tree is obstructing sidewalk. Repaired concrete beginning to fail. Bulb out is an option.

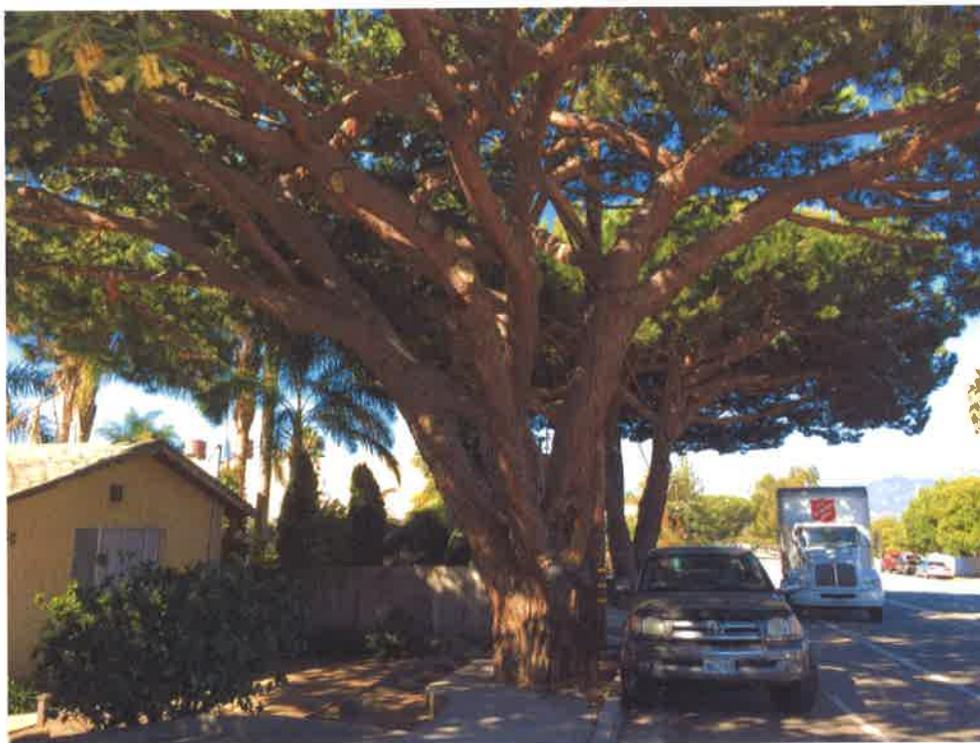
Arrow points to #24. Mitigate risk with pruning. Tree overhangs sidewalk creating an obstacle for pedestrians as witnessed by homeowner, but he also loves the tree, not the roots. Bulb out is an option (more photos next page).

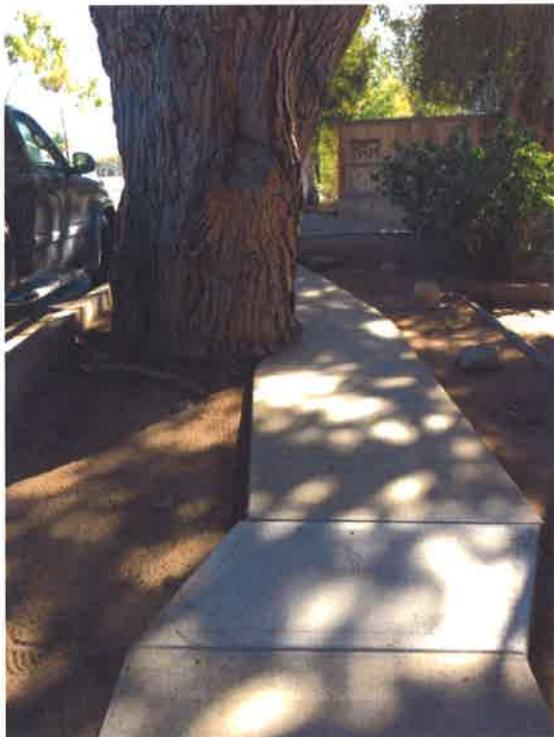
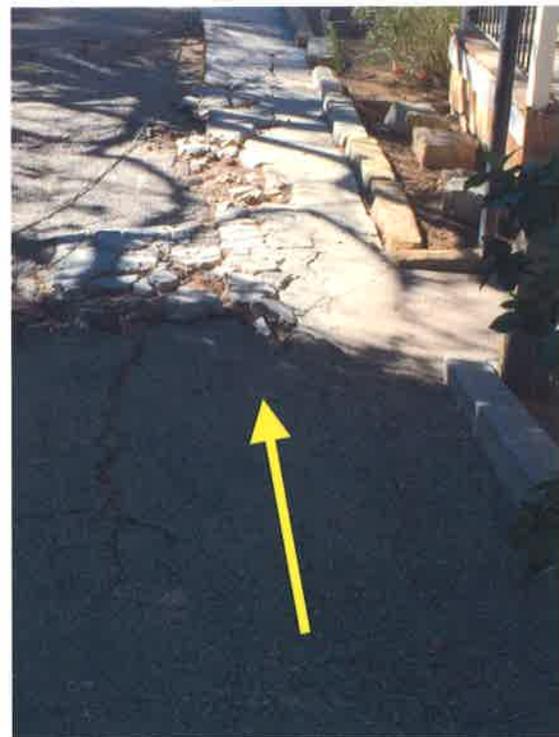
There is a drop of about 12" on the south side of the narrow sidewalk, where the trunk becomes an obstacle, creating a dangerous situation (arrows upper right). Lower right arrow points to damaged driveway.

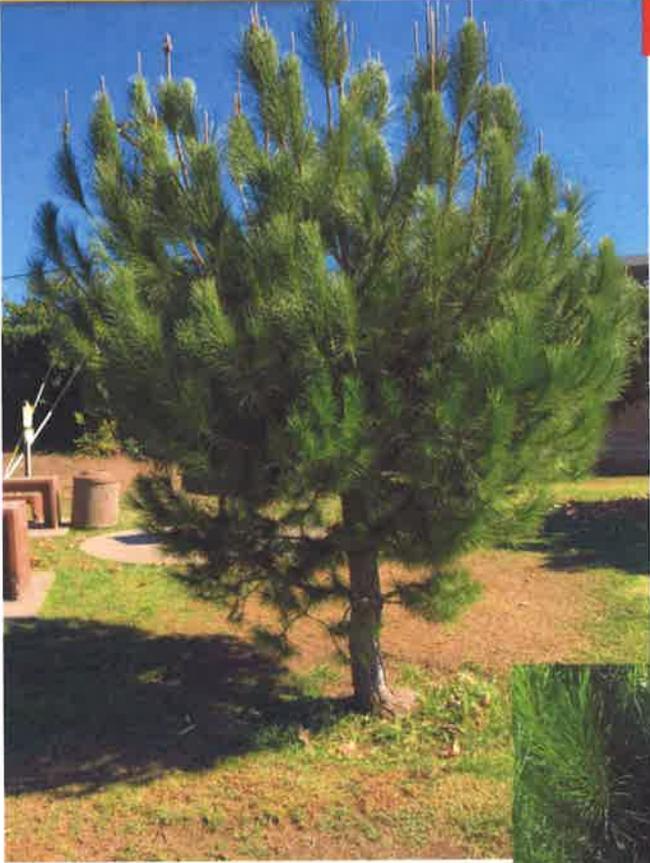
El Carro (#25)

NO RISK TREE

Structural prune young tree. Remove this limb now before it develops into a large co-dominant limb.

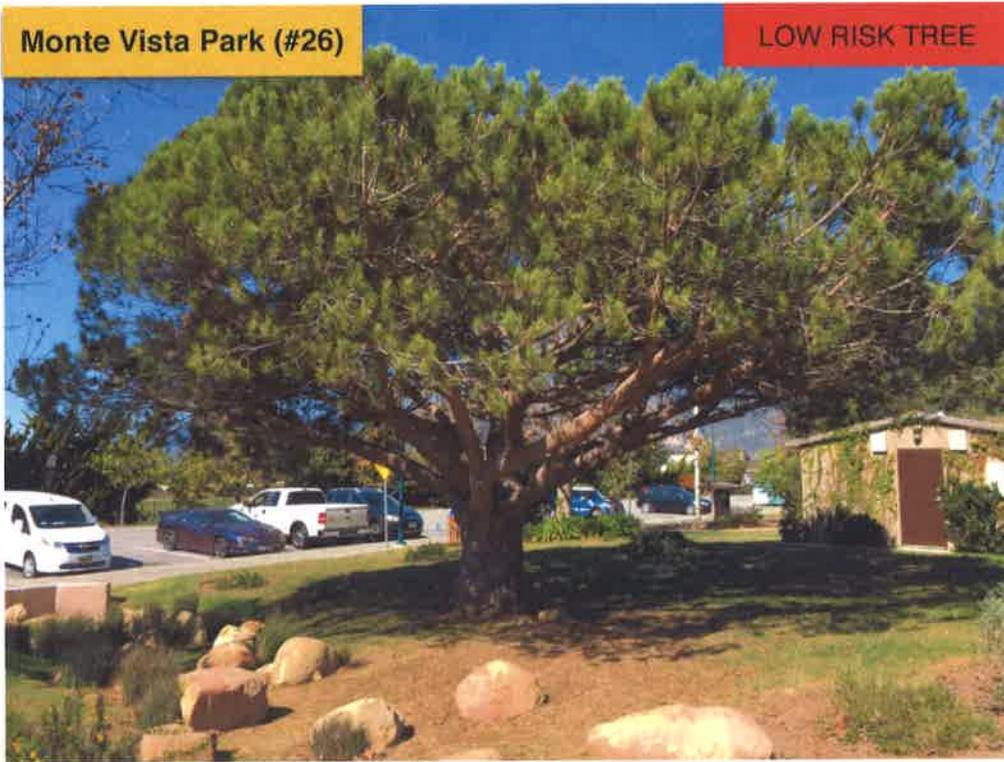
Park tree in low use area but warrants pruning to improve structure and reduce long term potential to split.

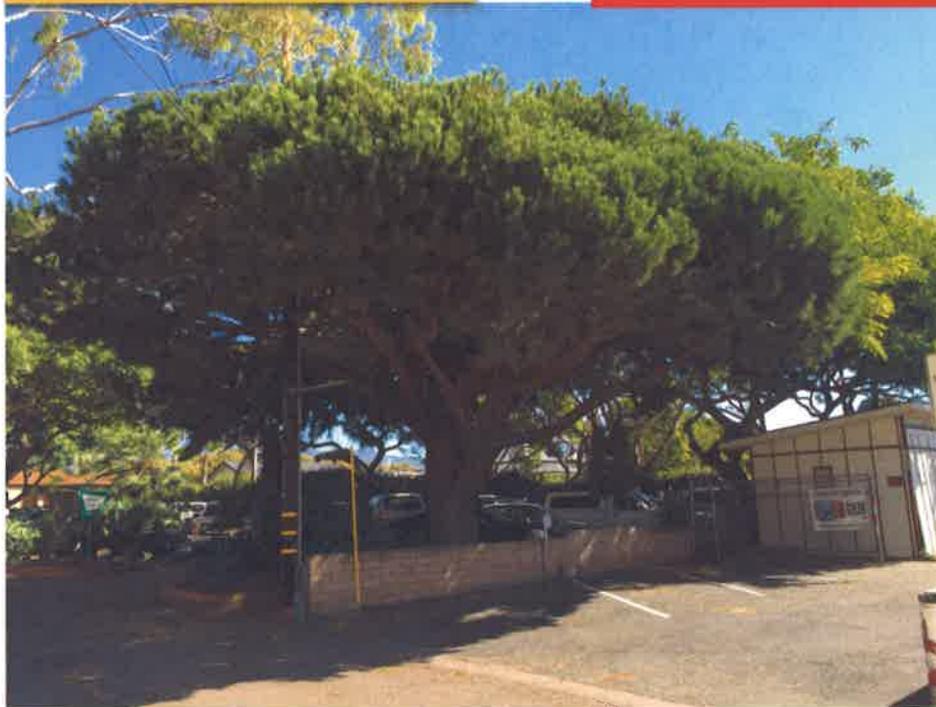
Wullbrandt Way - Parking (#27)

MODERATE RISK TREE

Tree in parking lot is dense and heavy. Pruning should reduce risk. Also needs lifting for clearance (more photos next page).

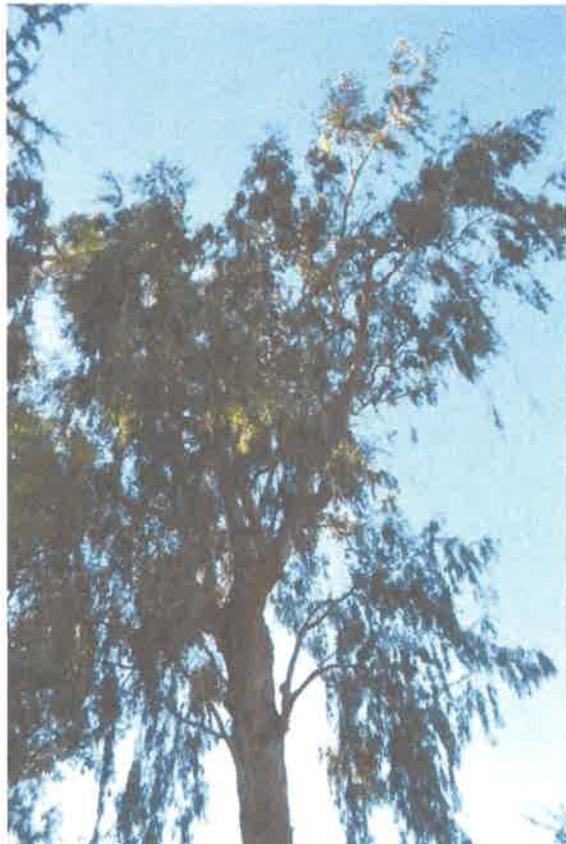
Tree 2

Potential scaffold reductions on north east side

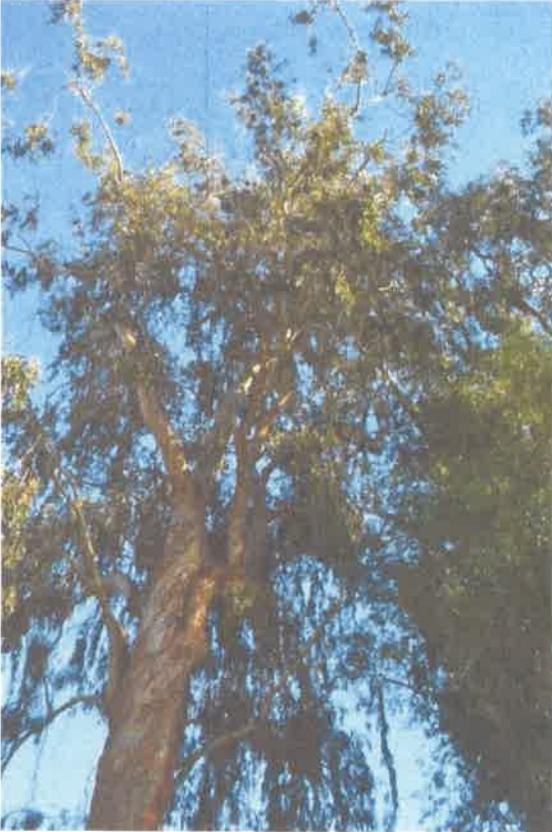
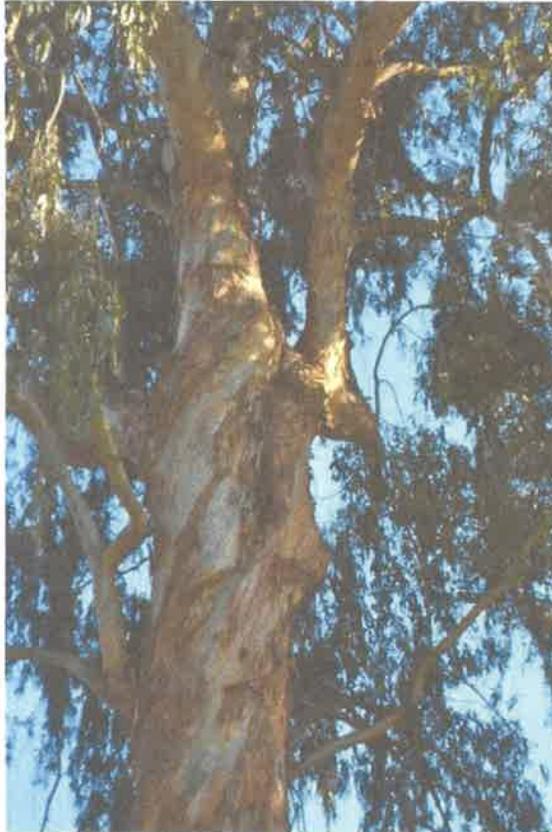
Weak attachment

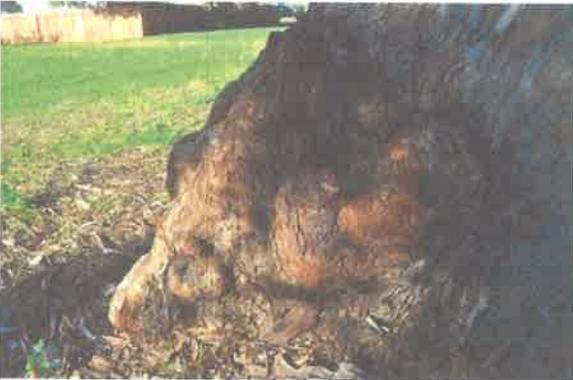
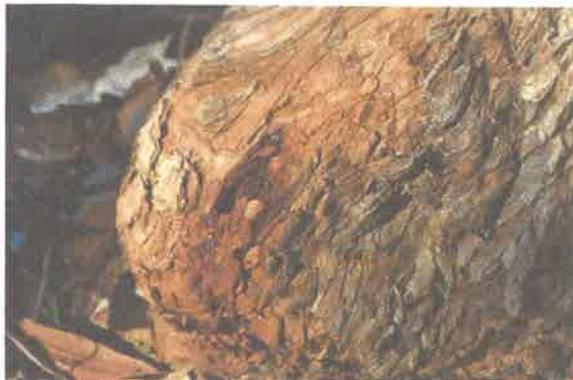
Sap oozing from burl

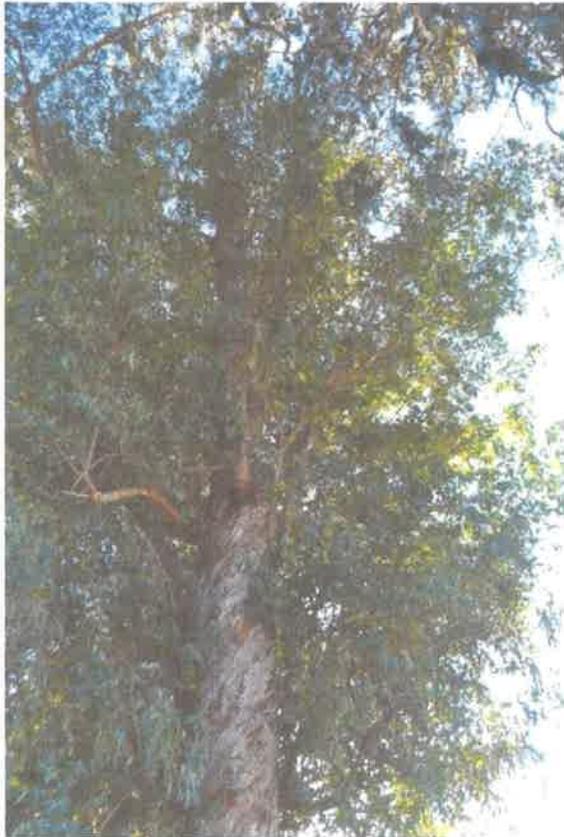
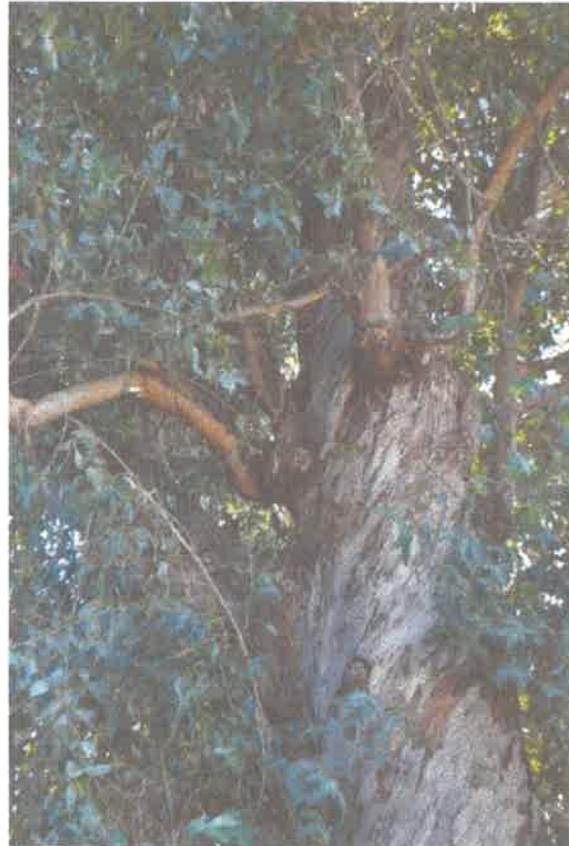
Tree 3
Species: Tasmanian Blue Gum (*Eucalyptus globulus*)
DSH: 36" Diameter at Standard Height
Height: 70'
Canopy: 49' (54' x 43')
Observations: Tree 3 appears to be in good condition. Tree 3 is protected on three sides by trees 2, 4 and 5.
Tree Defects: The parts of the tree most at risk of failure are the three, codominant scaffold branches approximately 15-20 feet up the tree.
Targets: People walking in the Park under tree 2 and within 105' of the tree.
Likelihood of failure: Unlikely
Likelihood of Impact: High
Likelihood of impacting target matrix: Unlikely
Consequences of failure: Severe
Tree 2 Risk Rating: Low
Mitigation Options: None recommended
Residual risk: Low

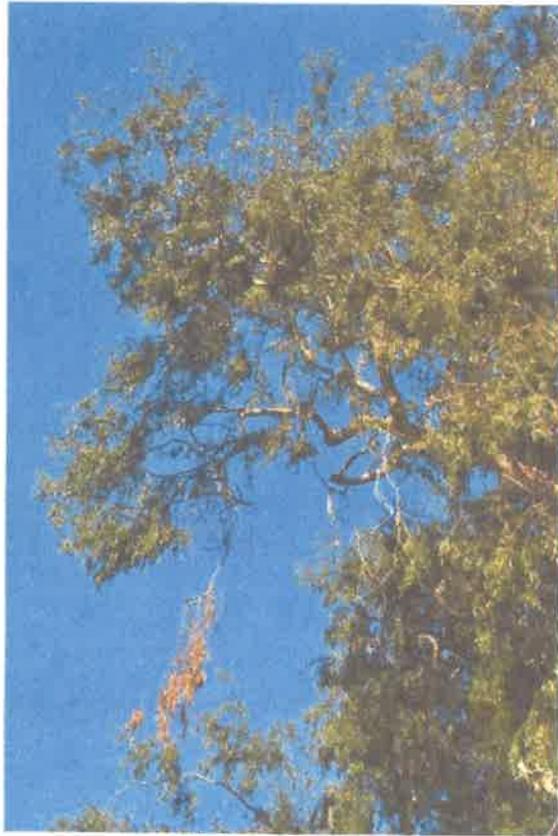
Tree 4
Species: Tasmanian Blue Gum (*Eucalyptus globulus*)
DSH: 64" Diameter at Standard Height
Height: 120 feet
Canopy: 85" (89' x 80')
Observations: Tree 4 appears to be in good condition.
Tree Defects: There are two parts of the tree most at risk of failure. The first is a approximately ¼ up the trunk where three 25"+ scaffolds have V-joints extending from the main trunk. Although the scaffolds are large in relation to the main trunk, the joints do not have included bark.
The second risk area is approximately half way up the trunk with three 25-30" scaffolds are within one foot of each other. The scaffold joints do not exhibit included bark, and the scaffolds are tapered, but overextended.
Targets: People walking in the Park under tree 4 and within 180' of the tree.
People walking on Eucalyptus St. sidewalks
People in cars parked along Eucalyptus St.
Likelihood of failure: Possible
Likelihood of Impact to target: High

Likelihood Matrix: Somewhat likely
Consequences of failure: Severe
Tree 4 Risk Rating: Moderate
Mitigation Options: Reduce length of overextended branches in middle and upper canopy
Residual risk: Moderate

Potential scaffold reduction

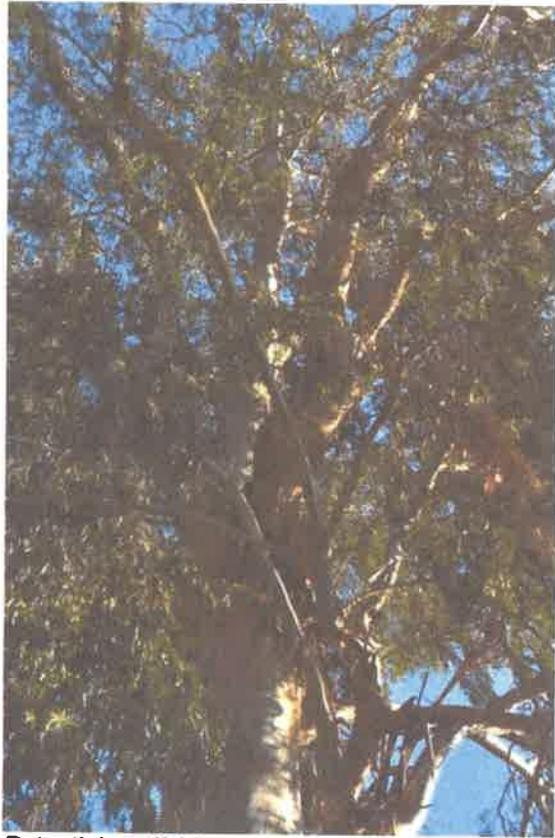
Tree 4

Potential scaffold reductions

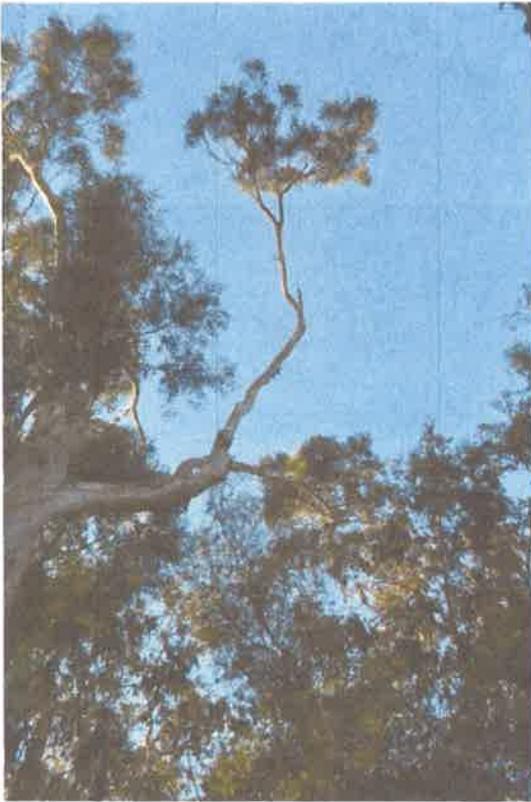
Tree 5
Species: Tasmanian Blue Gum (*Eucalyptus globulus*)
DSH: 125" Diameter at Standard Height
Height: 125 feet
Canopy: 93" (92' x 93')
Observations: Tree 5 appears to be in good condition. Areas of white fungus are located on the north east side of the burl, which sounds mostly hollow
Tree Defects: The parts of the tree most at risk of failure are 1) the 30"+ scaffold branch half way up the tree on the northwest side that is overextended and lion-tailed. 2) The scaffold one quarter of the way up on the west side with a poor junction with the trunk. 3) The two over-extended branches three-quarter of the way up the tree on the east side
Targets: People walking in the Park under tree 5 and within 188' of the tree.
 People walking on Eucalyptus St. sidewalks
 People in cars parked along Eucalyptus St.
 People in houses along Eucalyptus St.
Likelihood of failure: Possible
Likelihood of Impact to Target: High

Likelihood Matrix: Somewhat likely
Consequences of failure: Severe
Tree 5 Risk Rating: Moderate
Mitigation Options: Reduction of scaffolds, no parking on west side of Eucalyptus St. within target area, warning signage,
Residual risk: Moderate

Tree 5 potential scaffold reduction

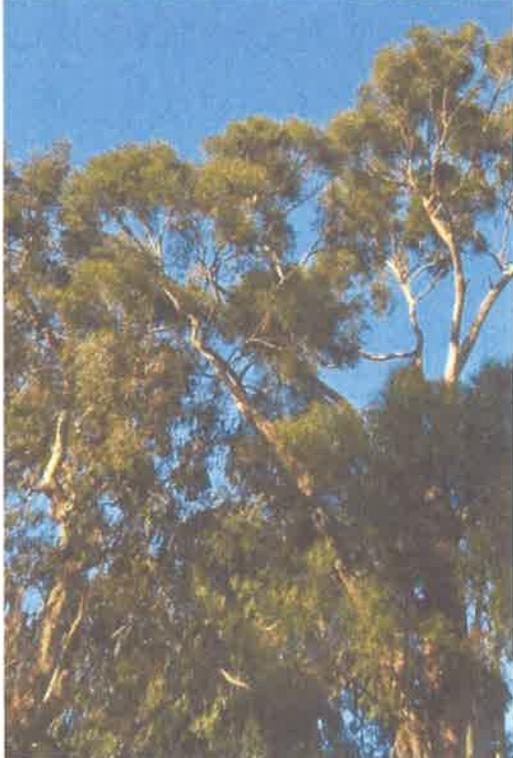
Potential scaffold reduction

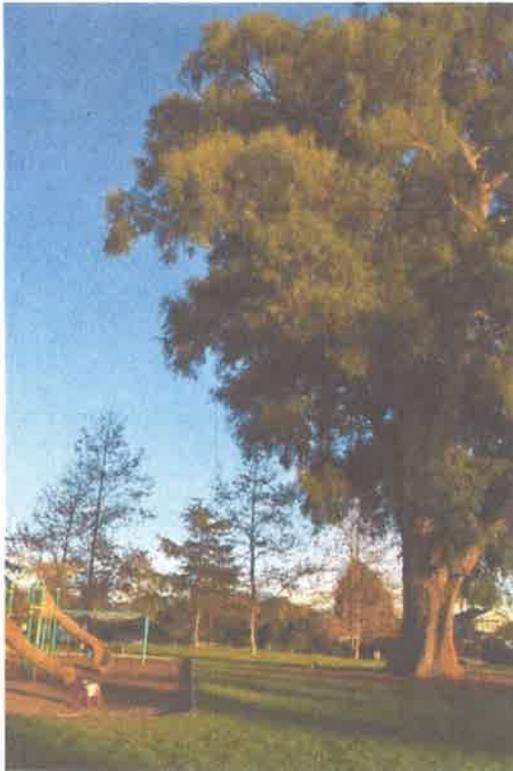
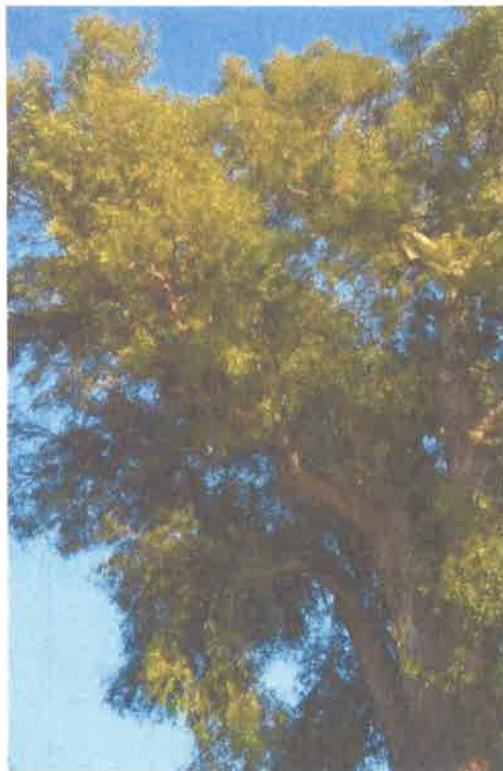
Species: Tasmanian Blue Gum (*Eucalyptus globulus*)
DSH: 93" Diameter at Standard Height
Height: 95 feet
Canopy: 75"
Observations: Tree 6 appears to be in fair condition. The bottom of the tree is partially hollow, with a flat edge on the southeast side indicating root issues, and sap ooze. The sap appears to be slime ooze, a harmless bacteria infection and not symptoms of damage from eucalyptus long horned beetle insect activity.
Tree Defects: The parts of the tree most at risk of failure are 1) the overextended branches on the north side of tree, 2) the three scaffolds next to each other about one quarter up the tree on the west side. 3) The scaffold on the southeast side. 4) The base of the tree and possible insect/root issues
Targets: People walking in the Park under tree 2 and within 143' of the tree.
People in playground
People in houses within target zone on south side Chaparral Dr.
Likelihood of failure: Possible

Tree 6 sap ooze, flat base

Likelihood of Impact to target: High
Likelihood Matrix: Somewhat likely
Consequences of failure: Severe
Tree 6 Risk Rating: High
Mitigation Options: Reduce two overextended branches on north side of tree, or consider moving playground 143' from trunk, level three analyses of sap wounds and root collar
Residual risk: Moderate

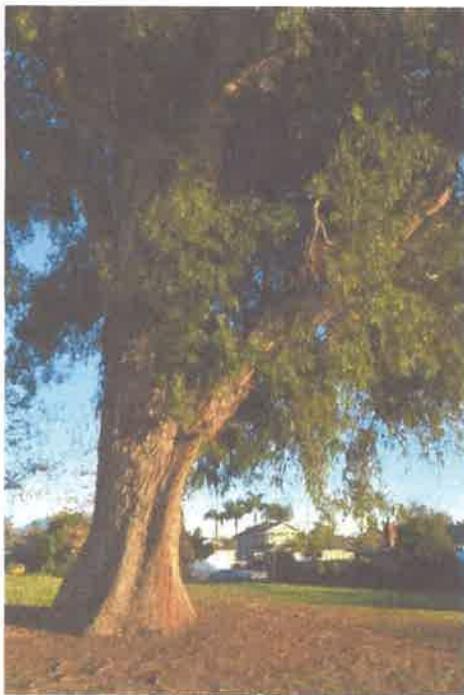
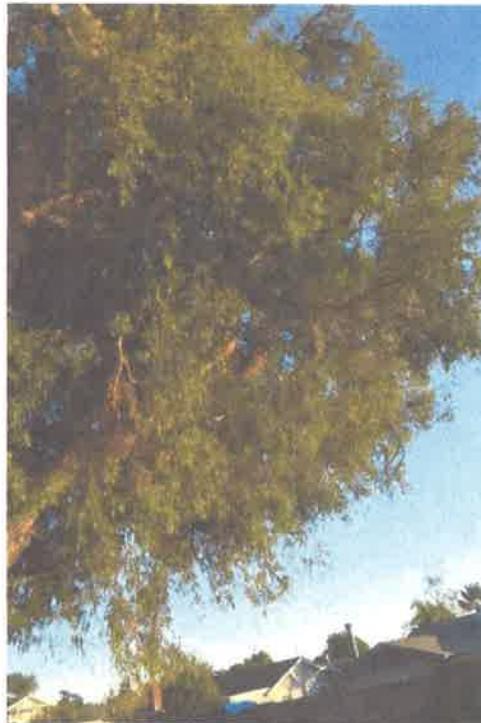
Tree 6 – Scaffold reduction on playground side

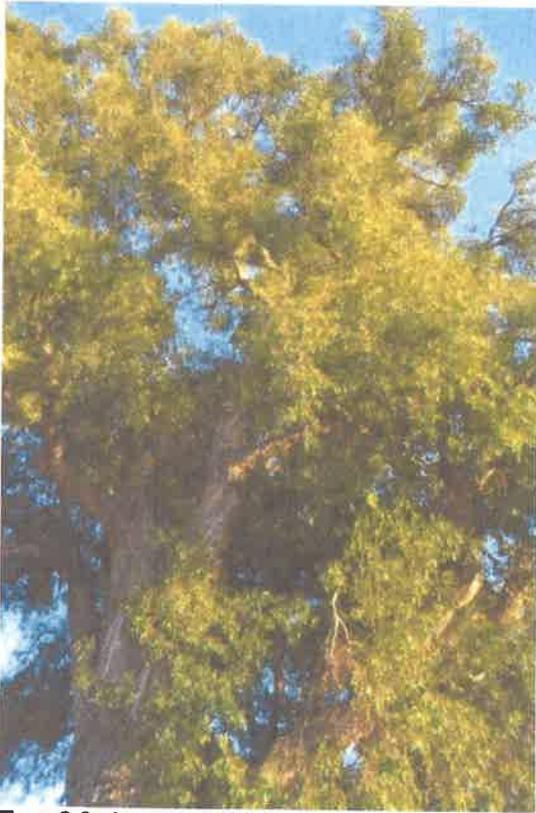
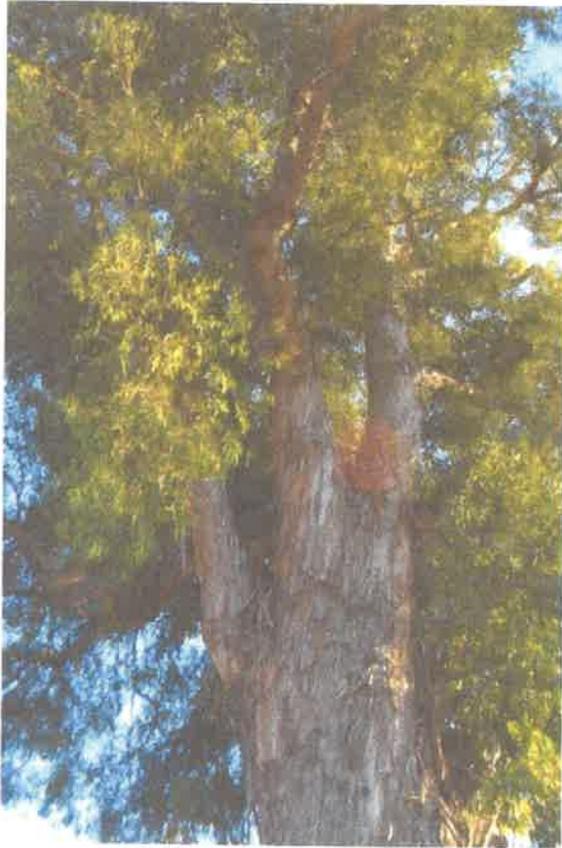
Tree 6 scaffold reduction

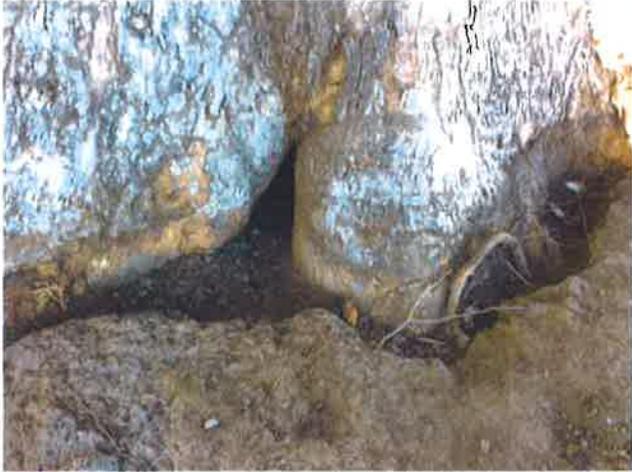
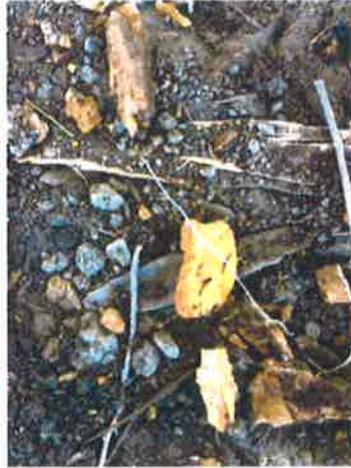
Duke McPherson's August 20, 2015 Arborist Report called for a closer inspection of the cavity on the north side of the tree. The cavity extends approximately 2 feet into the tree and about two feet high. While there is Brown Cubical Rot in the deadwood of the cavity, the remaining wood when probed by hand and with a five-foot probe is relatively solid. The tree is seven feet wide at this point, so there is approximately 5 feet of good wood on the southern side that will continue to support the tree.

Above-Cavity on north side, Right-decayed pieces, below looking up from inside cavity

1. To slow the progress of decay, the area around the cavity and the tree seven dripline should remain dry and not irrigated. Should the drought continue, the tree's periodic irrigation needs should be reevaluated in summer of 2016.

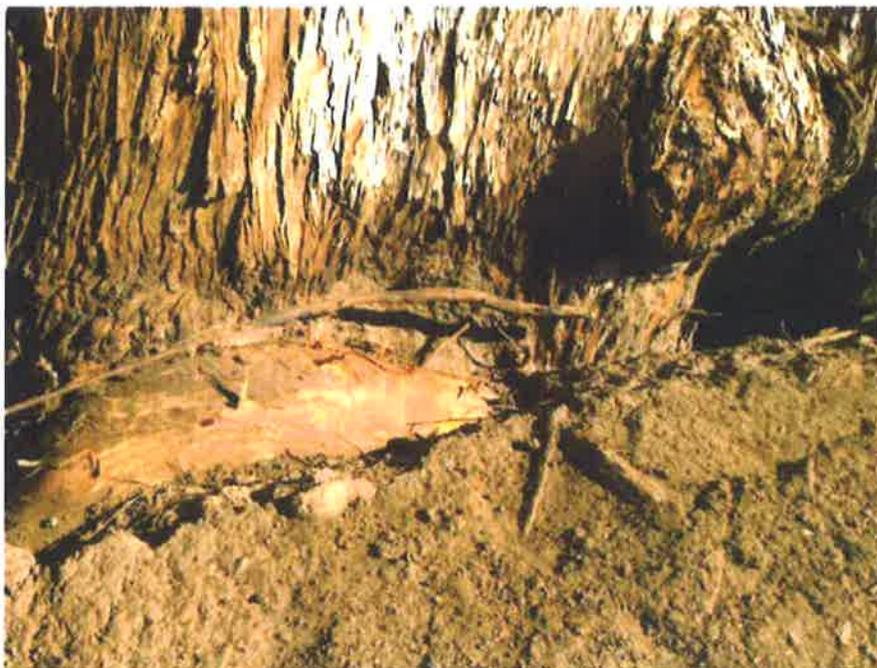
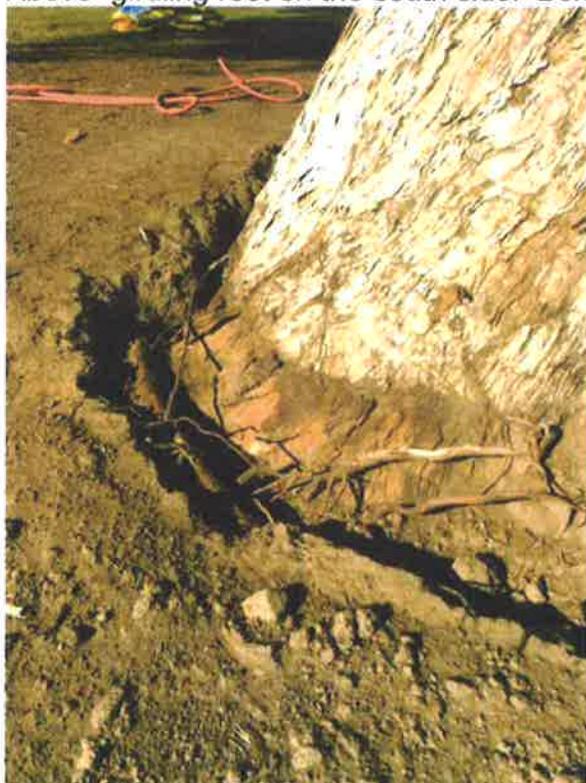
The air spade did uncover a 7' to 9" diameter girdling root on the south side of the tree. The flat shape of the southern side of the trunk indicated that this was likely.

Above -girdling root on the south side. Below – girdling root extending east along trunk

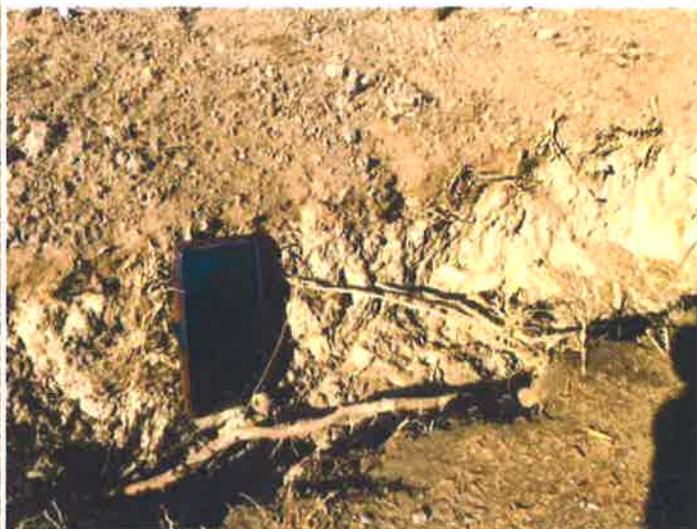
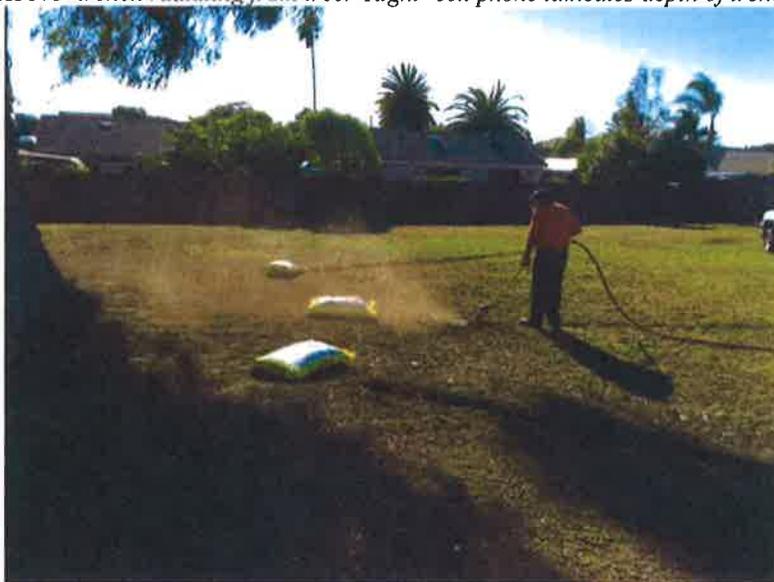
West Coast Arborist staff used the air spade to create eight trenches around the tree, each one about six inches deep and one foot wide. Each trench started about ten feet from the tree and extended about 25 feet to the edge of the canopy. Each trench was then backfilled with one two cubic foot bag of compost mixed in with the original soil. The purpose of the trenches is to loosen the compacted soil, add some organic material to the soil, and improve the ability of the tree roots to receive air and water.

Above -trench radiating from tree. Right- cell phone idincates depth of trench, note soil is dry about 3 inches below surface

4. All of the ground underneath the dripline of tree seven, especially the radial trench areas where the soil was recently loosened, should be covered with 3 to 4 inches of organic bark mulch. The grass does not have to be removed, but if the water is turned off, and the mulch is in place under the tree seven shady canopy, the grass will minimally active.
