**CITY OF CARPINTERIA
TREE ADVISORY BOARD
Thursday, April 7, 2016
(Special Meeting)**

Heath Ranch Park Eucalyptus Trees

Recommend the phased removal and replacement of four Eucalyptus trees and continued maintenance of one other at Heath Ranch Park.

Tree Evaluation Report: Blue Gums at Heath Ranch Park, City of Carpinteria

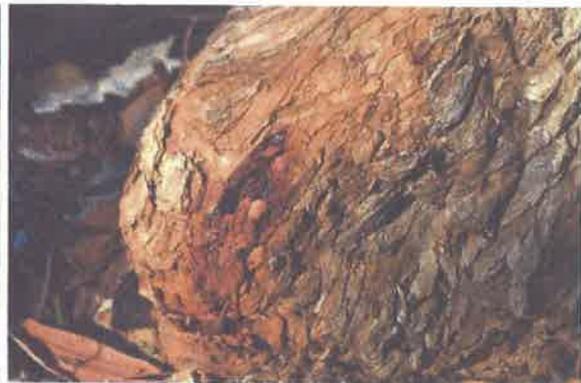
Sap oozing from burl

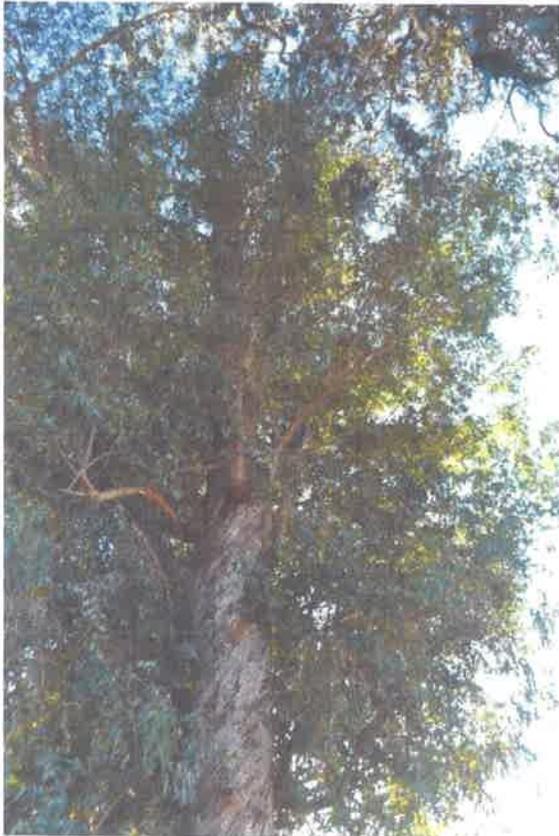
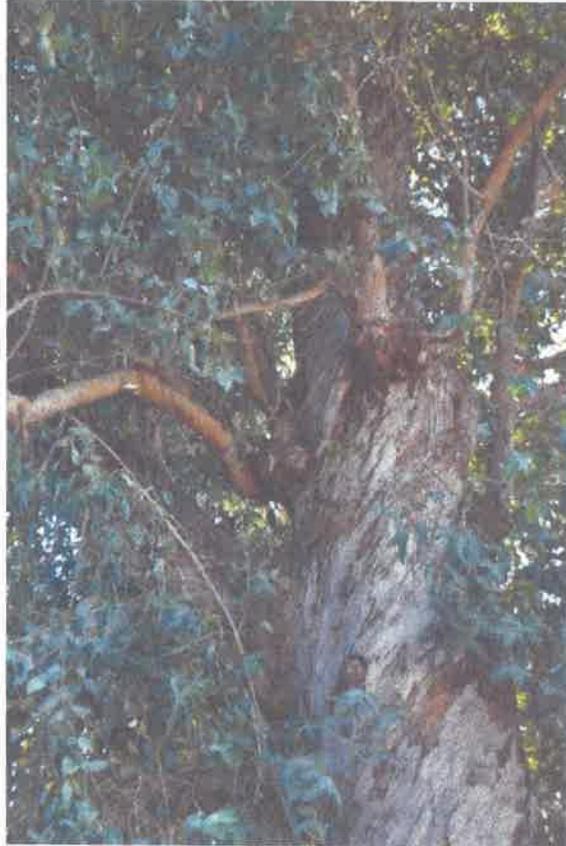
Tree 4
Species: Tasmanian Blue Gum (*Eucalyptus globulus*)
DSH: 64" Diameter at Standard Height
Height: 120 feet
Canopy: 85" (89' x 80')
Observations: Tree 4 appears to be in good condition.
Tree Defects: There are two parts of the tree most at risk of failure. The first is a approximately ¾ up the trunk where three 25"+ scaffolds have V-joints extending from the main trunk. Although the scaffolds are large in relation to the main trunk, the joints do not have included bark.
The second risk area is approximately half way up the trunk with three 25-30" scaffolds are within one foot of each other. The scaffold joints do not exhibit included bark, and the scaffolds are tapered, but overextended.
Targets: People walking in the Park under tree 4 and within 180' of the tree.
People walking on Eucalyptus St. sidewalks
People in cars parked along Eucalyptus St.
Likelihood of failure: Possible
Likelihood of Impact to target: High

Likelihood Matrix: Somewhat likely
Consequences of failure: Severe
Tree 4 Risk Rating: Moderate
Mitigation Options: Reduce length of overextended branches in middle and upper canopy
Residual risk: Moderate

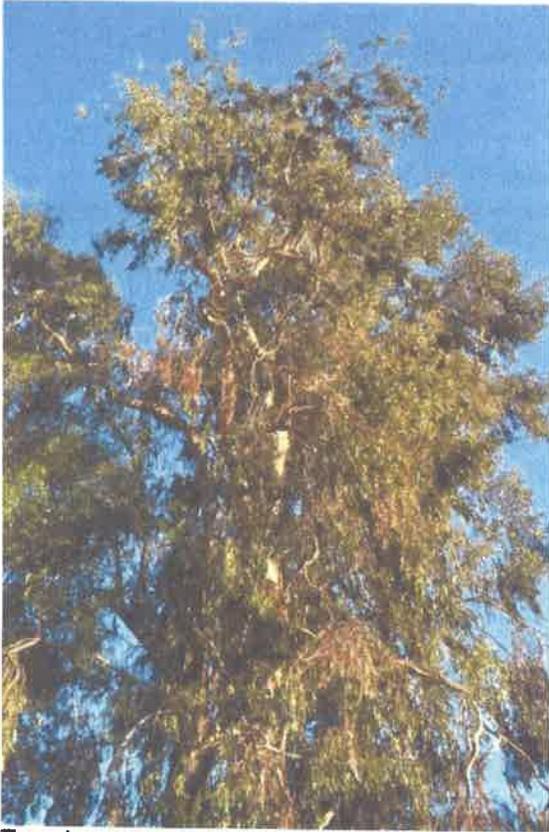
Tree 4

Potential scaffold reduction

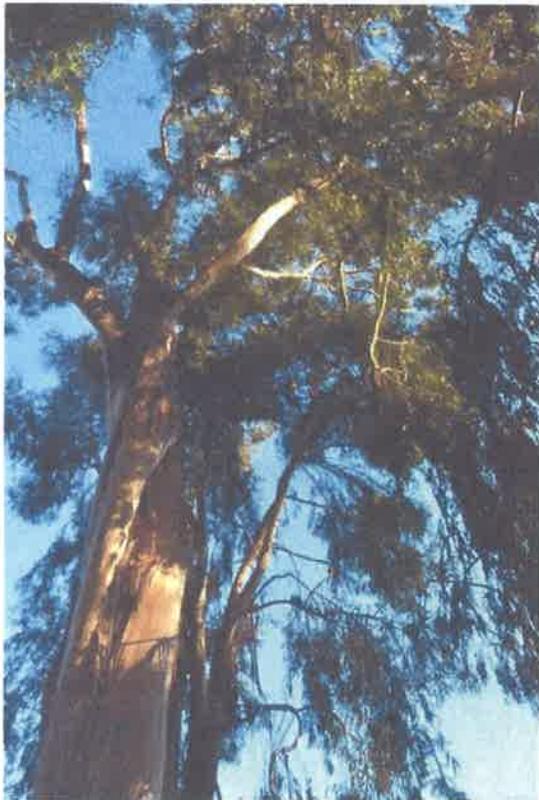
Tree 5
Species: Tasmanian Blue Gum (*Eucalyptus globulus*)
DSH: 125" Diameter at Standard Height
Height: 125 feet
Canopy: 93" (92' x 93')
Observations: Tree 5 appears to be in good condition. Areas of white fungus are located on the north east side of the burl, which sounds mostly hollow
Tree Defects: The parts of the tree most at risk of failure are 1) the 30"+ scaffold branch half way up the tree on the northwest side that is overextended and lion-tailed. 2) The scaffold one quarter of the way up on the west side with a poor junction with the trunk. 3) The two over-extended branches three-quarter of the way up the tree on the east side
Targets: People walking in the Park under tree 5 and within 188' of the tree.
 People walking on Eucalyptus St. sidewalks
 People in cars parked along Eucalyptus St.
 People in houses along Eucalyptus St.
Likelihood of failure: Possible
Likelihood of Impact to Target: High

Likelihood Matrix: Somewhat likely
Consequences of failure: Severe
Tree 5 Risk Rating: Moderate
Mitigation Options: Reduction of scaffolds, no parking on west side of Eucalyptus St. within target area, warning signage,
Residual risk: Moderate

Tree 5 potential scaffold reduction

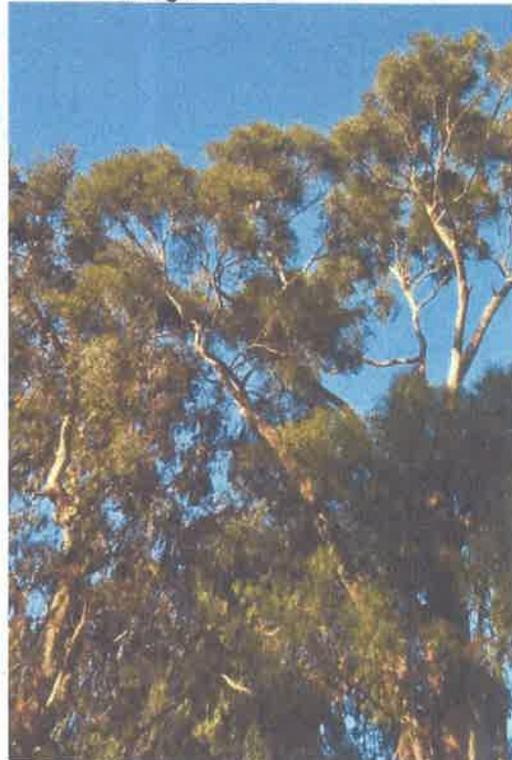
Potential scaffold reduction

Tree 6
Species: Tasmanian Blue Gum (*Eucalyptus globulus*)
DSH: 93" Diameter at Standard Height
Height: 95 feet
Canopy: 75"
Observations: Tree 6 appears to be in fair condition. The bottom of the tree is partially hollow, with a flat edge on the southeast side indicating root issues, and sap ooze. The sap appears to be slime ooze, a harmless bacteria infection and not symptoms of damage from eucalyptus long horned beetle insect activity.
Tree Defects: The parts of the tree most at risk of failure are 1) the overextended branches on the north side of tree, 2) the three scaffolds next to each other about one quarter up the tree on the west side. 3) The scaffold on the southeast side. 4) The base of the tree and possible insect/root issues
Targets: People walking in the Park under tree 2 and within 143' of the tree.
 People in playground
 People in houses within target zone on south side Chaparral Dr.

Likelihood of failure: Possible
Likelihood of Impact to target: High
Likelihood Matrix: Somewhat likely
Consequences of failure: Severe
Tree 6 Risk Rating: High
Mitigation Options: Reduce two overextended branches on north side of tree, or consider moving playground 143' from trunk, level three analyses of sap wounds and root collar
Residual risk: Moderate

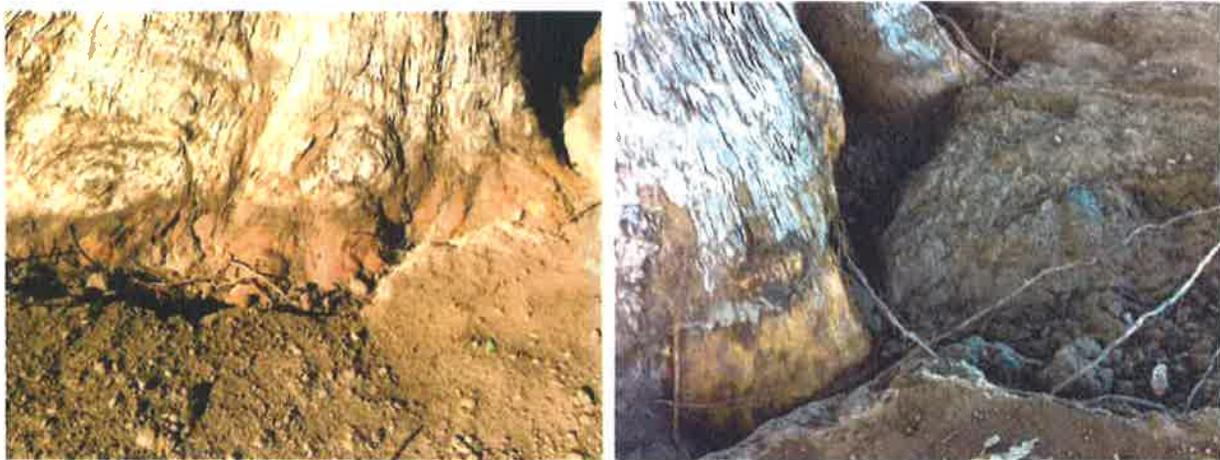
The irrigation penetrated approximately 3 inches of the upper soil, which did not allow as deep penetration with the air spade as we had anticipated, but it did allow the removal of approximately 8 to 12 inches of soil around the root collar. I was particularly interested in the gall at ground level on the south side of the tree, I did not see any cankers, fungal bodies, or wood discoloration at that location or elsewhere around the outside of the tree. I sounded the root collar with a rubber mallet all around the tree and I did not detect any significant hollow sounds.

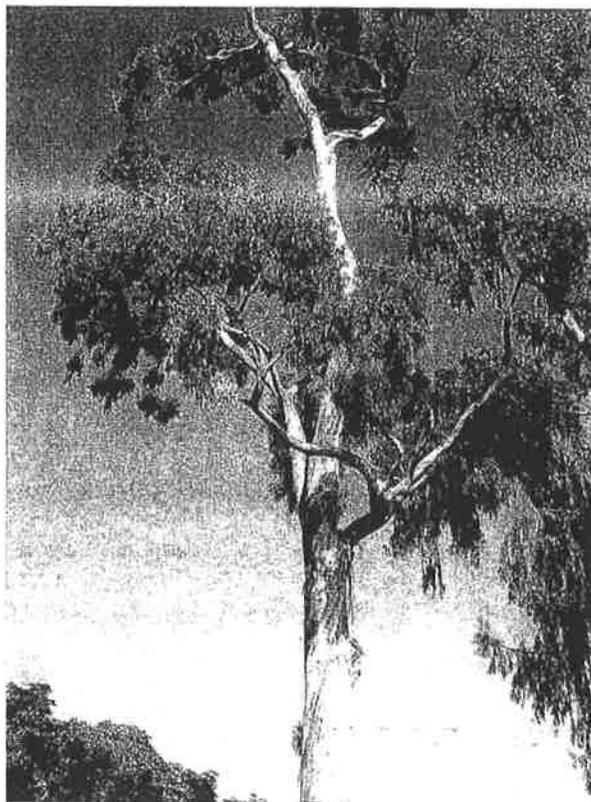
Figure 1.2

— Tree #1: This tree is located the farthest north in the park (see Figure 1.1, tree on left). It has a rather sparse canopy, with most of its growth up top (see Figure 1.2). Its trunk base has a huge lignotuber (see Figure 1.3), which is a woody tuberous mass that occurs naturally in some Eucalyptus species¹. There are two small cavities within the lignotubers, and there are signs of borer infestation (see Figure 1.4). There is turf growing with six feet of one side of the trunk, and the soil around the trunk was moist the day of the inspection. RESISTOGRAPH RESULTS (see Appendix B): 4 locations tested, 1 cavity found (S).

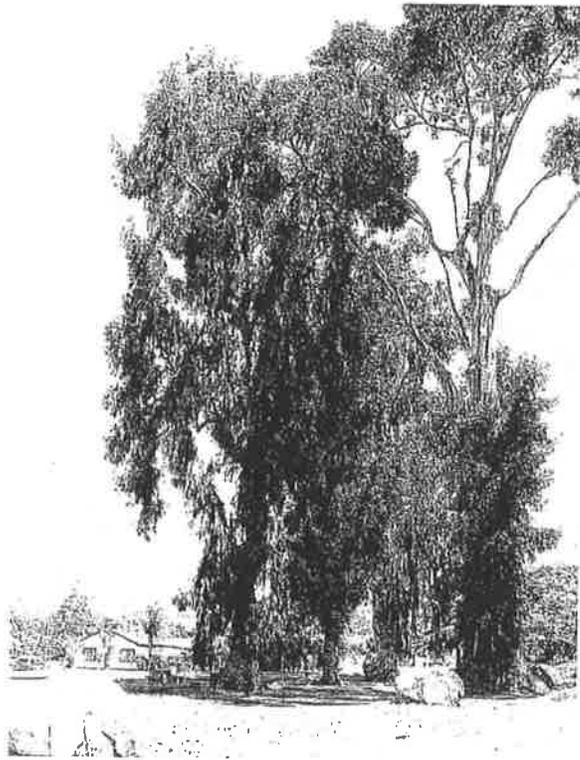
Figure 4.1, Tree #4 (left)

+ Tree #4: This tree is located on the north side of playground (see Figure 4.1, tree on left). Although it has a lot of foliage, much of it is below the main canopy structure. This tree also has a profusion of seed caps throughout most of its foliage, and there is some evidence of tortoise beetle damage on some leaves. There is also one major limb that extends out over a picnic table on its west side (see Figure 4.2). Like the other trees, the base of the trunk is surrounded by damp soil (with turf nearby), and there is moss growing on the bark in some areas (see Figure 4.3). RESISTOGRAPH RESULTS: 4 locations tested, no cavities found.

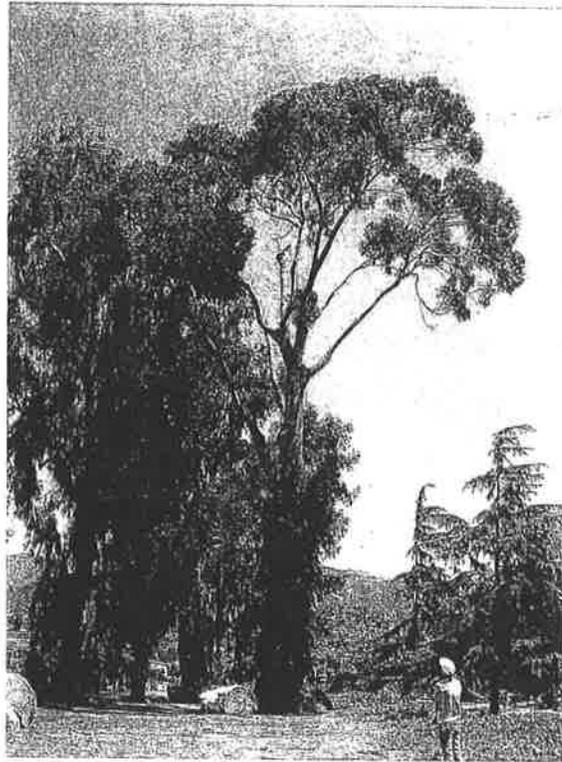
Figure 5.1, Tree #5

— Tree #5: This tree is located more on the Eucalyptus Street side (see Figure 5.1). It is the tallest of the Blue Gums at the park and it has the largest trunk diameter. However, it has a rather sparse canopy, with a profusion of watersprout growth covering one side of its lower trunk (see Figure 5.2), and both the watersprout growth and the sparse canopy growth contain many seed caps. Its trunk base is swollen with lignotubers, and there are

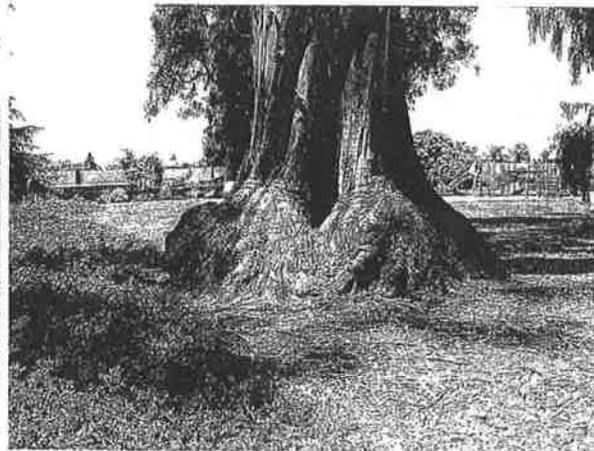
Figure 5.3

trunk inclusions as well (see Figure 5.3). The soil was moist but not damp. RESISTOGRAPH RESULTS: 4 locations tested, 2 cavities found (N, E)

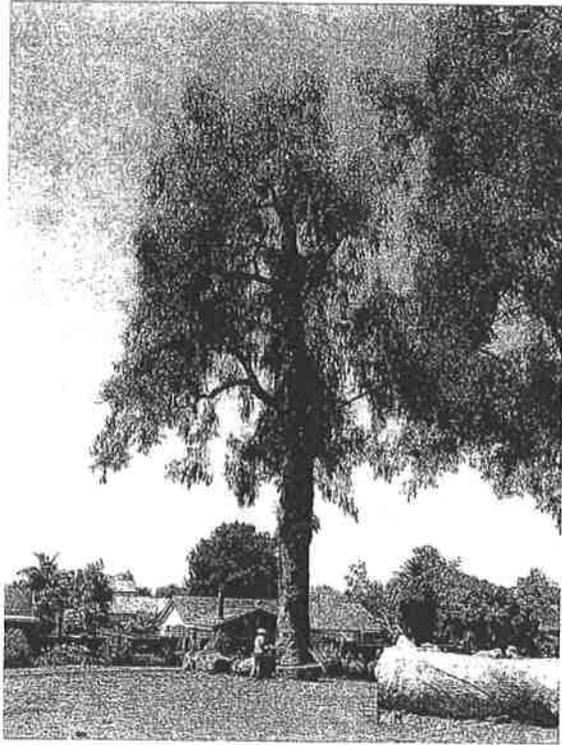
Figure 6.1, Tree #6

- Tree #6: This tree is at the south end of the park (see Figure 6.1). Most of its foliage is up in the canopy, although there is more watersprout growth on the lower limbs (see Figure 6.2). There is a beehive at one of the limb scars and some minor tortoise beetle damage, as well as a profusion of seed caps within the foliage. The soil around the trunk is wet, and there are several sections on some trunk swellings that show some rot (see Figure 6.3). RESISTOGRAPH RESULTS: 4 locations tested, 2 cavities found (N, E)

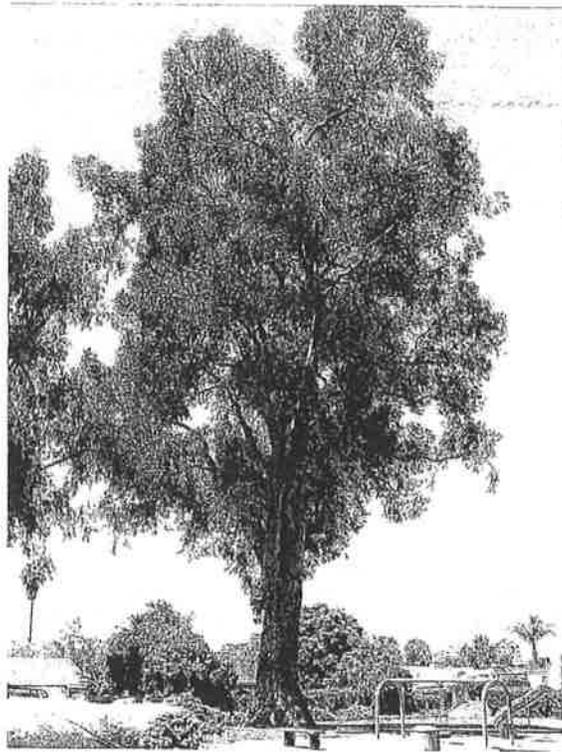
Figure 7.1, Tree #7

- Tree #7: Located next to the sand lot, this Blue Gum has the largest canopy spread of all the trees (see Figure 7.1). Its major limbs are spread out to form a large canopy, although there is one included attachment between two major limbs (see Figure 7.2). Most of its growth and foliage is up in the canopy, and there is minor tortoise beetle damage. Also, the tree has just a small number of seed capsules within its foliage. There is one bird's nest within a crotch up in the canopy (see Figure 7.3). The trunk is swollen, with one cavity near its base (see Figures 7.3 & 7.4). The soil around the trunk is damp, with grass growing less than two feet from the circumference of the trunk. RESISTOGRAPH RESULTS: 4 locations tested, no cavities found.

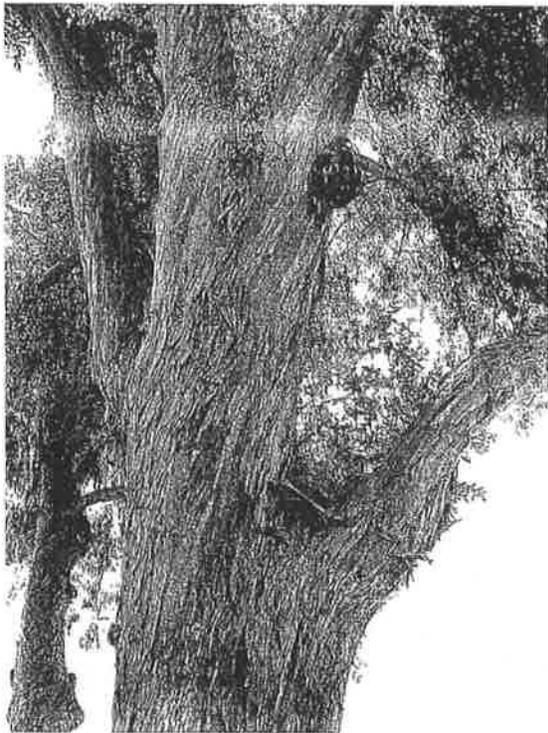
Figure 7.2, Included Attachment
