# Gas Transmission Pipeline Presentation

City of Carpinteria  
May 14, 2012

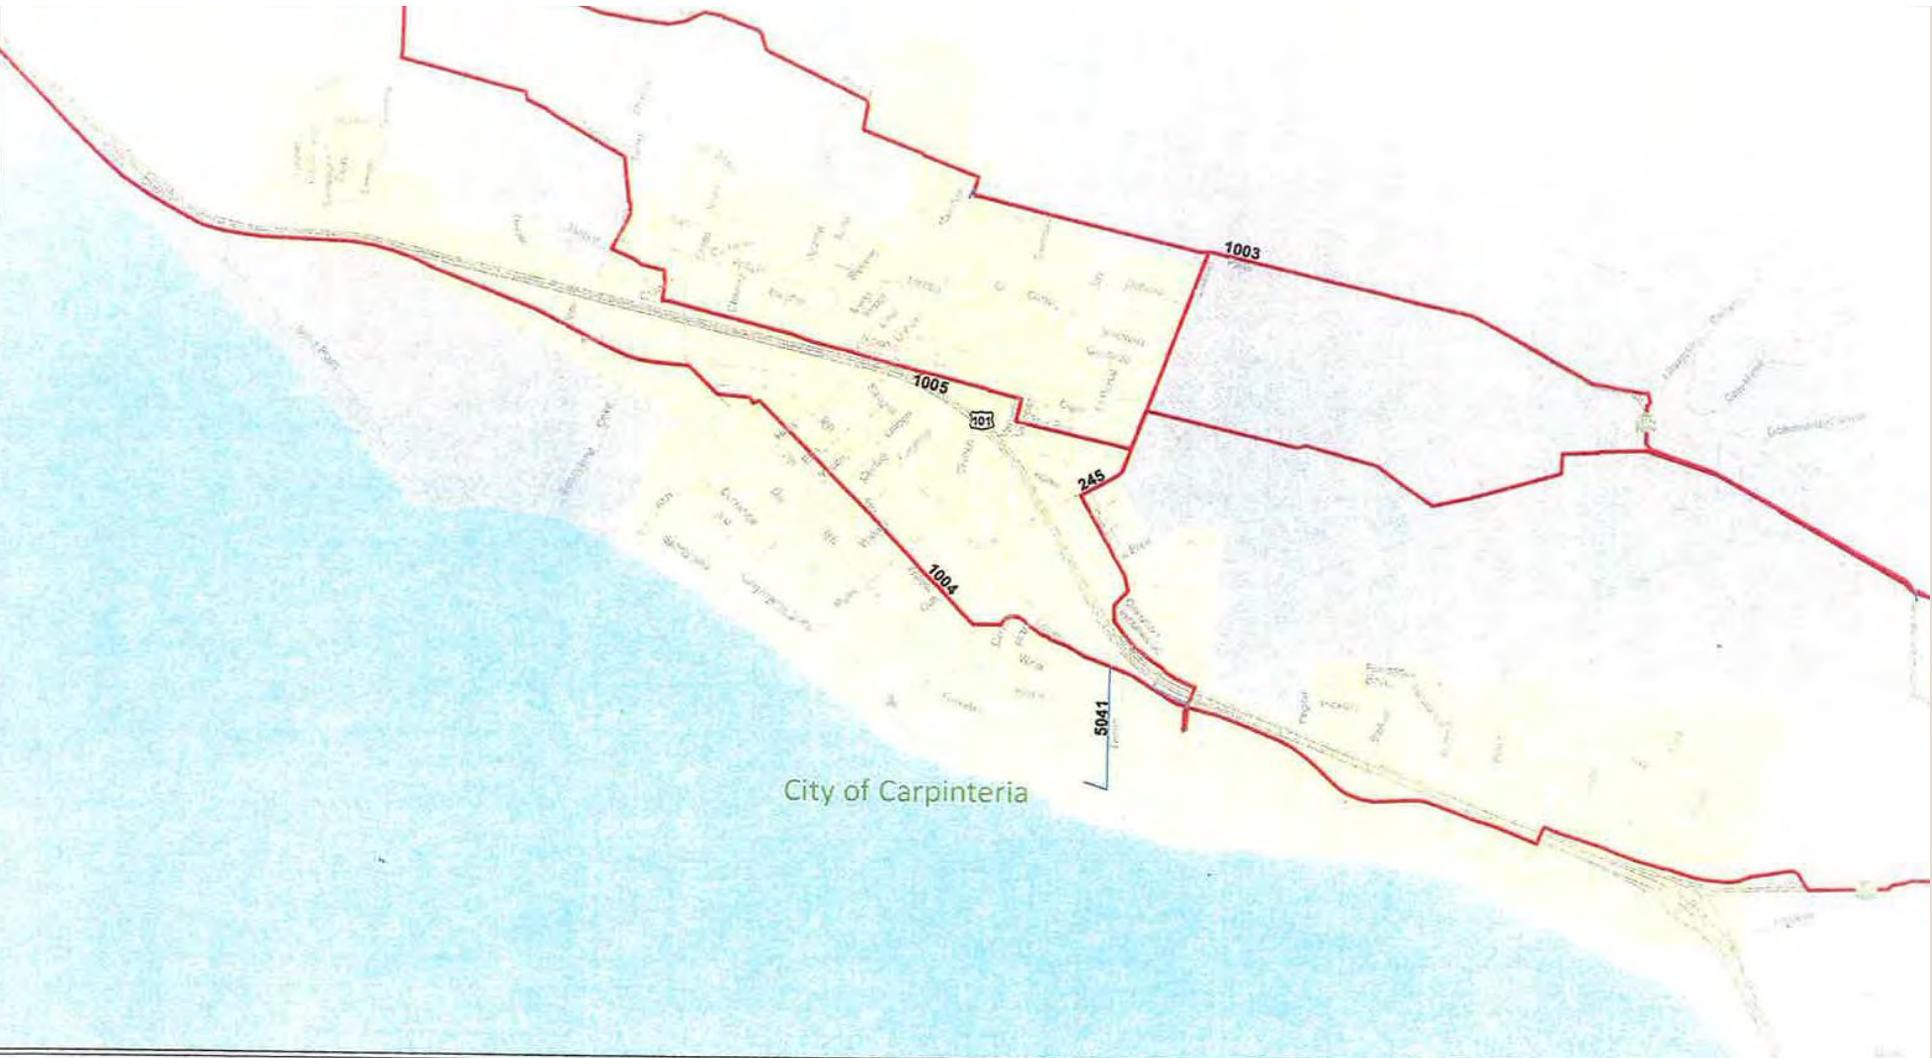
# Carpinteria Transmission System

High Pressure Gas Pipeline

- DOT Transmission
- Distribution High Pressure

**Southern California Gas Company**  
**High Pressure and Transmission System**

- Three high pressure gas transmission pipelines.
- Installed in 1930, 1944 and 1950.
- Made of steel.
- Transport odorized natural gas.
- **Automatic shutoff valves installed in the 1980's.**
- Two lines are in-line serviceable – one line is not, but it has had its pressure lowered.
- Lines are leak surveyed every two months – no leaks were detected.
- Line integrity assessment occurs every 7 years.
- Two odorant stations also located in Carpinteria.
